# Bendix Magneto Impuse coupling replacement

Steps to remove the Bendix Magneto impulse coupling.

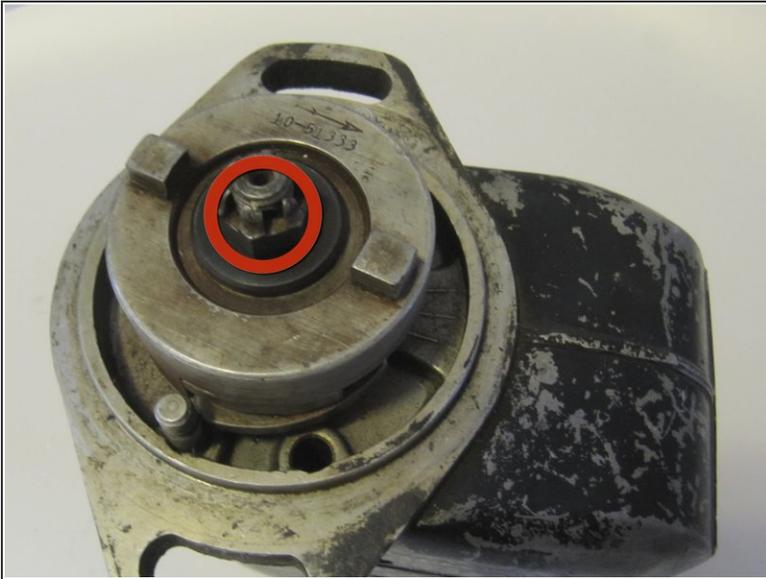
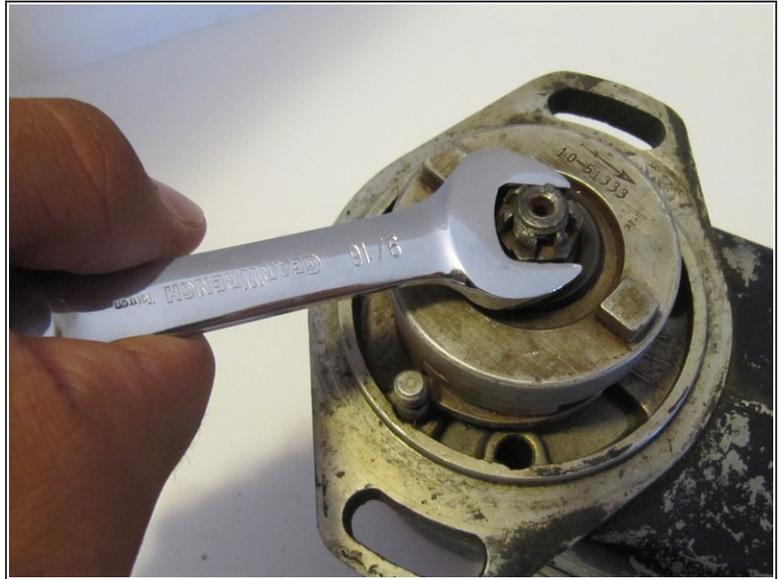
## Step 1 — Impulse Coupling

- Use a 9/16 wrench to unscrew the nut on the drive shaft.

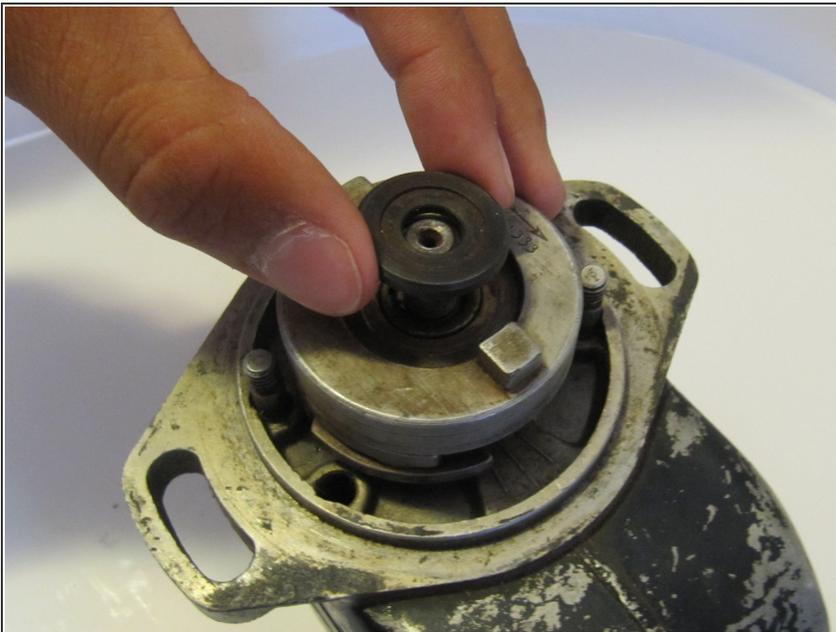
## Step 2

- Remove the lock washer underneath the nut.

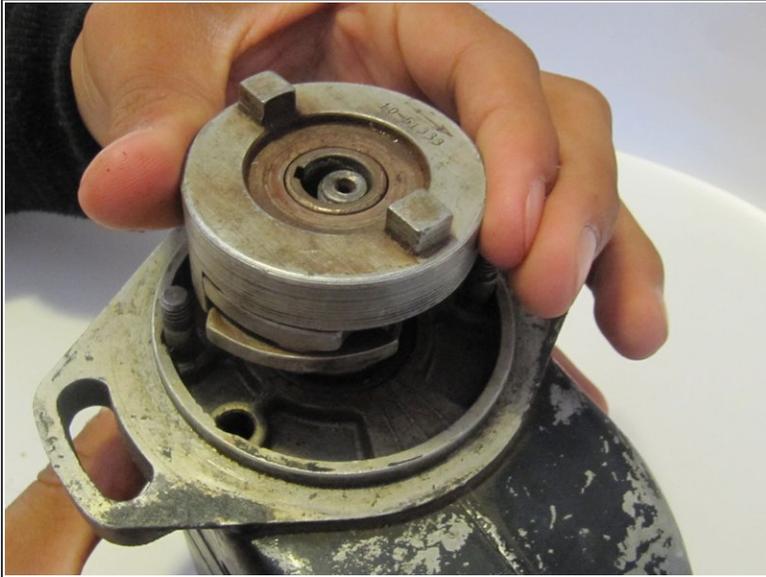
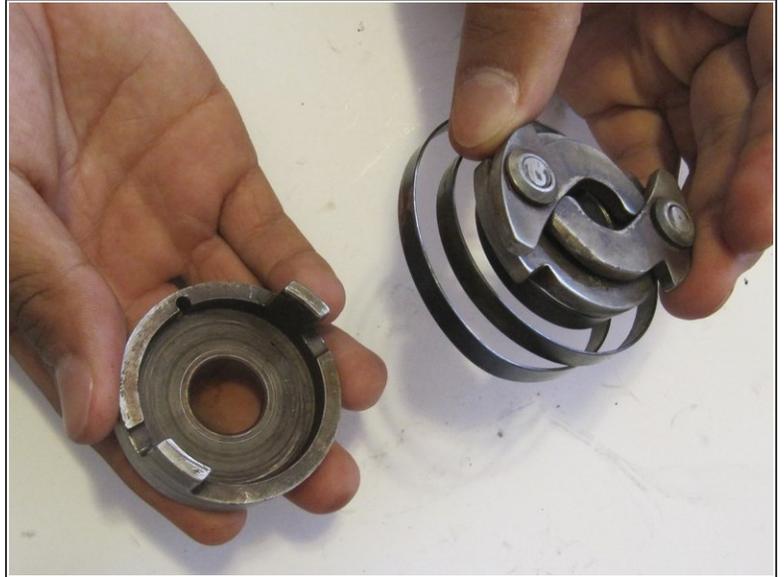
### Step 3

- Pull away the impulse coupling.

To reassemble your device, follow these instructions in reverse order.
