Dell VRP100 Auxiliary Cord Replacement

How to replace the auxiliary cord to fix the audio in a Dell VRP100.

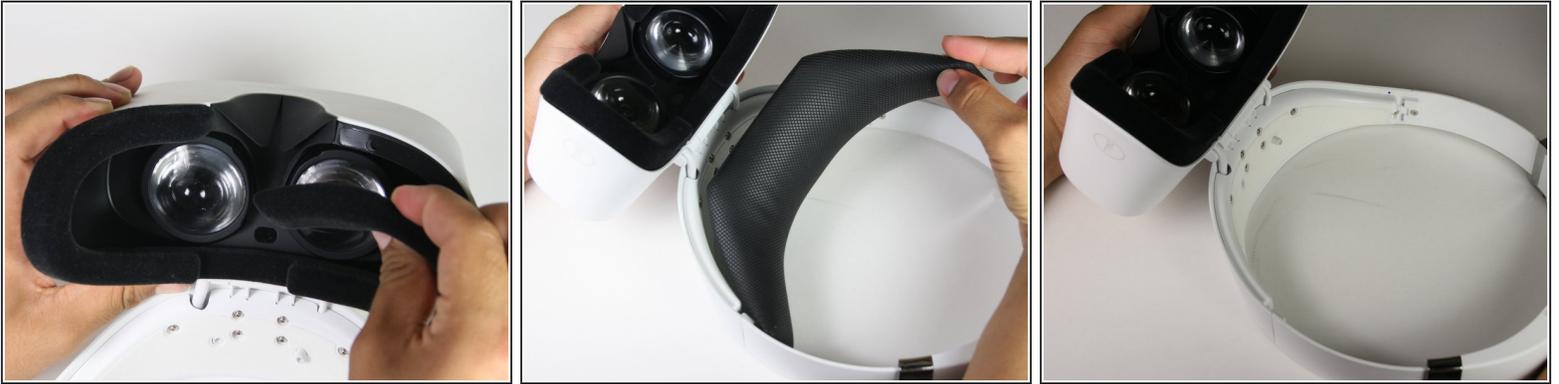
Step 1 — Cover Panel

- Remove the black foam padding by peeling away slowly.
- Remove the front and back padding from the headset by peeling away slowly.

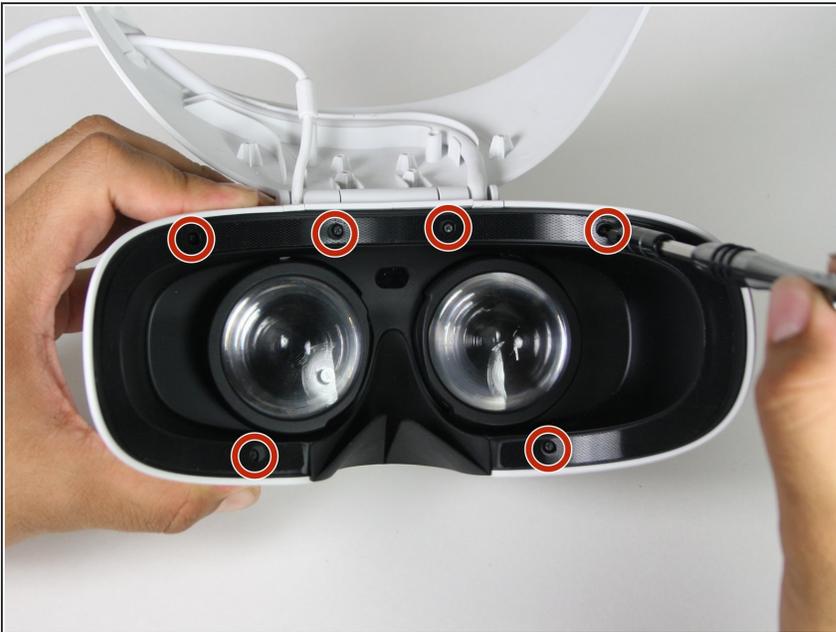
Step 2

- Remove the six 5.5mm PH000 screws from the cover by rotating counter-clockwise.
- Cover panel may need to be pushed in before inserting screws.

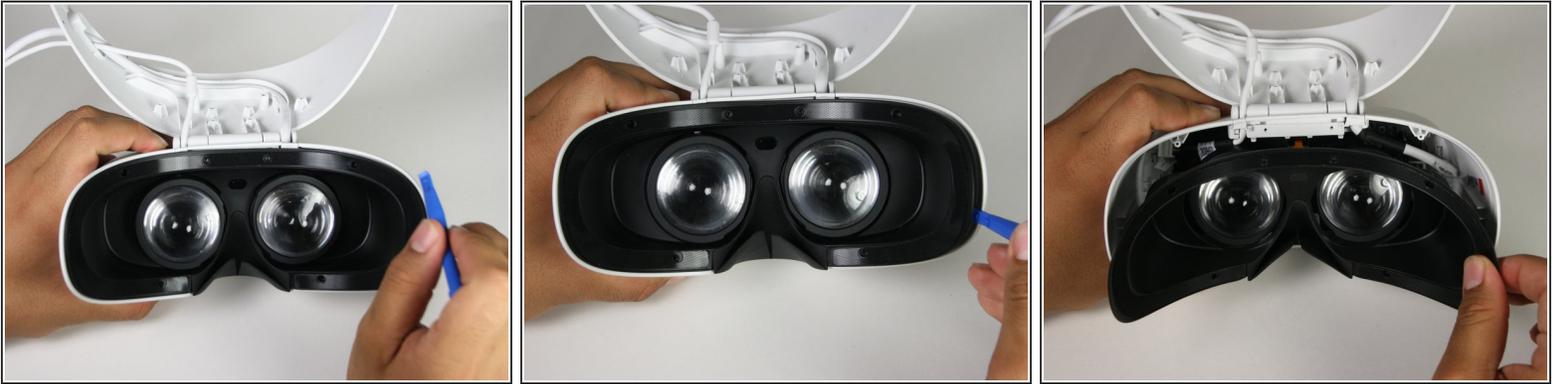
Step 3

- Remove the cover using one of the plastic opening tools, and then carefully pull it from the casing.

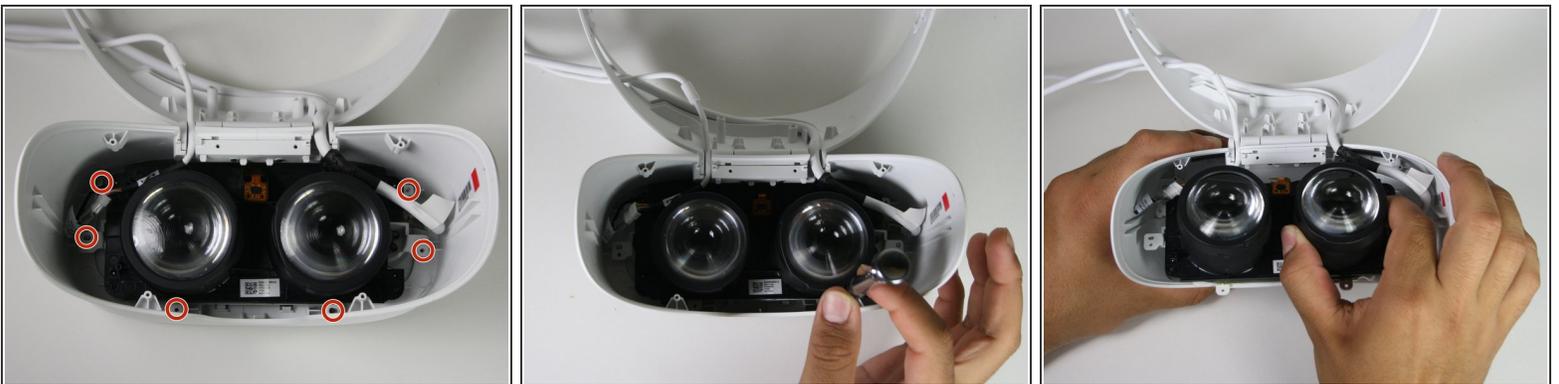
Step 4

- Remove the six 5.5mm PH000 screws from the cover by rotating counter-clockwise.
- Carefully remove the lens and motherboard assembly from the white casing.

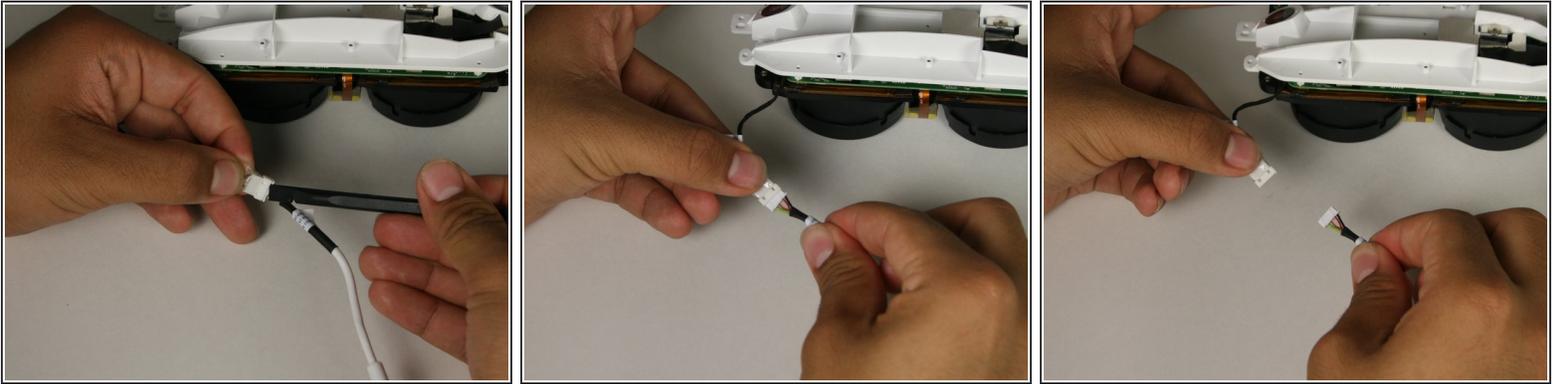
Step 5 — Auxiliary Cord

- Separate the external connector of the auxiliary cord.
- ⓘ A spudger may be needed to separate the connector.

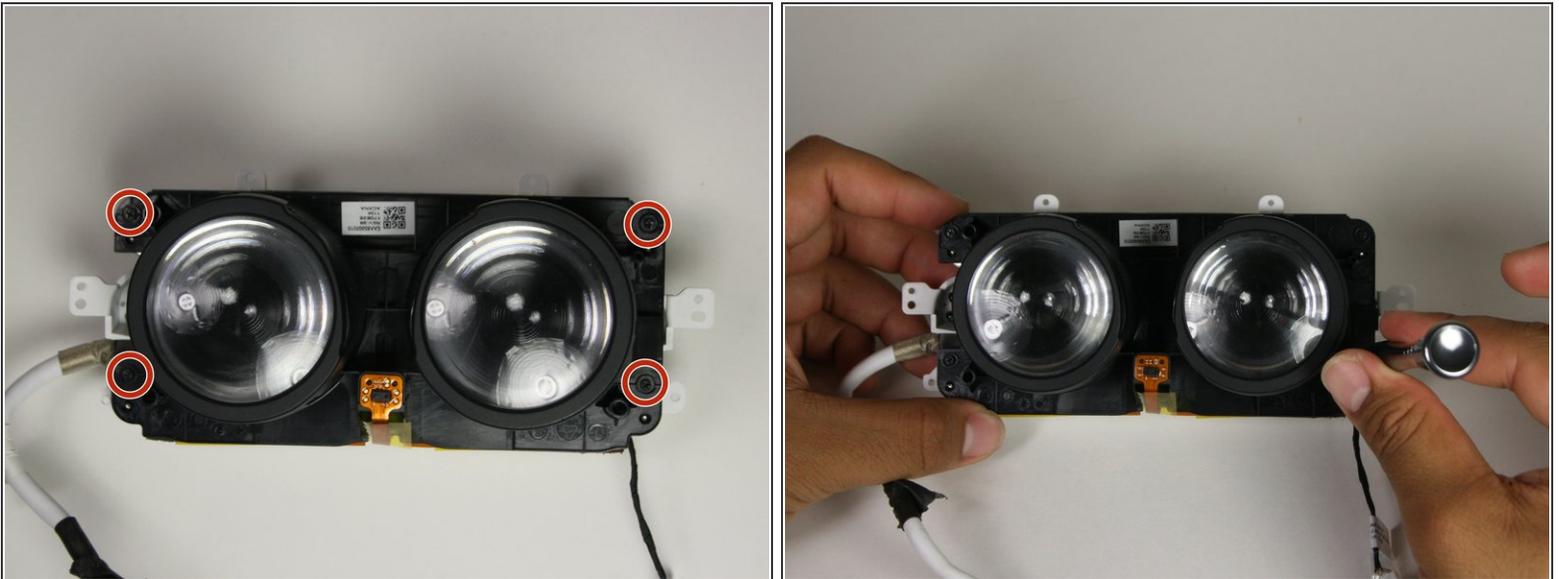
Step 6

- Remove the four 2.5mm PH000 screws by rotating counter-clockwise.
- Separate the lens housing from the motherboard panel.
