# How to Repair an Internal Leak in the Steam Wand of a Starbucks Barista

This guide will help you quickly fix an internal leak in the steam wand of the Saeco SN006 model.

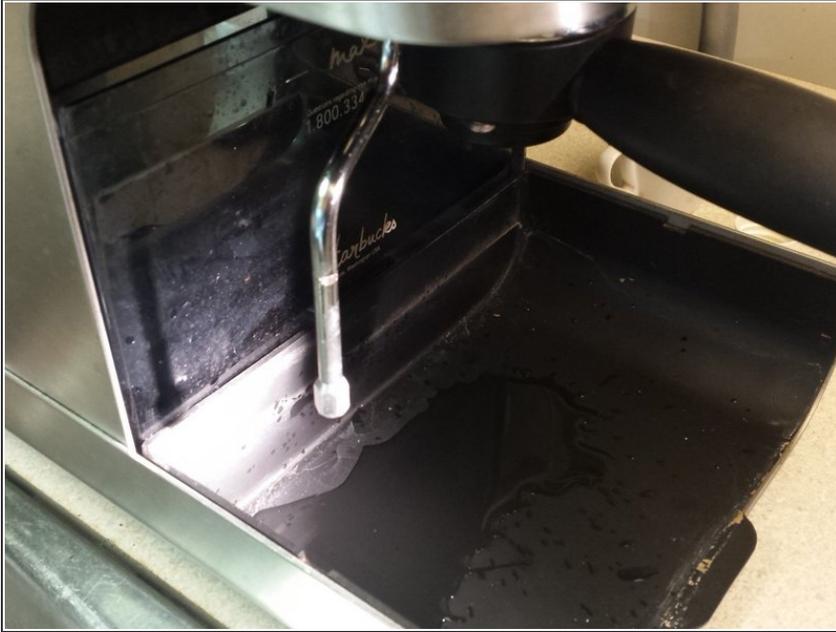
## Step 1 — How to Repair an Internal Leak in the Steam Wand of a Starbucks Barista

- When there is water leakage from the steam valve, there are 2 sources, external and internal. External leaks are a matter of replacing bushings and shown elsewhere. This guide shows how to deal with internal leakage. First, descale the machine with a commercial product, like Dezcal. Unplug the machine from the power source then follow the steps:

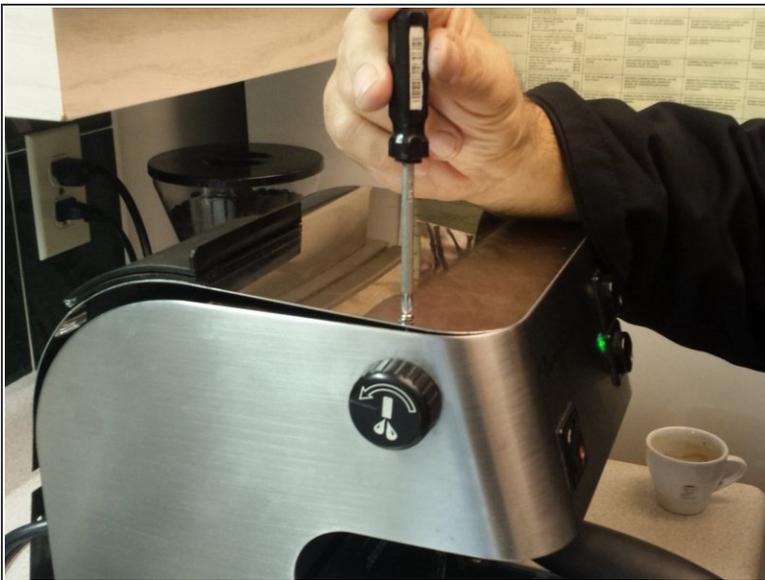
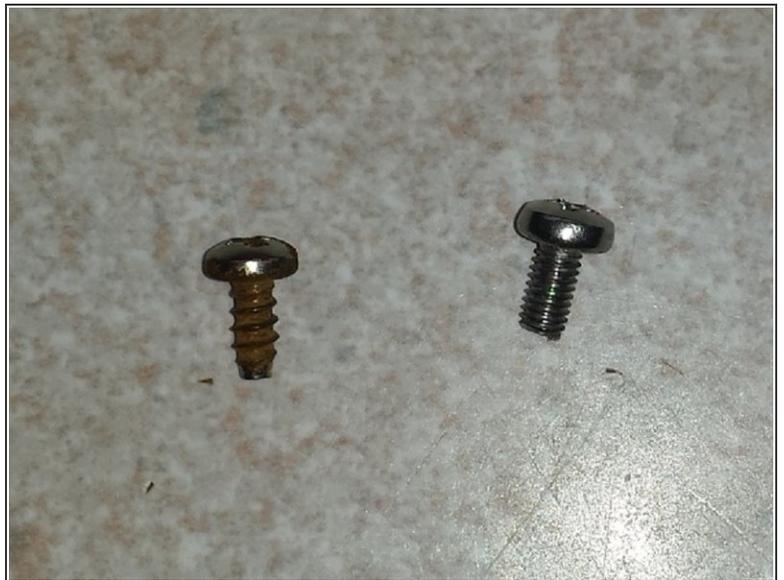
## Step 2

- Remove the six screws holding down the cover. Note that the top screws have fine threads, while the four lower screws have coarse threads. Keep this in mind for later reassembly. Once the screws are off, remove the cover.

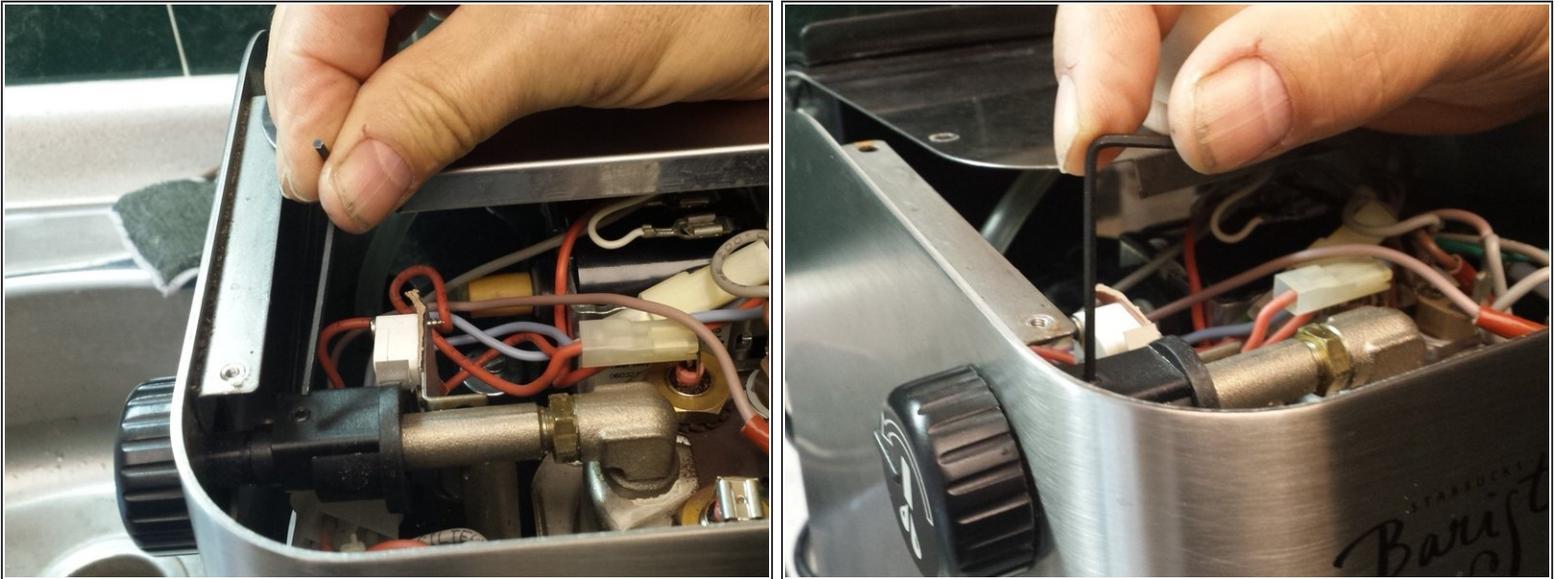
### Step 3

- Note where the steam valve knob connects to the valve assemble, at the top is a small hex nut. Use the 2mm hex wrench to loosen the nut by turning it counter clockwise, about 1/4 turn. Hold on to the wrench, keeping the steam knob shaft in the upright position.

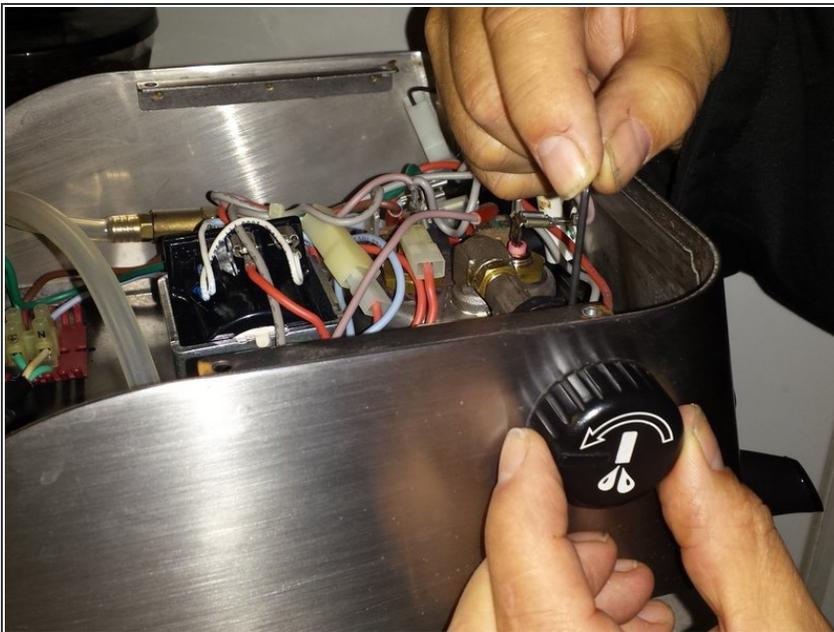
### Step 4

- Now, while bracing the hex wrench, turn the steam valve knob slightly in a clockwise direction, perhaps 1/8th of a turn or less. This is compressing the seat of the steam valve plunger to close off the water leak when the machine is on.

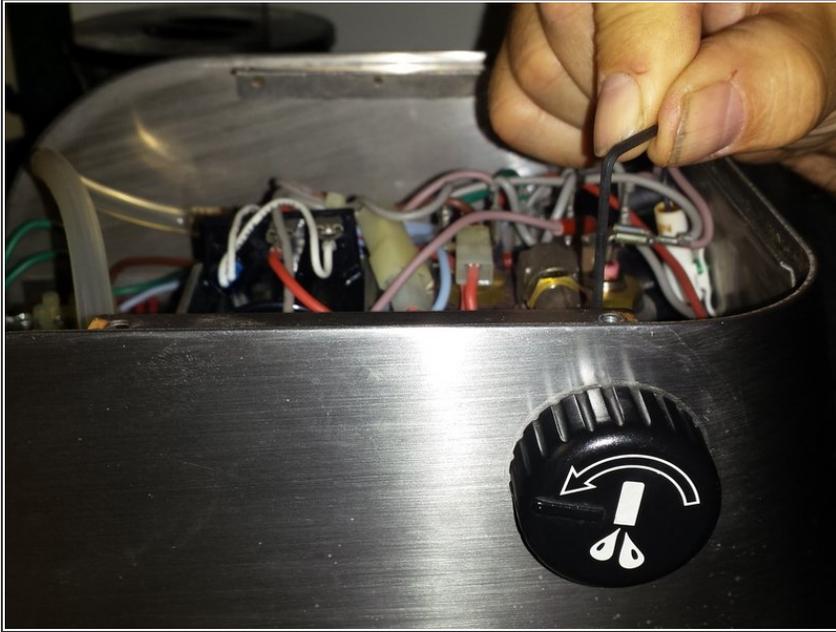
## Step 5

- Tighten the hex nut firmly.

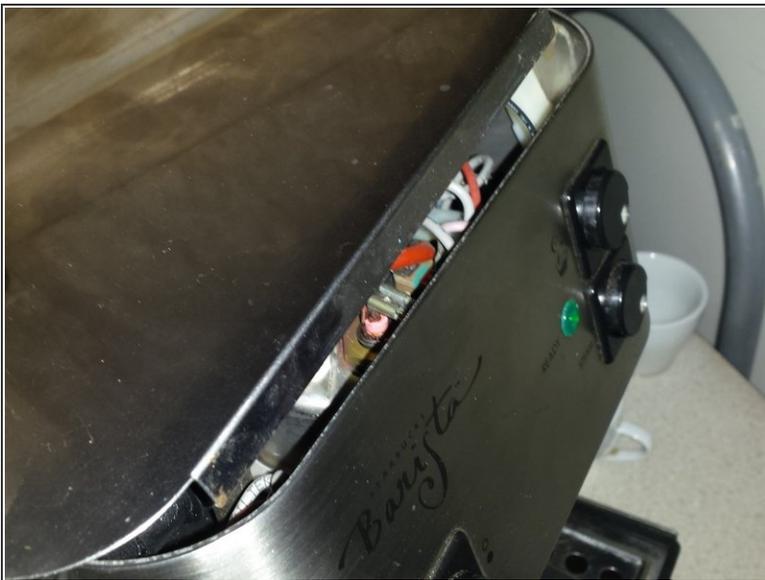
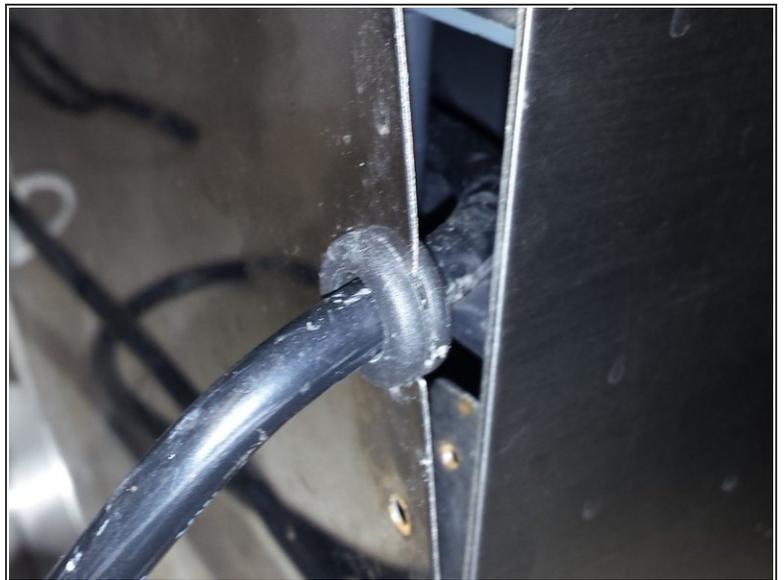
## Step 6

- Replace the cover, making sure the steel lip at the front is in its slot, and that the black plastic bushing is in place at the back of the cover. Replace two of the six screws, to save time in case you have to repeat the process.

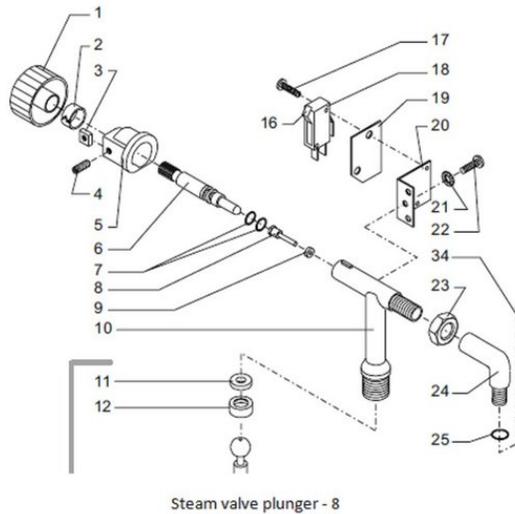
## Step 8

- If the steam wand is still leaking after a second try, then the steam valve plunger needs to be replaced. This is part number 8 on the schematic. Overhaul kits can be acquired from sources like [espressocare.com](http://espressocare.com). You can follow the tear down instructions on this site, or some of the video sources on [youtube.com](http://youtube.com).

If the wand still leaks after trying this, a more detailed repair is required.
