# Pioneer FH-X730BS Auxiliary Inlet Replacement

How to replace the Pioneer FH-X730BS Auxiliary Inlet.

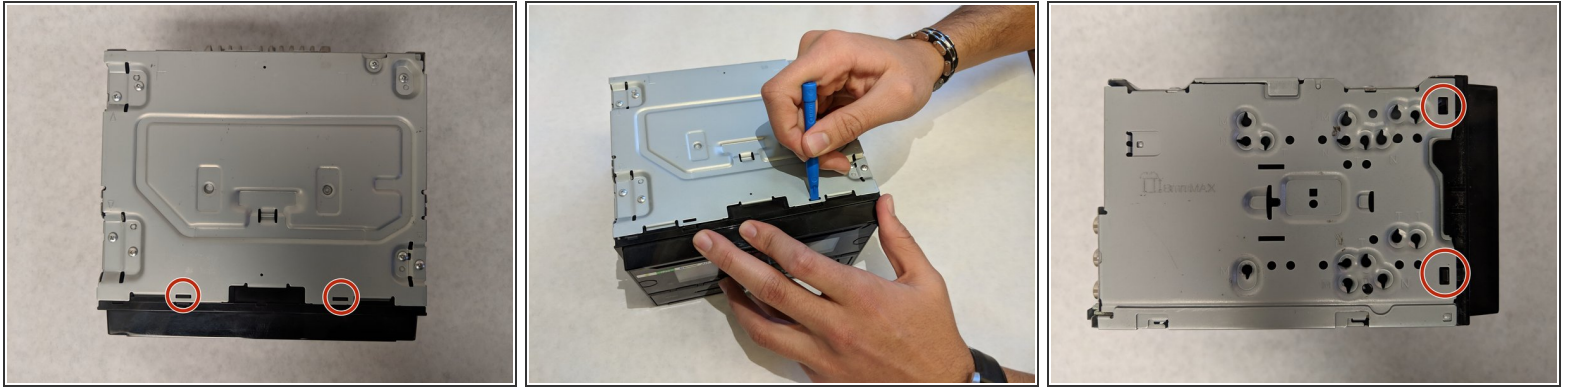
## Step 1 — Deck Buttons

- Apply pressure to the tabs on each side using the plastic opening tool.
- You will need to pull the face away from the frame while unhooking the tabs.

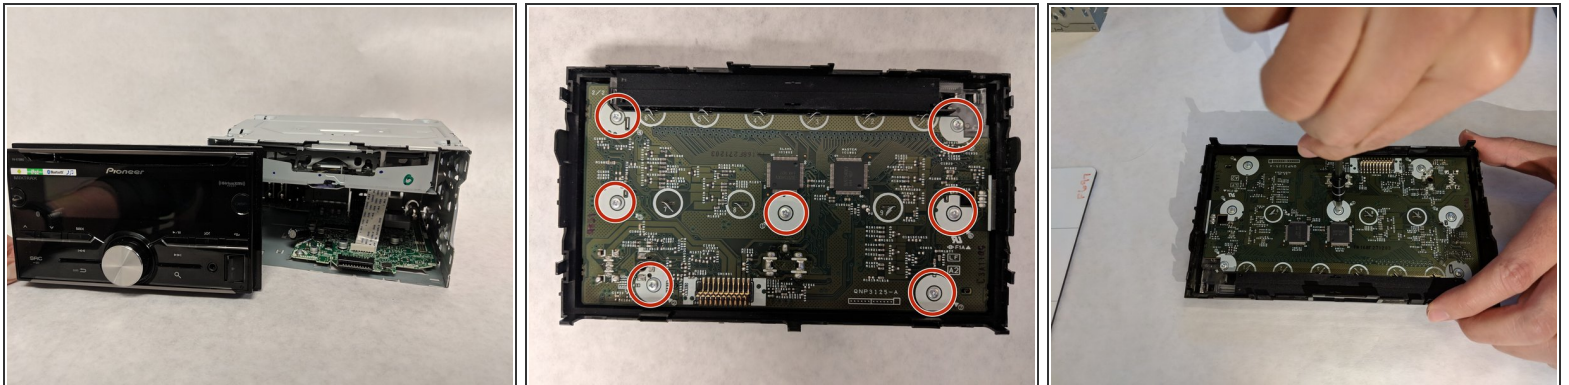
## Step 2

- After removing the stereo face from the frame it should look similar to this.
- Remove the seven 11.2mm Phillips #1 screws on the rear side of the stereo face.

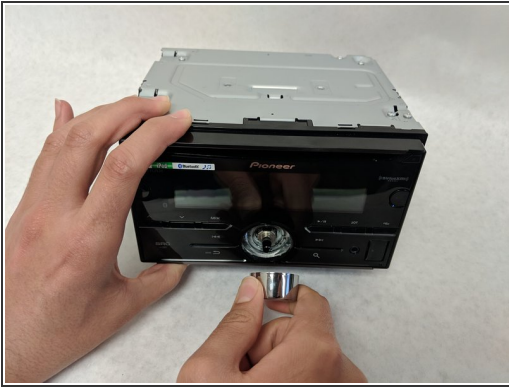
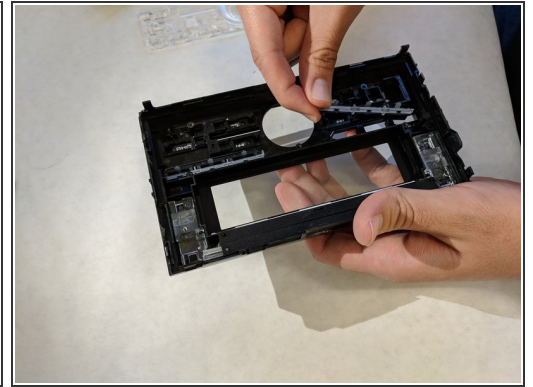
### Step 3

- Remove the volume knob by pulling it towards you and pull the motherboard out of the face.
- The audio buttons can now be taken out. You can flip the face downwards and tap the audio buttons.
- You can now insert the replacement audio buttons into the face.

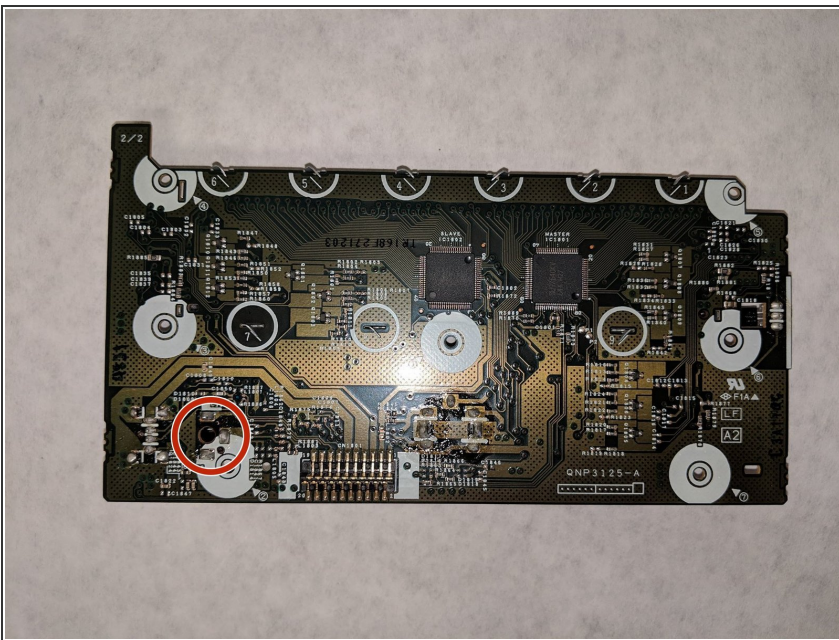
### Step 4 — Auxiliary Inlet

- Here you are able to desolder the auxiliary ports from the circuit board and solder a replacement auxiliary port on.
- ⚠ The end of the soldering iron will be hot.

To reassemble your device, follow these instructions in reverse order.
