iPad Pro 12.9" 3rd Gen Teardown

Our video team tears down the new iPad Pro 12.9", finding some hefty speakers, and lots and lots of glue.

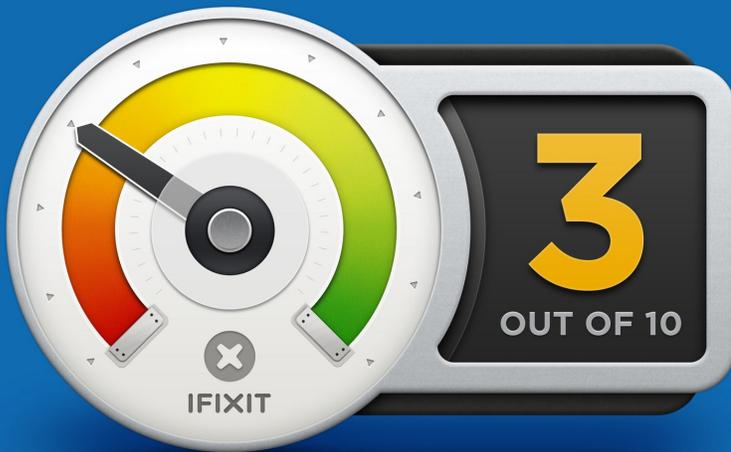
REPAIRABILITY SCORE:

- The iPad Pro 12.9" 3rd Gen earns a **3 out of 10** on our repairability scale (10 is the easiest to repair):
 - The USB-C port is modular and can be independently replaced.
 - The lack of a physical home button eliminates a common failure point and may simplify repairs.
 - The battery is secured with both easier-to-remove stretch-release tabs *and* conventional, non-removable adhesive.
 - The LCD and front panel glass are fused together—simplifying the opening procedure, but increasing the cost of repair.
 - Gobs of adhesive hold most everything in place, making all repairs more difficult.
