How to Fix Keurig K75 Platinum Brewing System Water Pump Leak

This guide will show you how to fix internal water leaks for the Keurig B70 Platinum Brewing System.

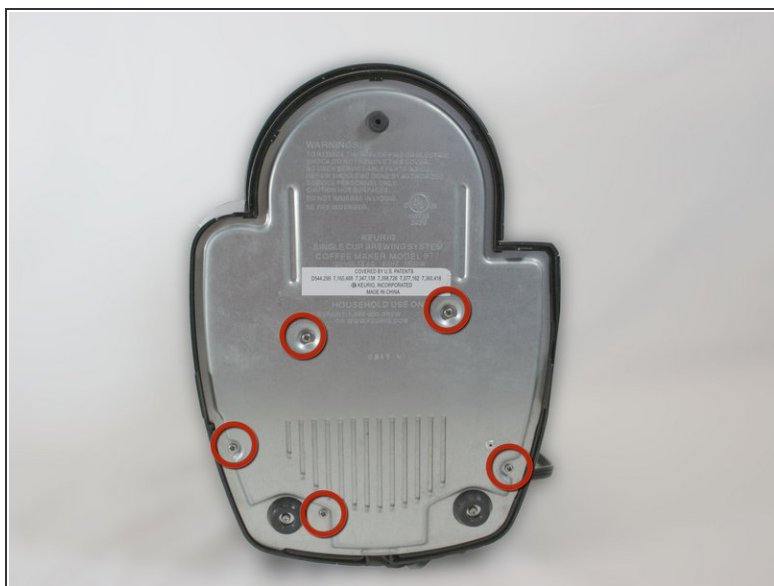
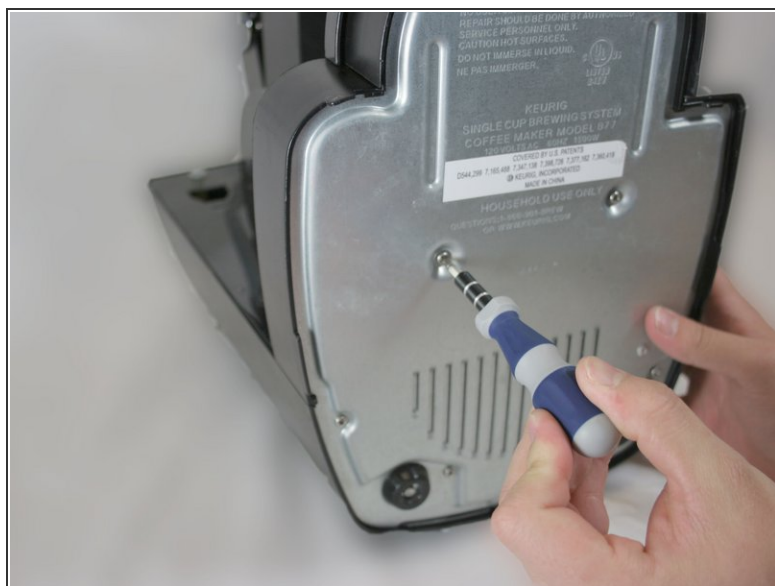
Step 1 — Baseplate

⚠ Before beginning the repair, turn off the brewer and disconnect it from any power source.

- Move the brewer so that the metal baseplate is easily accessible.
- Remove the five silver 4 mm Phillips #2 screws from the baseplate.

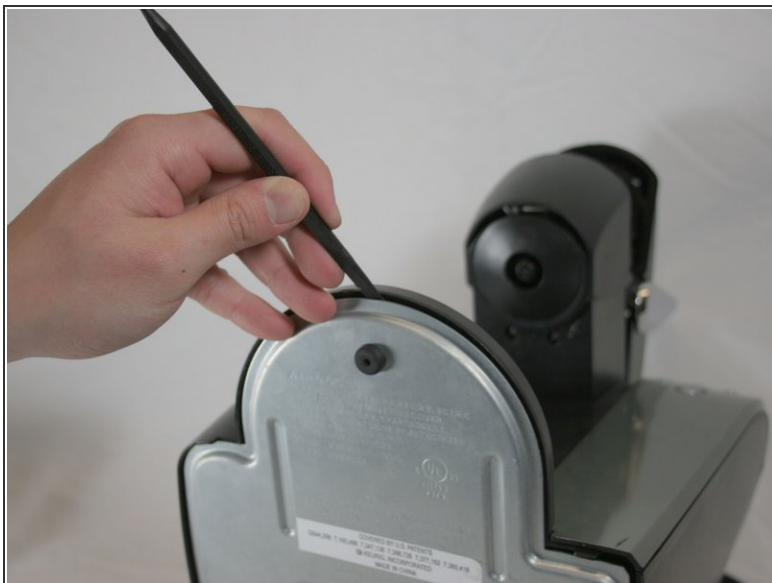
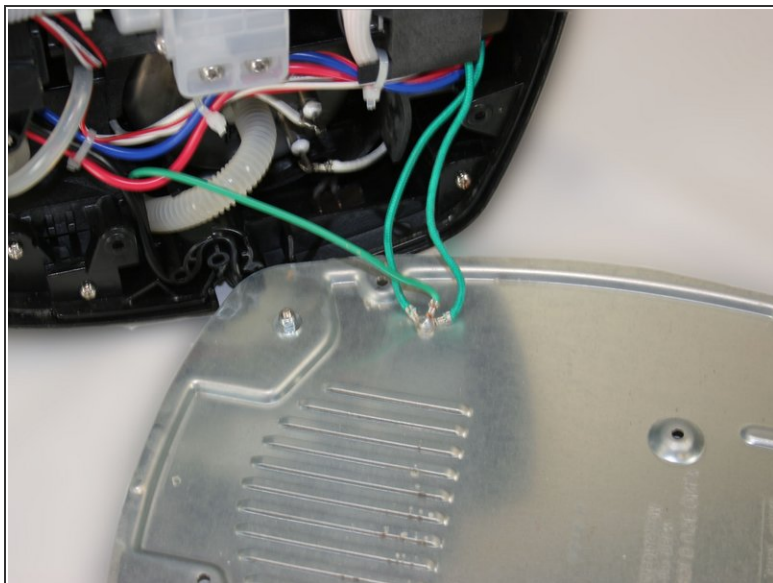
Step 2

- Using a spudger, gently pry the metal baseplate from the brewer.
- Gently set down the baseplate.

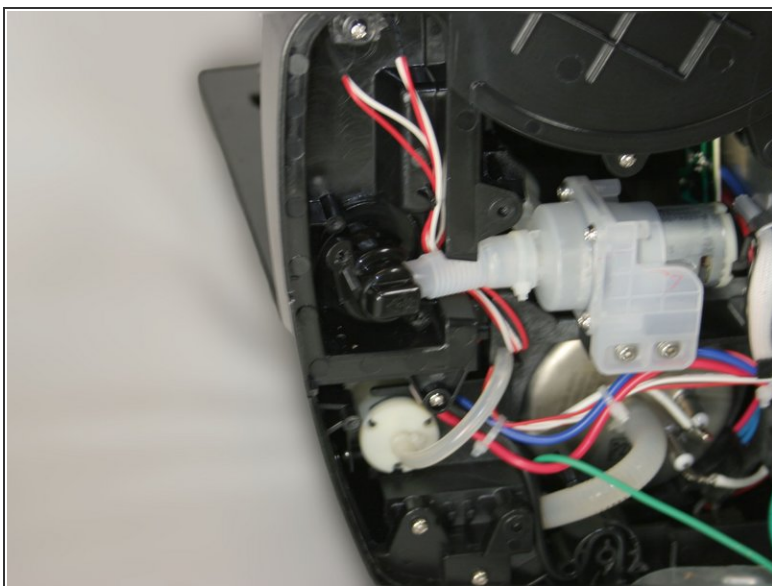
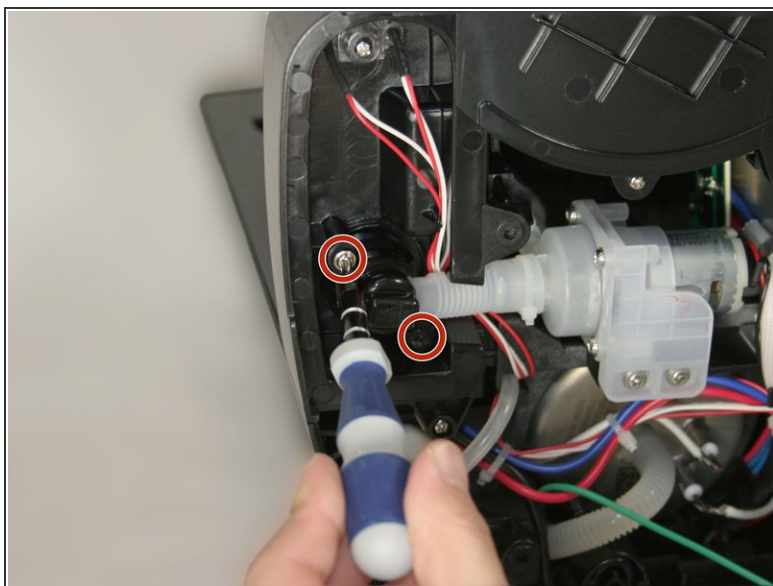
Step 3 — How to Fix Keurig K75 Platinum Brewing System Water Pump Leak

- Remove the two silver 4mm Phillips #2 screws that hold the water pump in place.

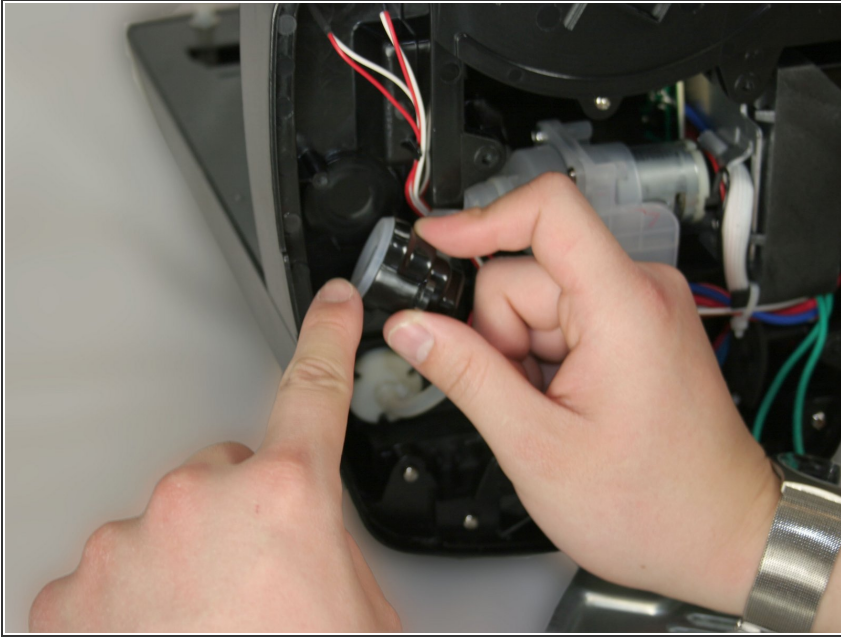
Step 4

- Realign the rubber gasket of the water pump to create a tight fit.
