GE 27990G3 Cordless Phone Teardown

Full teardown of a cordless phone from 2001.

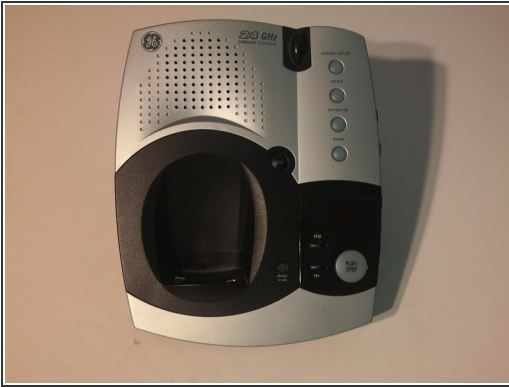
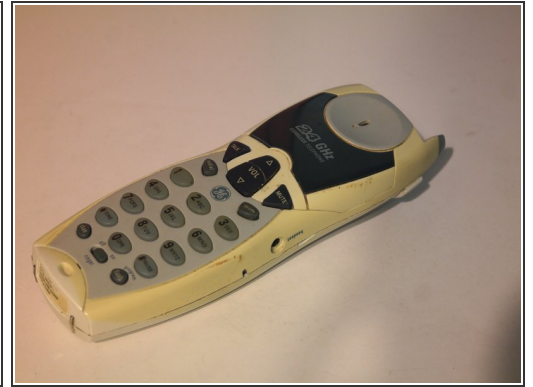
Step 1 — GE 27990G3 Cordless Phone Teardown

- This is a teardown of a GE 27990G3 cordless phone system from 2001. Sadly, while it still works, its 2.4 GHz wireless transmitter interferes with WiFi.

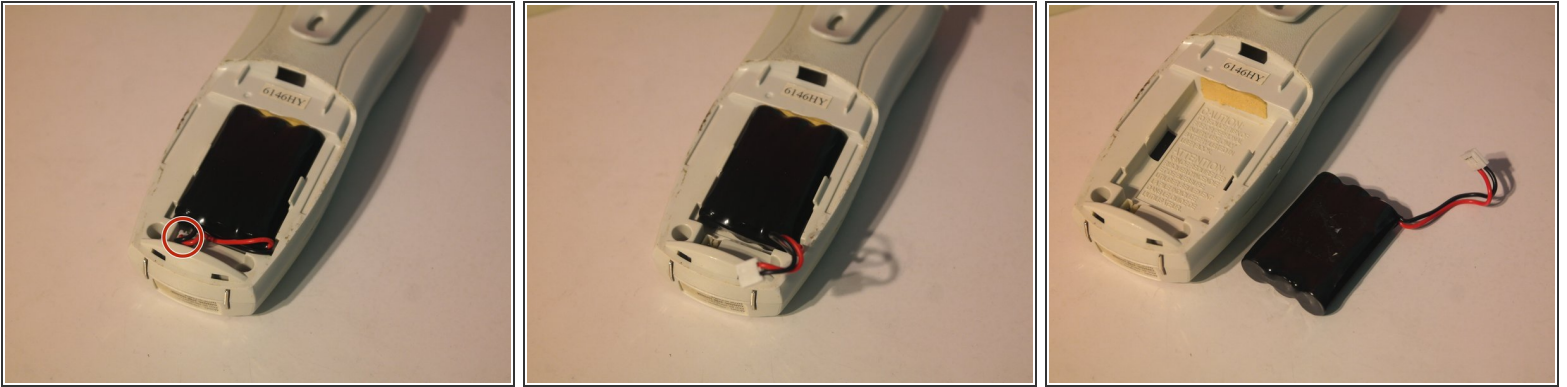
Step 3

- Use needlenose pliers to disconnect the battery connector.
- The battery is a 3.6V Nickel-Cadmium rechargeable battery made up of 3 AAA-sized cells

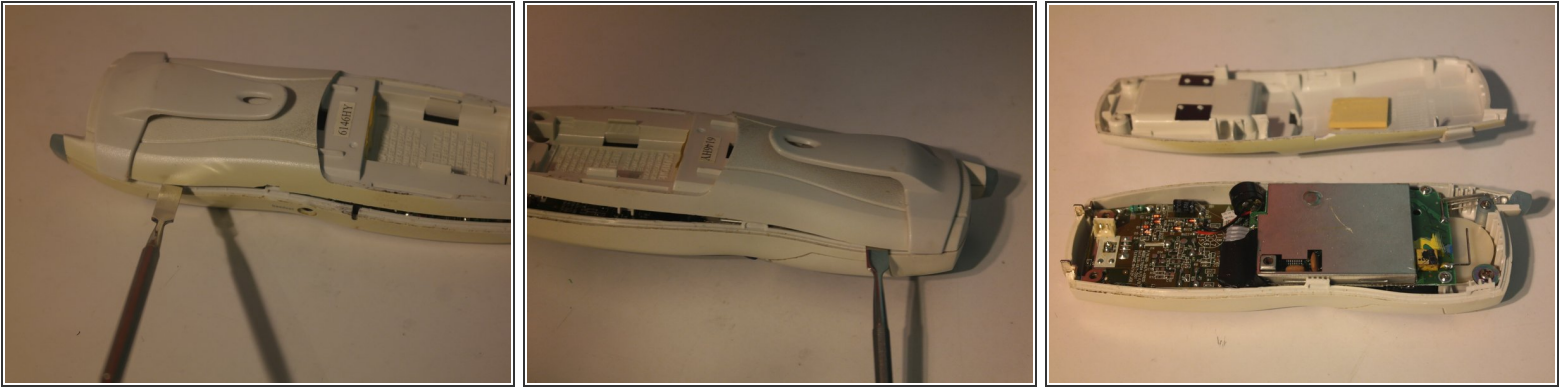
Step 5

- After some aggressive spudgering (the pictures make it look much easier), the back of the case can be removed.

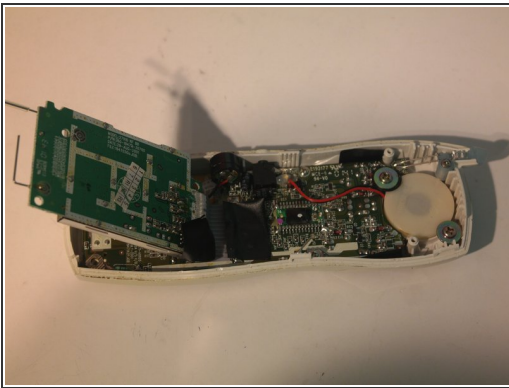
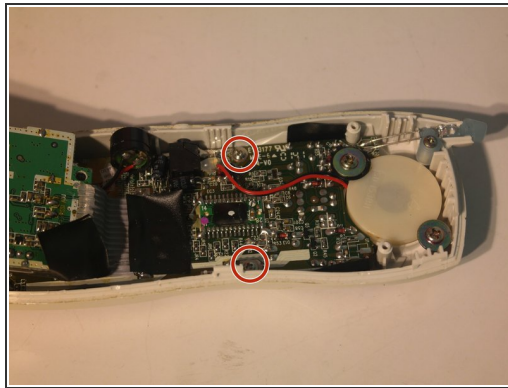
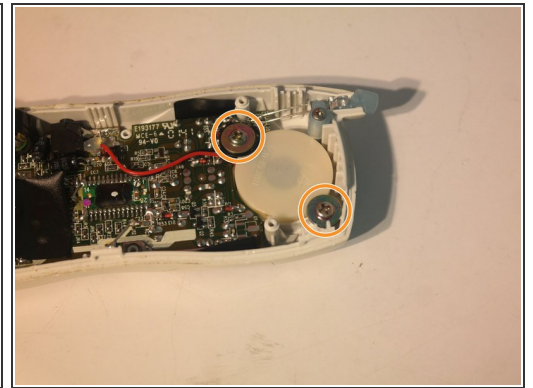
Step 8

- The wireless board can be flipped up, but is still attached to the main board by a short ribbon cable.
- Remove 2 screws on the main board.
- Remove 2 screws on the speaker.

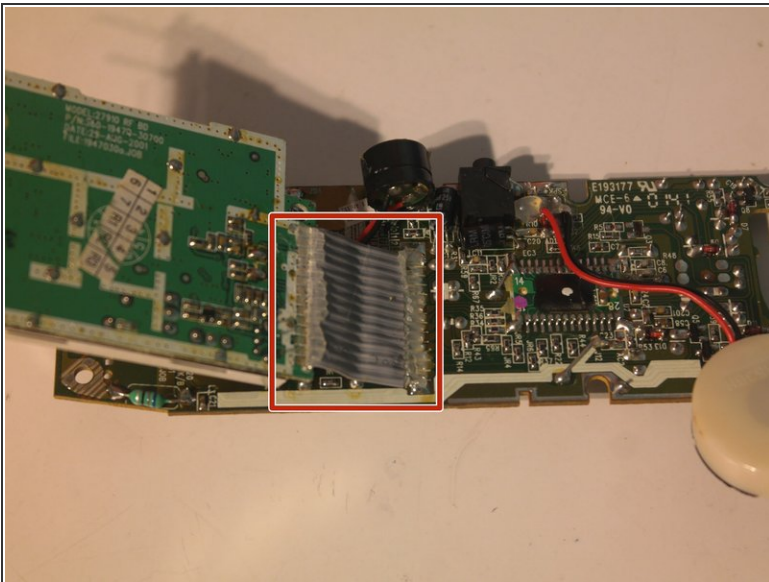
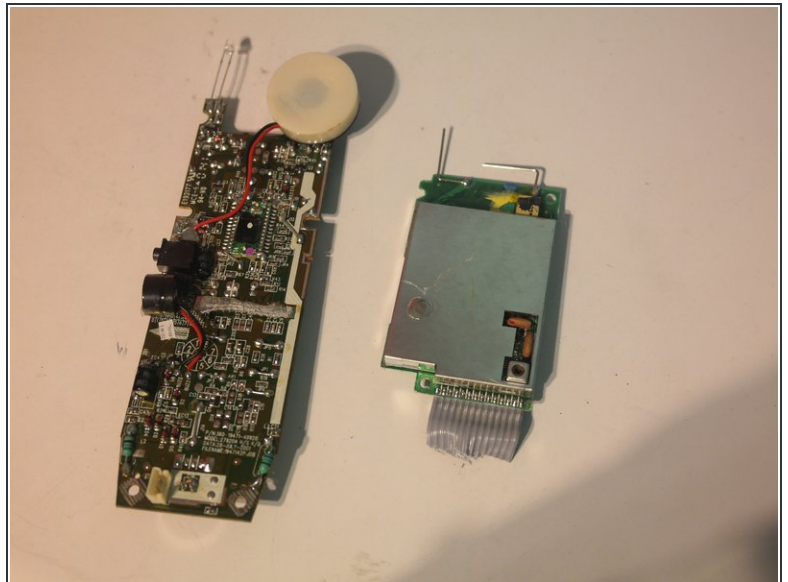
Step 10

- The wireless board is attached by a soldered and hot-glued in ribbon cable, which must be cut off to remove.

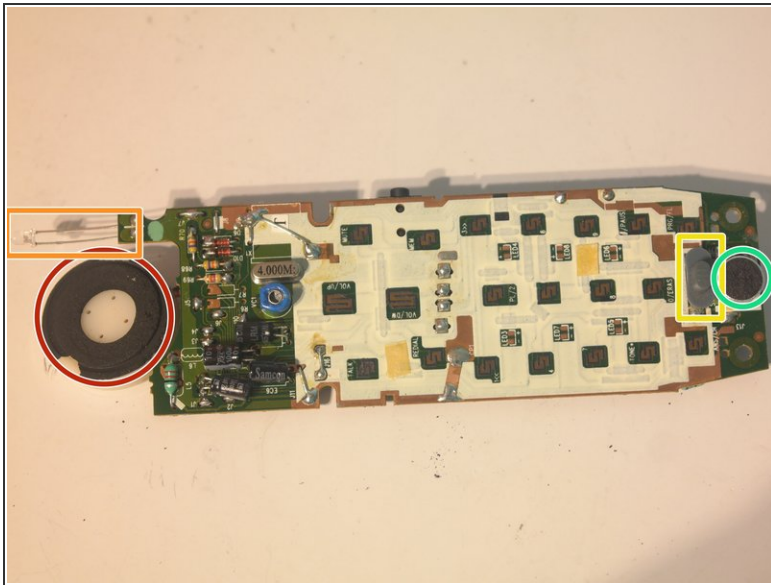
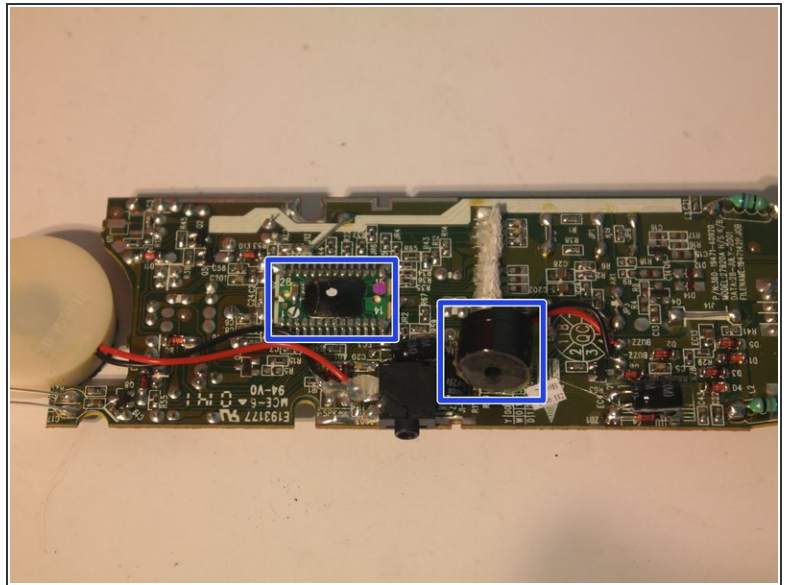
Step 11

- Components on the main board:

- Speaker
- Message indicator LED
- Ringer switch
- Electret microphone
- Unknown potted 'Blob' IC
- Piezo buzzer for ringer

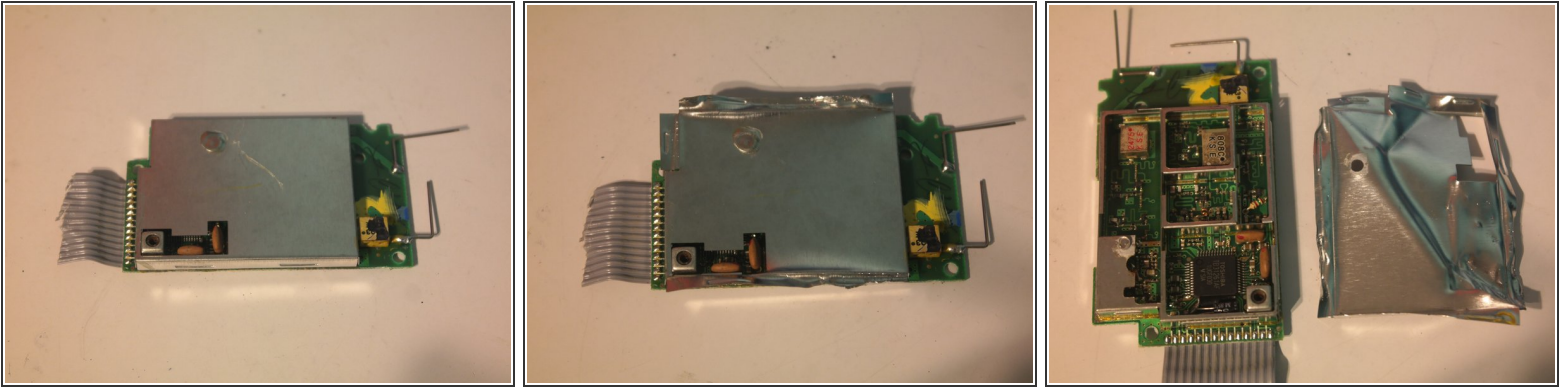
Step 12

- Whoever designed the wireless module really didn't want anyone to know what was inside. The very thick EMI shield is **soldered, crimped, and epoxied on**.
- The shield took about 20 minutes to remove with diagonal cutters, 2 pairs of pliers, and 3 metal spudgers.
- Needless to say, the shield is irreversibly damaged and the wireless module will probably never work again.

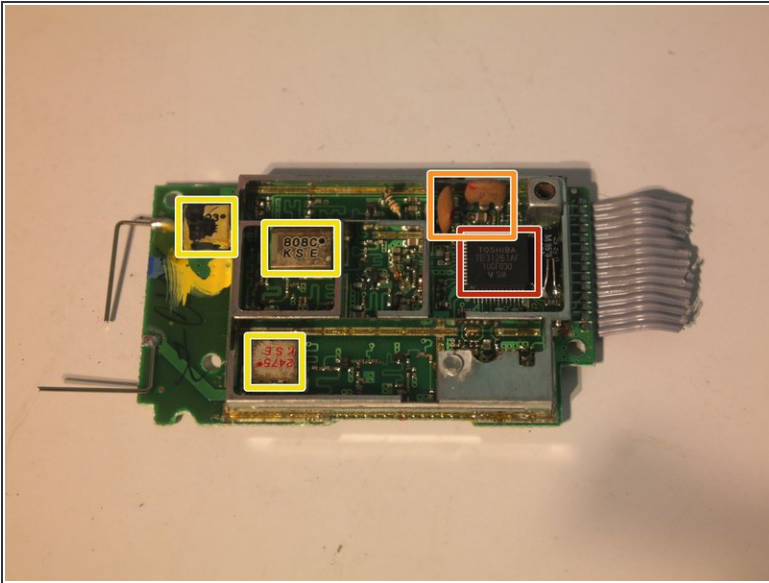
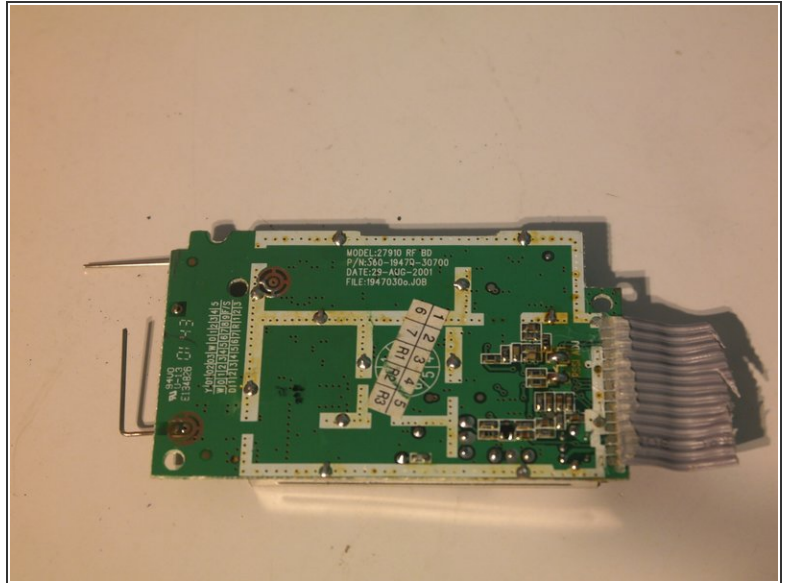
Step 13

- Components inside the wireless module:
 - Toshiba [TB31261AF](#) cordless telephone RF chip
 - Ceramic resonators
 - Unidentified square ceramic components with 2 cylindrical holes in them horizontally (anyone who has an idea what they are, please comment.)
- The back of the board says that it was manufactured on August 29, 2001, making the phone 14 years old at the time of writing.
- Interestingly, the Toshiba TB31261AF is designed for a 900MHz cordless telephone, but this is a 2.4GHz model.

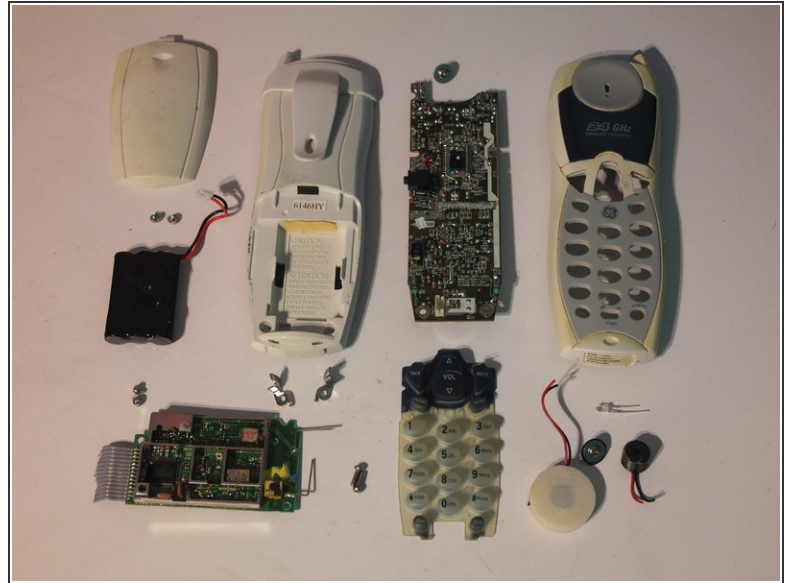
Step 14

- Repairability score: 6/10
- Phone is held together with only phillips screws.
- Battery, the most likely part to fail, is a standard component and is easily replaceable.
- Case is difficult to open.
- Wireless module is very hard to replace and impossible to repair.
- All wires (except for the battery) are soldered to the circuit board instead of using connectors.

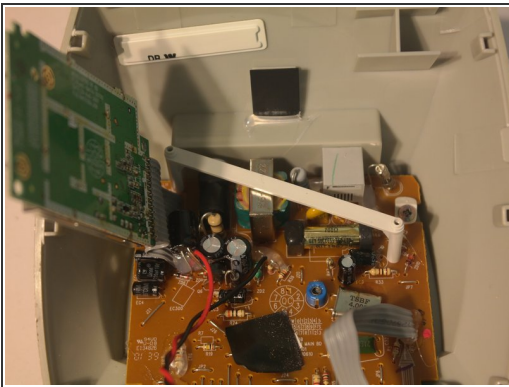
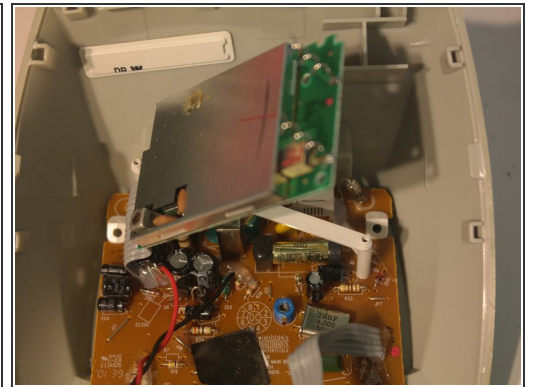
Step 18

- Just like in the handset, the wireless module is connected to the main board with a soldered ribbon cable. I'm sensing a theme here.
- Remove 2 screws that hold down the main board.

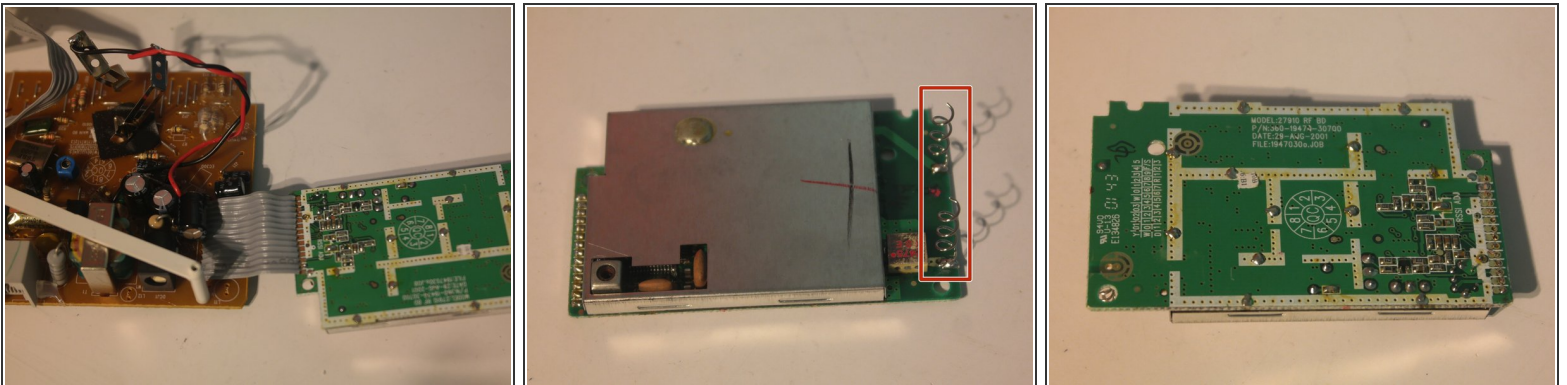
Step 20

- The wireless module can be cut away from the logic board.
- This wireless module is identical to the one in the handset except for the fact that it used coiled wires instead of straight wires for antennas.

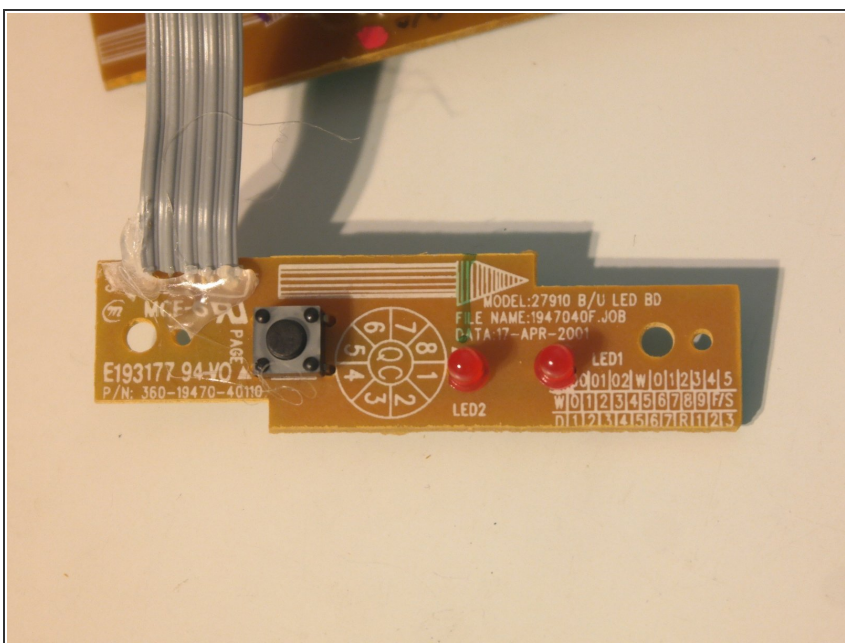
Step 22

- The button board contains a lonely button, 2 LEDs, and is connected with a soldered ribbon cable reinforced with hot glue.
- This board appears to have been manufactured on April 17, 2001.

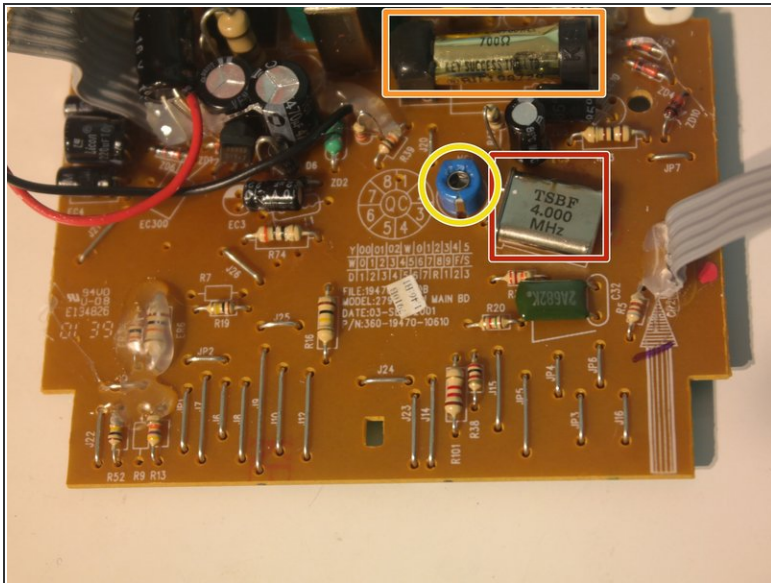
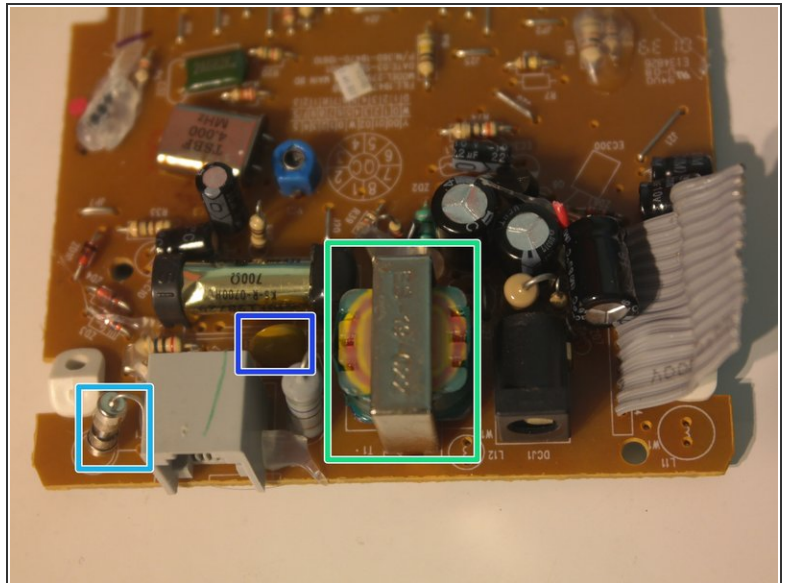
Step 23

- Components on the main board:
 - 4 MHz crystal
 - [Reed relay](#)
 - Variable capacitor
 - Small audio transformer
 - Miniature fuse
 - Varistor for surge protection
- This board was manufactured on September 3, 2001.

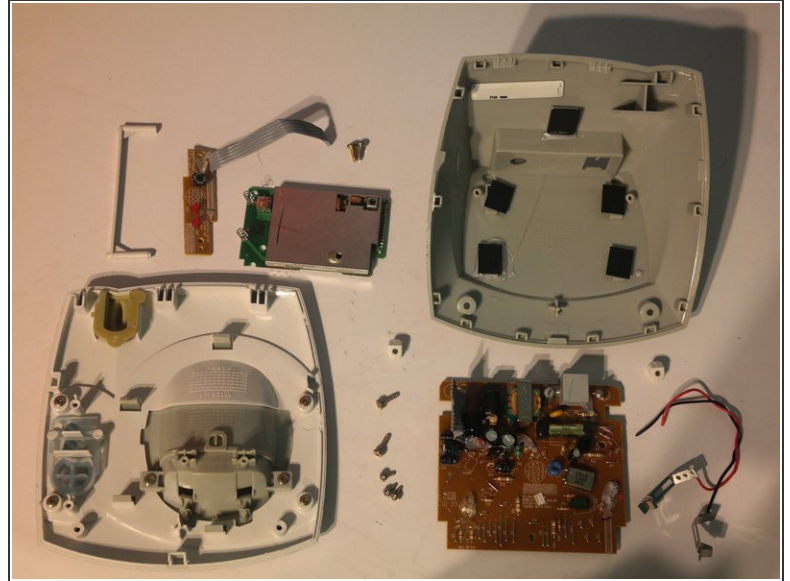
Step 24

- Repairability Score: 4/10
 - Secondary base station is assembled with only phillips screws.
 - Circuit boards use mainly through-hole parts, so repair of individual components is easier.
 - Case requires lots of spudgering to open.
 - Removing the board requires a long screwdriver.
 - Wireless module is very hard to replace and impossible to repair.
 - All wires and ribbon cables are soldered to the board and reinforced with hot glue.

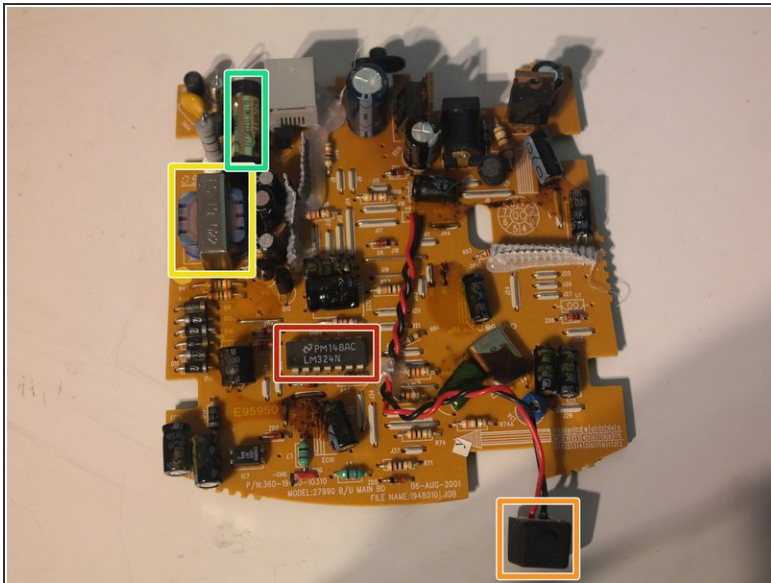
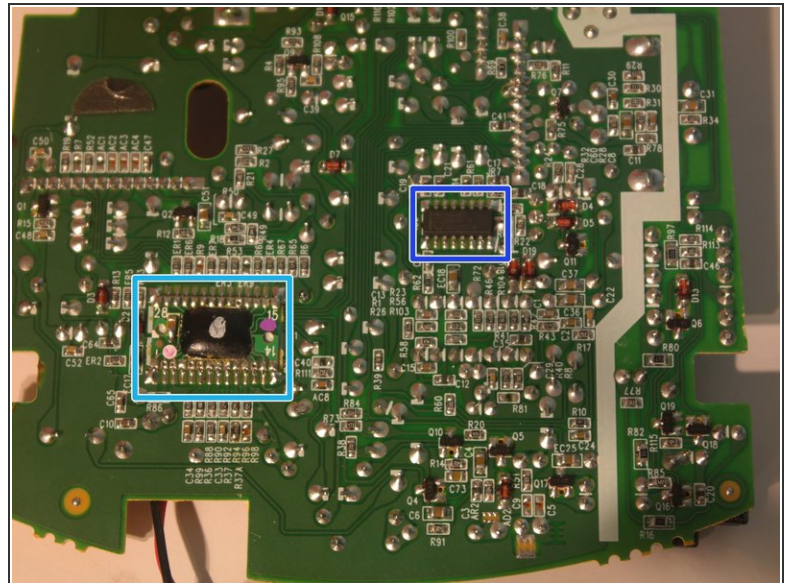
Step 31

- Components on the main board:
 - [LM324](#) Quad Operational Amplifier
 - Electret microphone
 - Small audio transformer
 - Reed relay
 - Same potted 'Blob' IC found in the handset
 - [HEF4053](#) triple SPDT analog switch

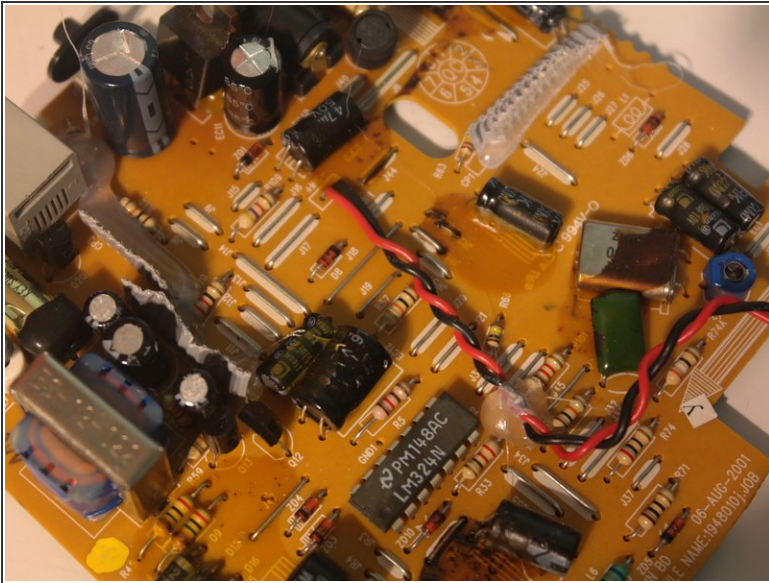
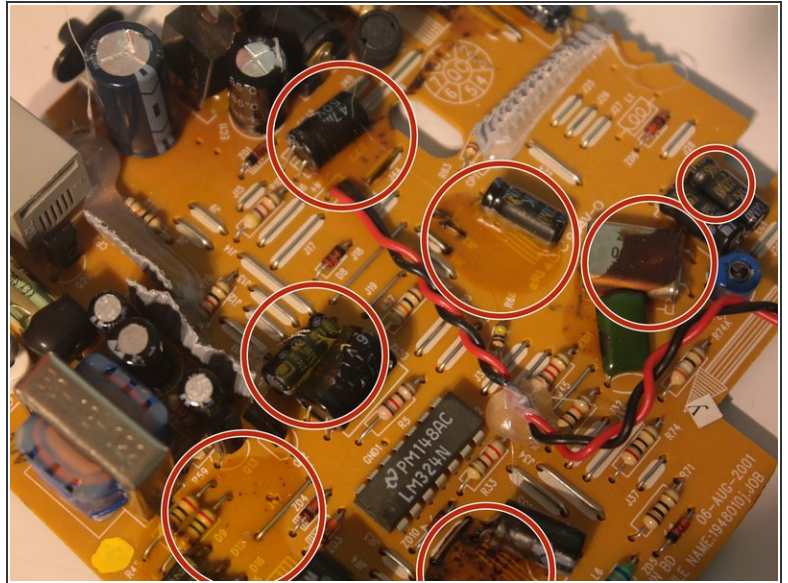
Step 32

- The main board in the base station has patches of an unknown yellowish-brown substance on it that appears to be some kind of weak adhesive, and it seems to be scattered in no obvious pattern.

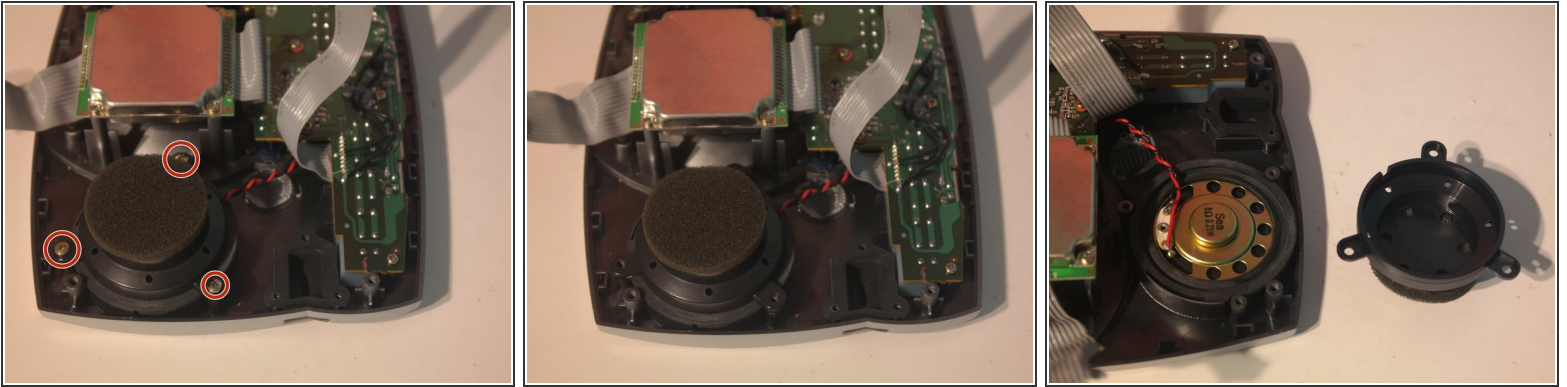
Step 34

- Remove 3 screws to remove the speaker cover.
- This speaker cover appears to have been designed to accomodate both a low-profile speaker and a speaker with a larger magnet on the back.

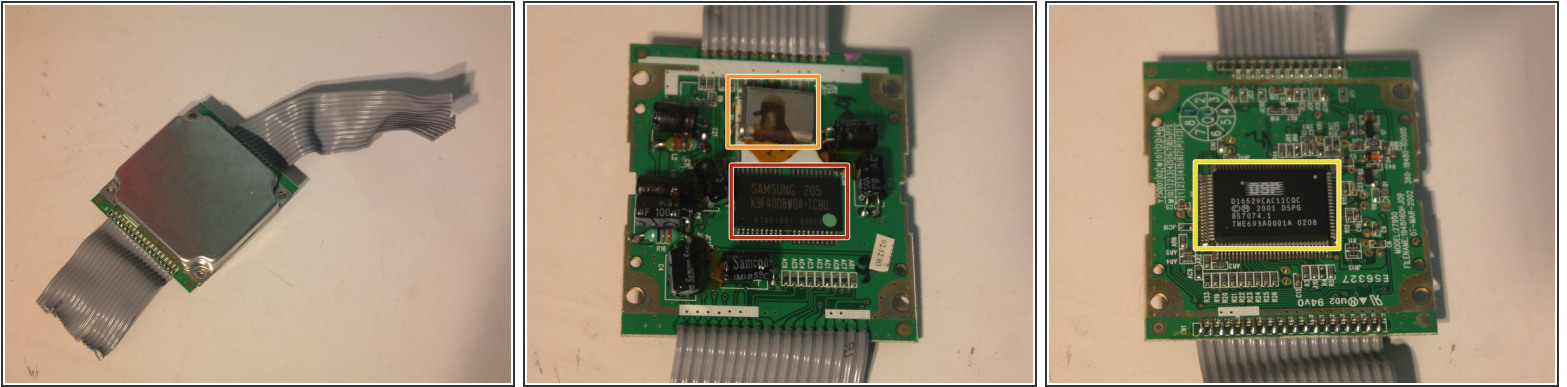
Step 38

- So what is inside the mysterious metal box?
 - [Samsung K9F4008W0A-TCB0](#) 512x8 Kb (512 KB) flash memory (designed for digital audio recording)
 - Crystal oscillator, covered in the same unusual substance found on the main board.
 - Unknown IC [D16529CAC11CQC](#). Googling it turns up nothing that makes any sense.
- This board is probably where the messages are stored.

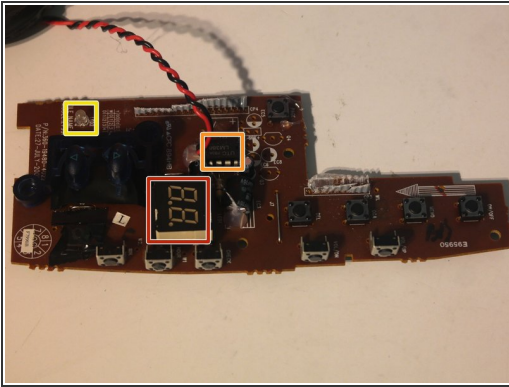
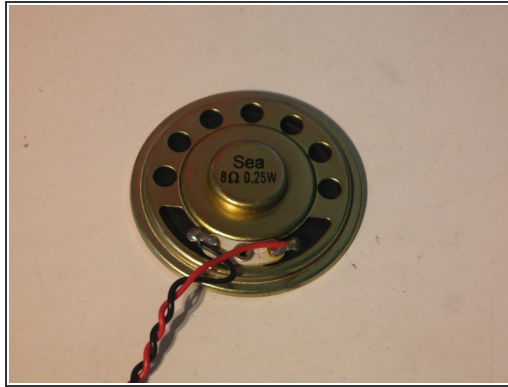
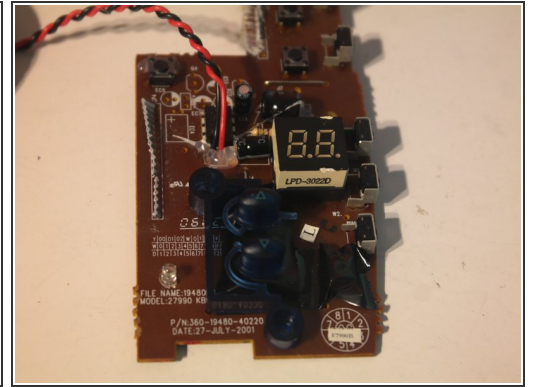
Step 39

- The major components on the top case board:
 - Dual 7-segment display
 - [LM386](#) audio amplifier
 - Message indicator LED
- This board was manufactured on July 27, 2001.
- The speaker is a standard 2" low profile 8 ohm 0.25 watt speaker.

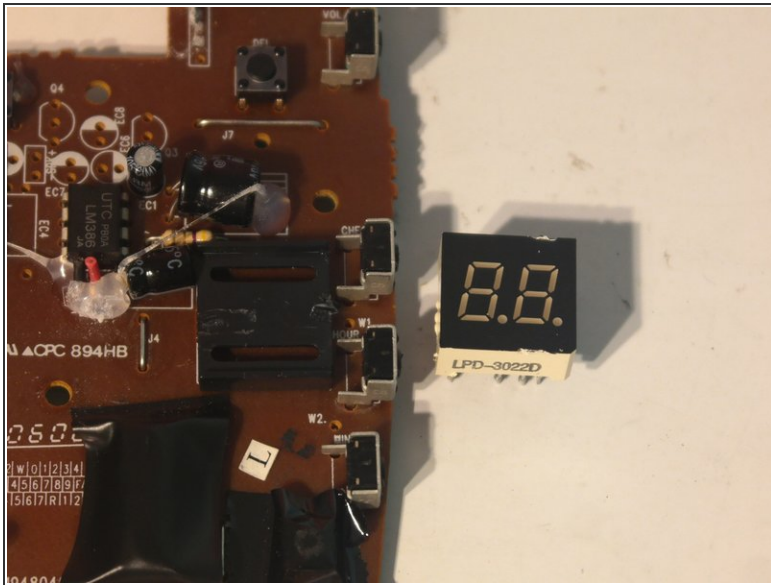
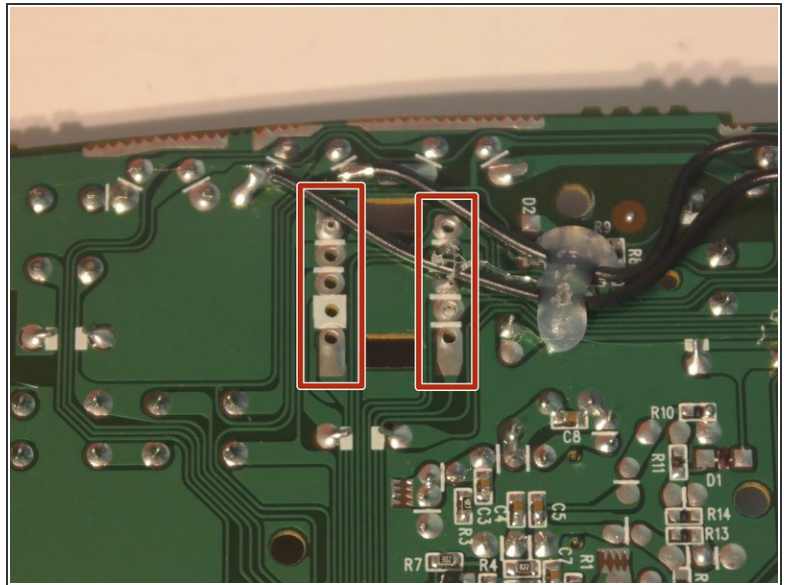
Step 40

- All of the boards in this phone system have **terrible** solder quality. I was able to cleanly remove the 7-segment display, about 20 capacitors, 3 voltage regulators, 1 transformer, and 2 crystal oscillators without damaging them using needle nose pliers.
