Philips Norelco BeardTrimmer 3100 Blade Replacement

Removing the blades on the Philips Norelco 3100 BeardTrimmer.

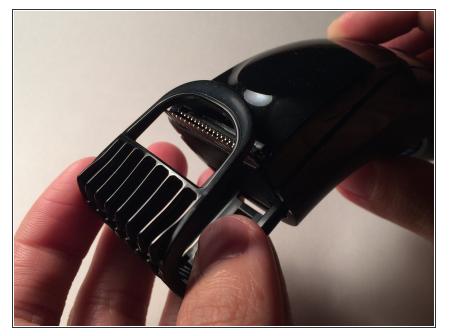
Step 1 — Blade

• Remove the comb from the head of the trimmer.
