Chef's Choice M115 Linkage Pins Replacement

Written By: James Herin

INTRODUCTION

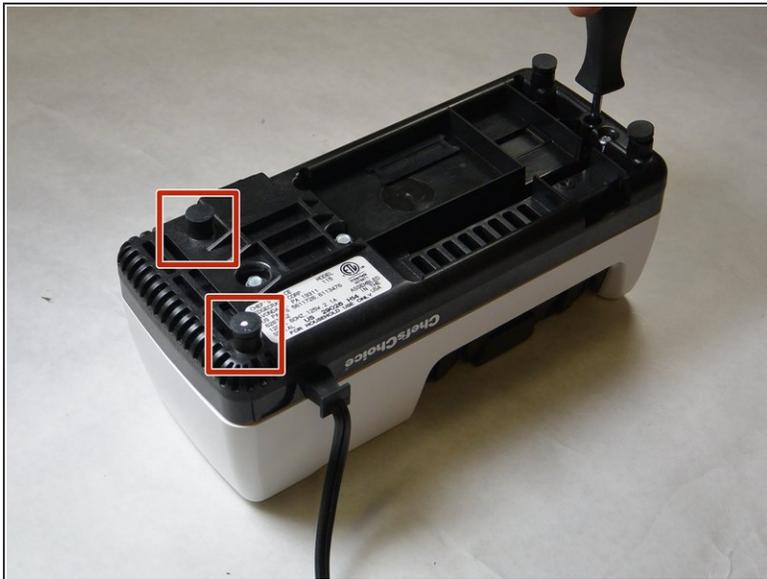
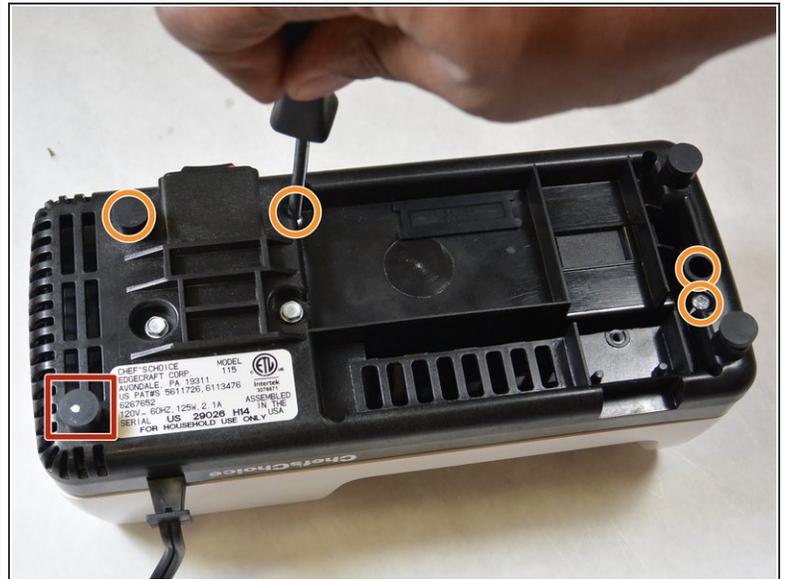
Step 1 — Case

- Remove the two rubber feet on the motor side of the device.
- Remove the five Phillips screws from the bottom of the case.
- ⓘ These screws are recessed deep in the device, so a long, thin screwdriver is required.

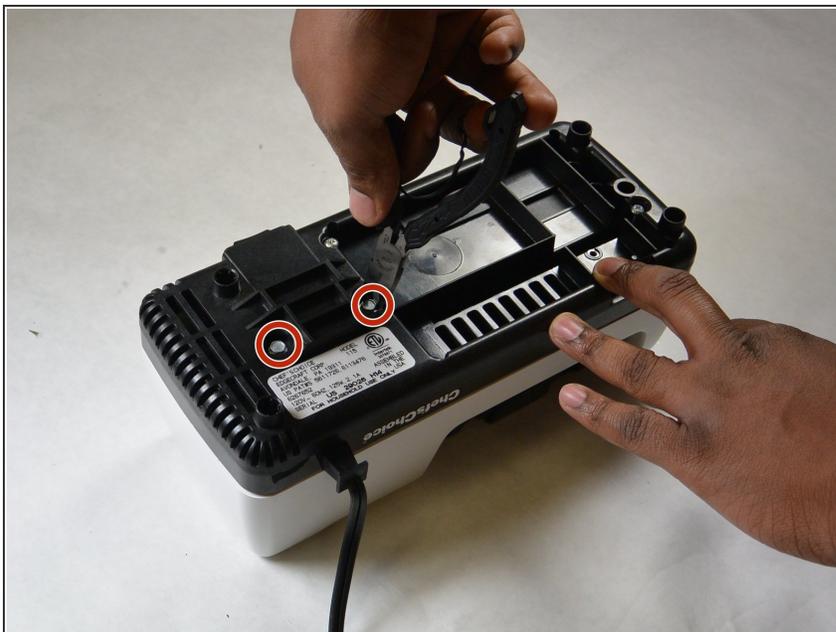
Step 2

- Remove the two hex-cap screws on the bottom using a pair of pliers.

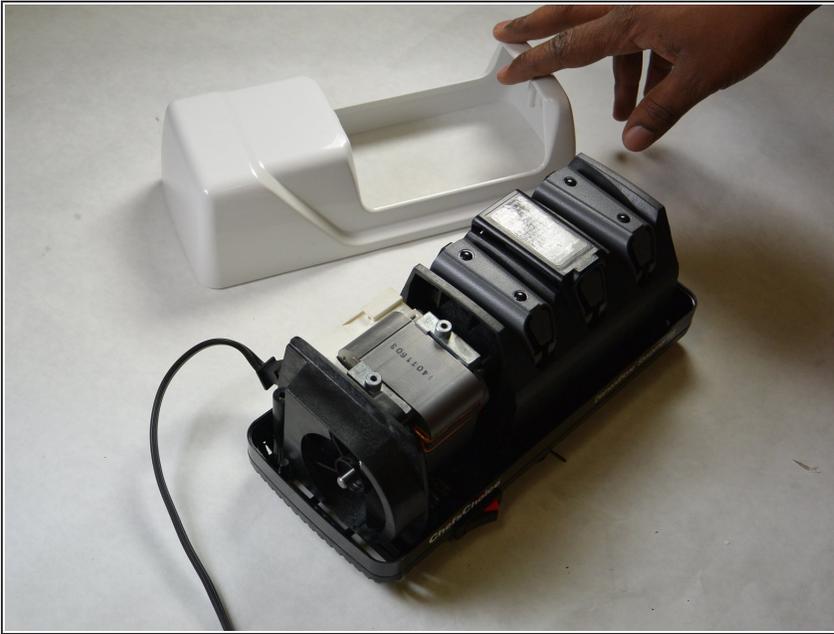
Step 3

- Carefully flip the device right-side-up while grasping the top and bottom pieces.
- ⓘ The white cover should lift off with no resistance. If it does not, ensure all screws were removed in previous step.

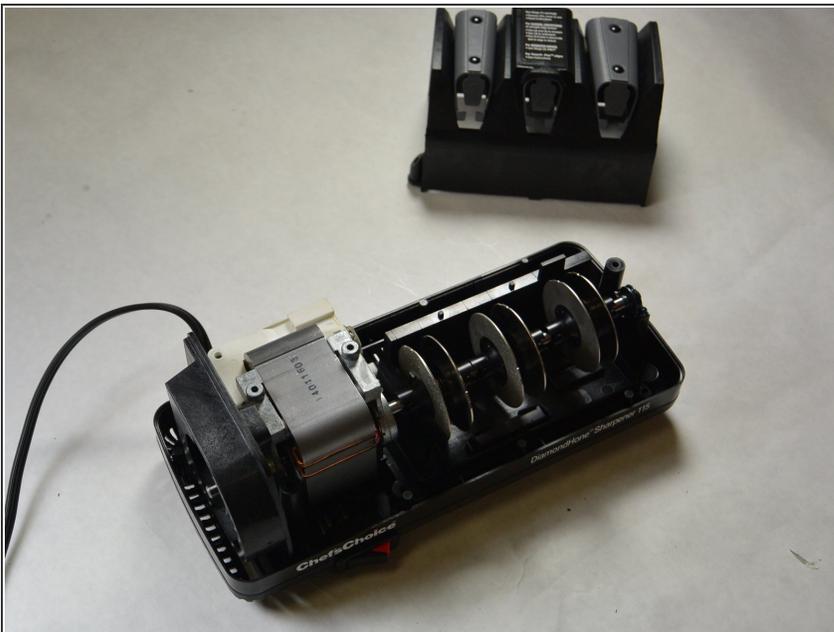
Step 4

- Remove the sharpener guard by gently pulling up on it.
- ⓘ If the sharpener guard does not come off easily, ensure all screws were removed in step 1.

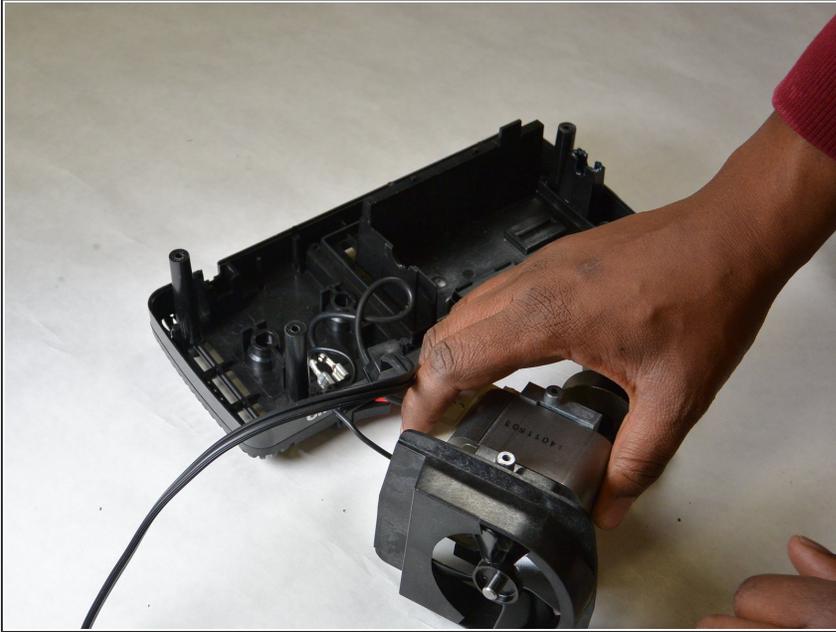
Step 5 — Grinding Disc Linkage Pins

- Remove the motor and shaft assembly from the bottom of the case housing.

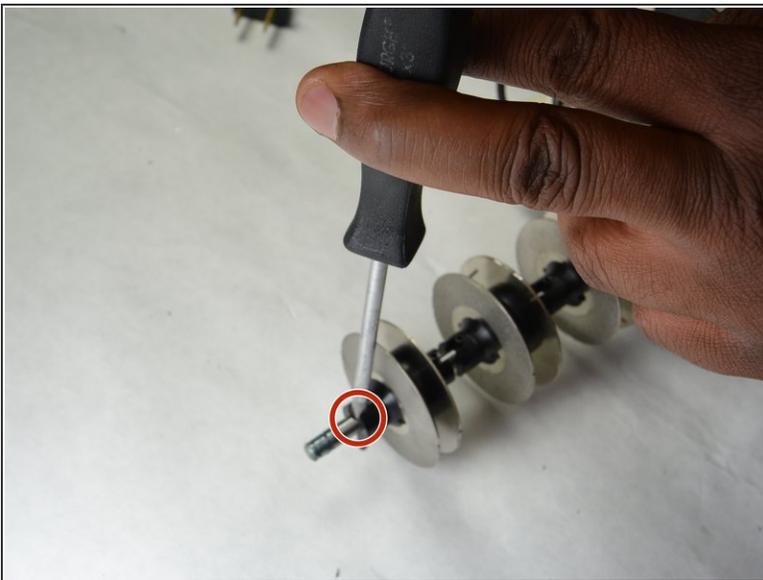
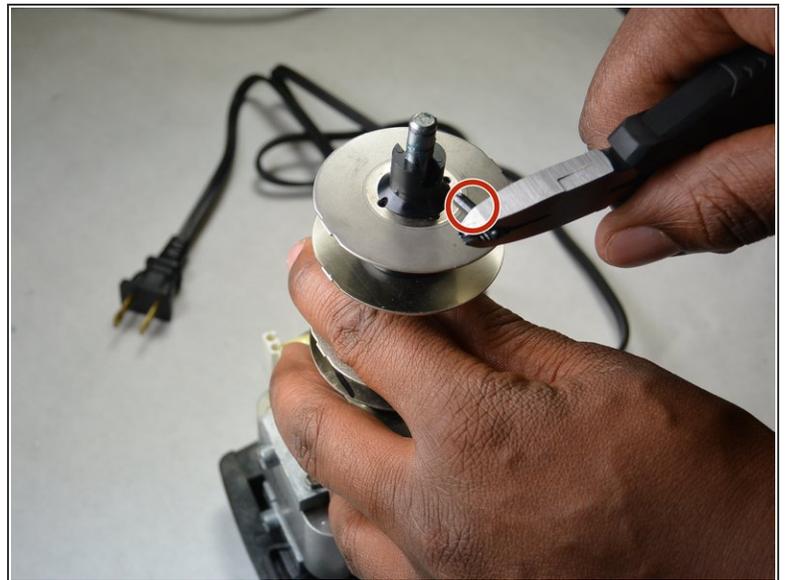
Step 6

- Use a screwdriver to push the pin out of the rod.
- Use pliers to pull the pin the rest of the way out.

To reassemble your device, follow these instructions in reverse order.
