Toshiba Equium M70 Faulty Graphics

This will fix the dreaded graphics driver issues, when windows says the driver has stopped responding. The problem is caused by a very thin heat sink on the GPU, with little to no thermal paste, when the chip heats up the thin heat sink expands & concave

Written By: Terry Sim

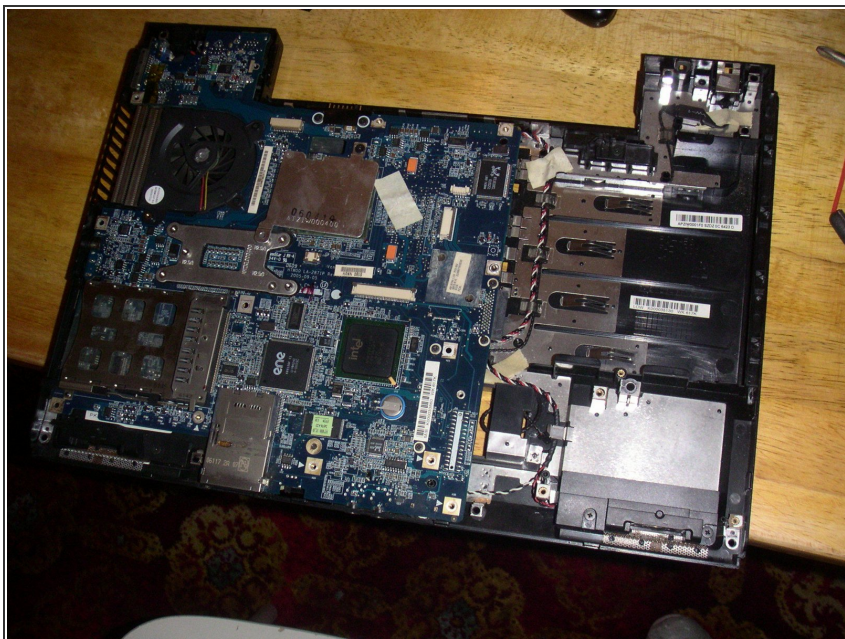
Step 1 — Toshiba Equium M70 Faulty Graphics

- This is a complete top half strip down to fix (takes me less than 30 minutes)
