Canon DM-100 microphone rattle noise fix

How to fix the Canon DM-100 video microphone rattle noise. For Canon Vixia / Legria cameras in the HF-series.

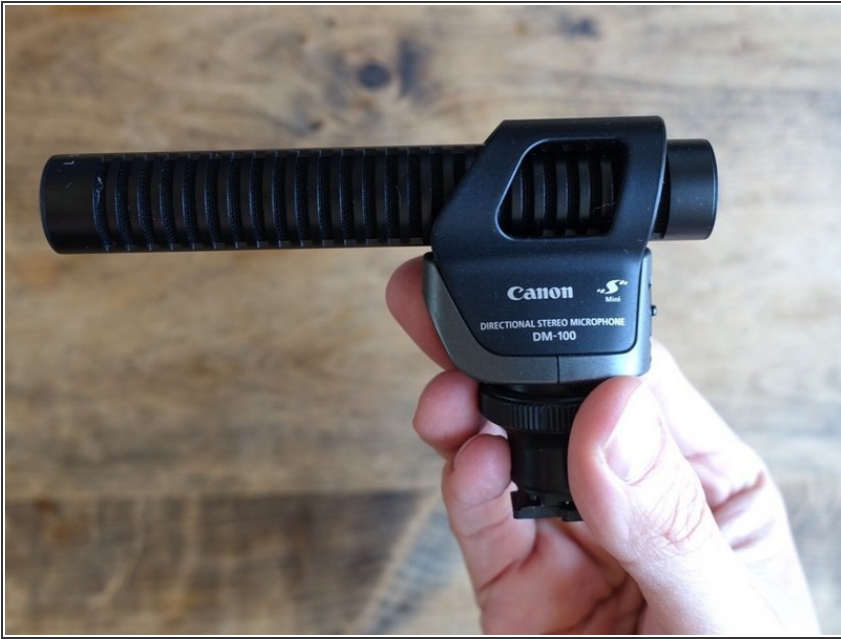
Step 1 — The Mic

- This is the rattly beast.

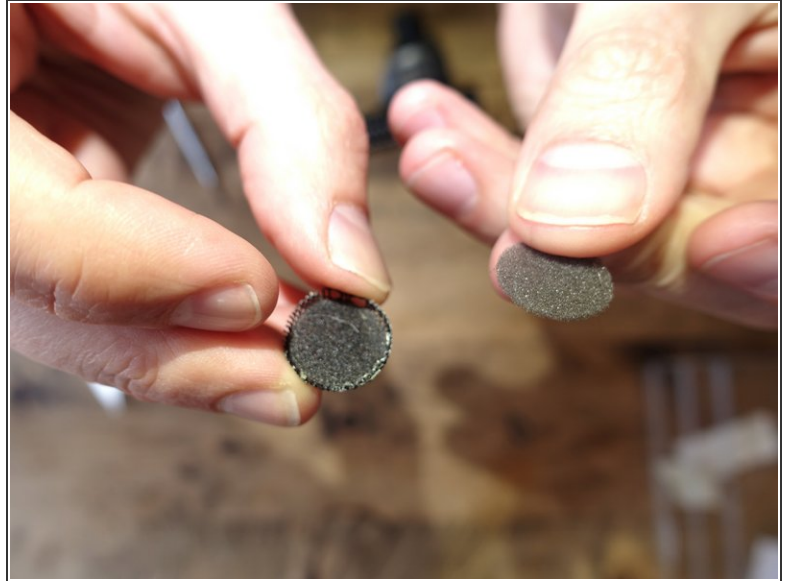
Step 3 — The culprit

- Canon has used an elastic band for vibration reduction of the directional "sound pipe" (seen as a circle behind the elastic band).
- The pipe visible behind the elastic is supposed to be mounted to the inner wall with the two marked circular joints.
- These incredibly weak joints are bound to break as the rubber loses its elasticity.

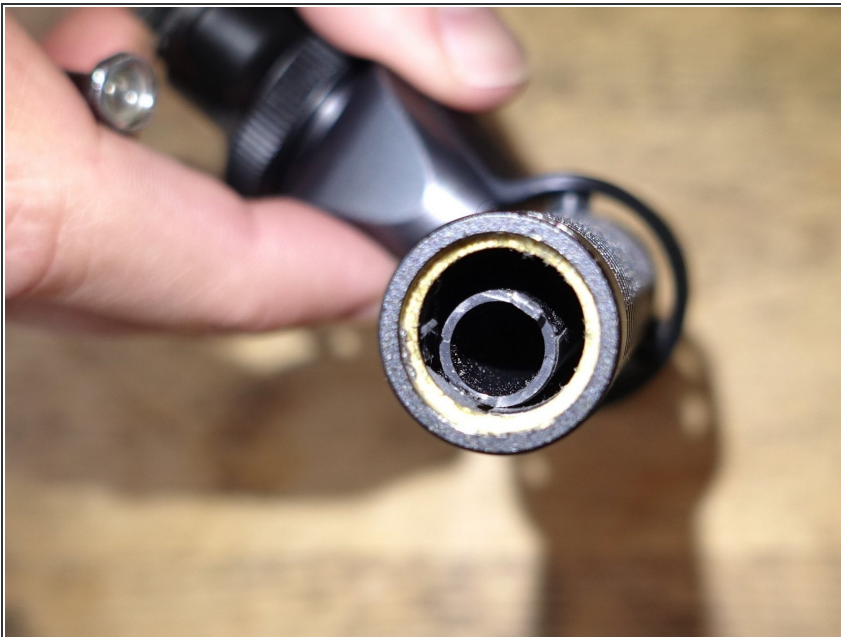
Step 5 — Clean slate

- The culprit of the rattling noise is now apparent. A plastic cylinder stretches through the whole of the

microphone, enabling the microphones forward focused / directional sound.

- When the rubber band breaks because of the bad joints, this thing hits the inner side of the cylinder.

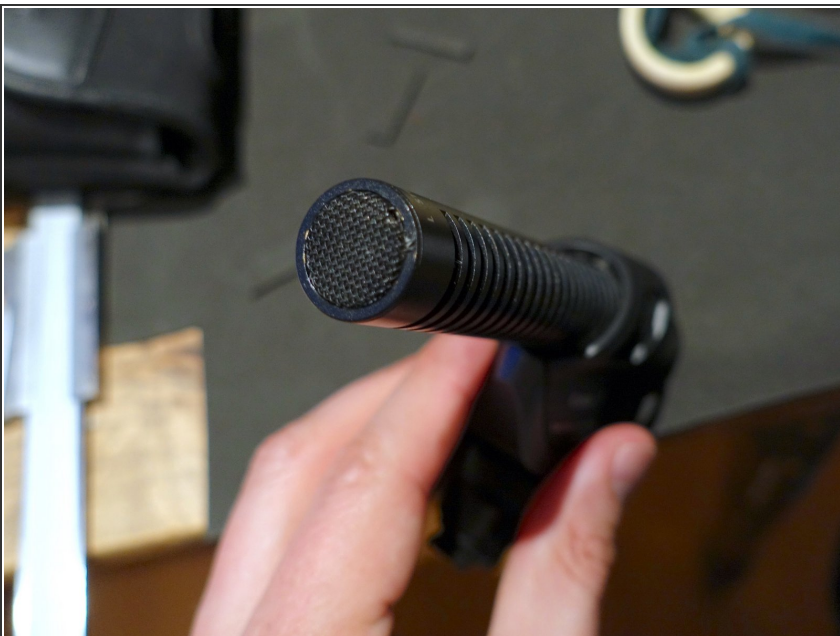
Step 10 — Done

- There! 190\$ microphone fixed for less than a dollar.
- The audio quality isn't affected at all.

This fix is a permanent fix to Canons poor design. Since the pipe is solid, and the foam is only reaching about 2cm into the pipe, audio quality is not affected at all.
