# Ninja Coffee Bar® Single-Serve System Valve Tubes Replacement

Changing the tubes when the Ninja Coffee Bar®...

Written By: Naser Aldousari

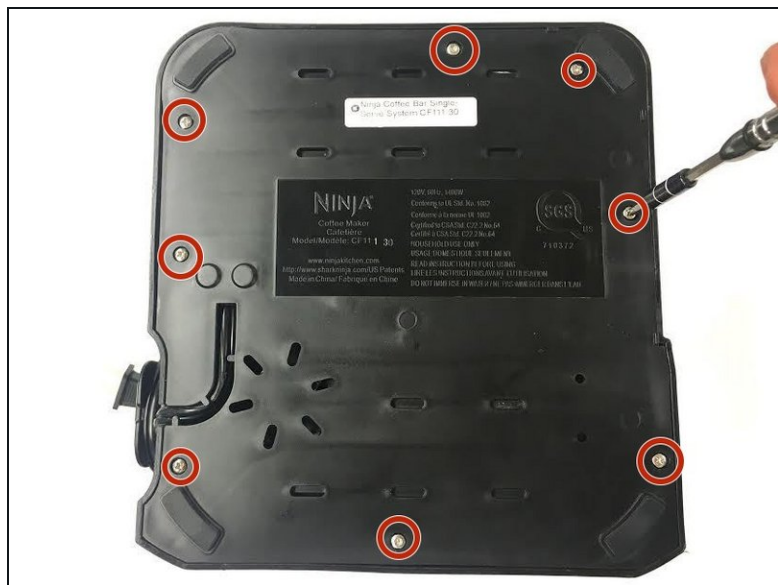
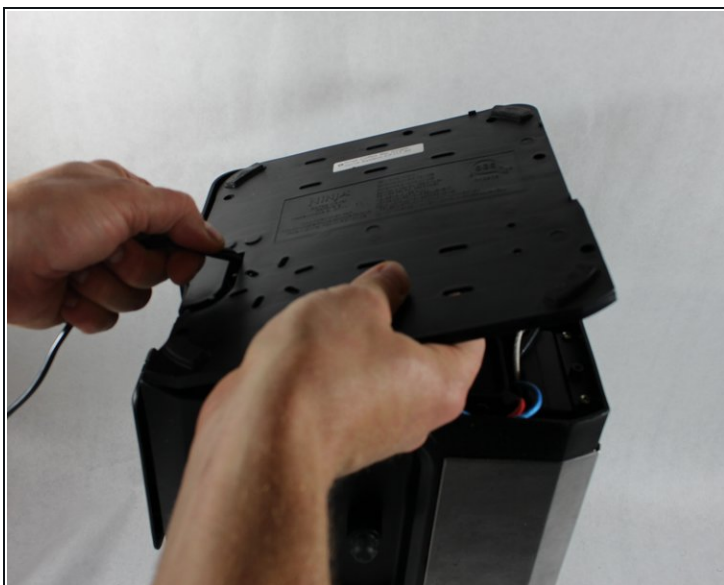
### Step 1 — Valve Tubes

- Remove the eight 6 mm screws using the Phillips #1 screwdriver.
- Remove the bottom cover.
