Dell Chromebook 3180 Charging Port Replacement

Dell Chromebook Chare port removal and replacement.

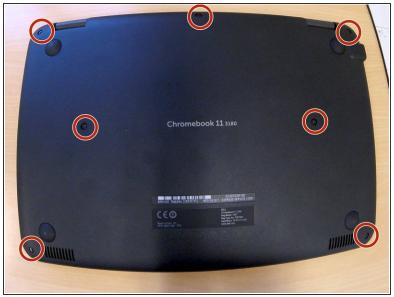
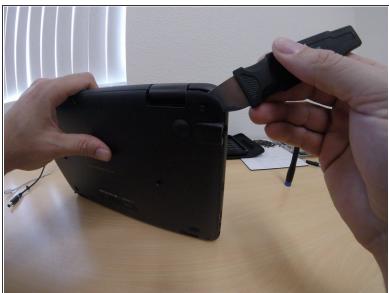
Step 1 — Remove Bottom Cover / Shell

- Remove the 7 screws from the back cover with a Phillips #0 screwdriver
- Once all 7 screws have been removed, you can start to pry apart the back cover with your Plastic Blade or your fingers. (See pic)

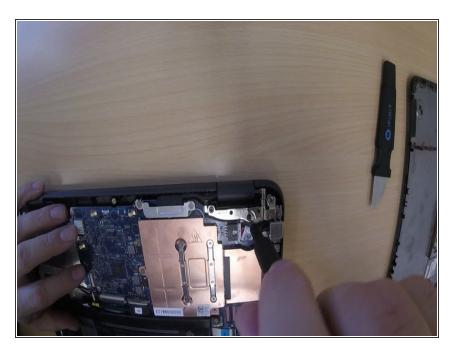
Step 2 — Remove Screws from Hinge/Charging Port

- Using a Phillips #0, remove the 2 screws from the right side hinge.
- Lift the chromebook base in order to force the hinge in an upward position. This will provide you enough room to remove the charging port.
- Remove the 2 charging port screws
- Unplug the charging port connector from the Motherboard

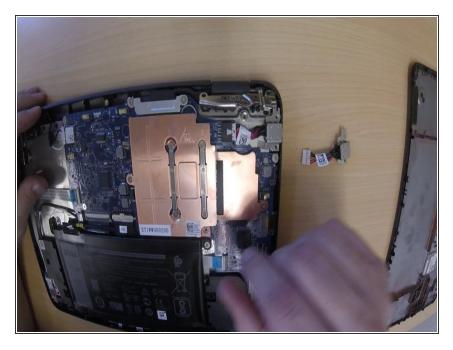
Step 3 — Replace Charging Port

- Disconnect the charging port connector from the motherboard.
- Replace the charging port if needed by connecting the new charging port connector to the motherboard.
- Using a Phillips#0, replace the 2 charging port screws.

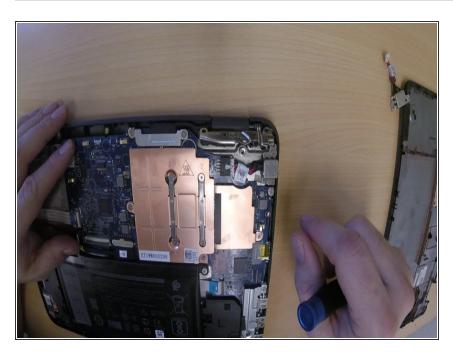
Step 4 — Secure Right Hinge

- Reset the right side hinge back into place by pressing down so the hinge is flush against the chromebook base.
- Secure with the 2 screws using your phillips #0.

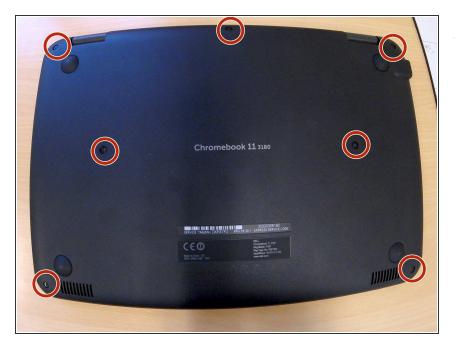
Step 5 — **Replace Bottom Cover**

Secure all 7 screws with a Phillips #0
