JVC KW-V820BT Rear Panel Removal and Replacement

Steps to repair and replace the fan in the JVC KW-V820BT audio device.

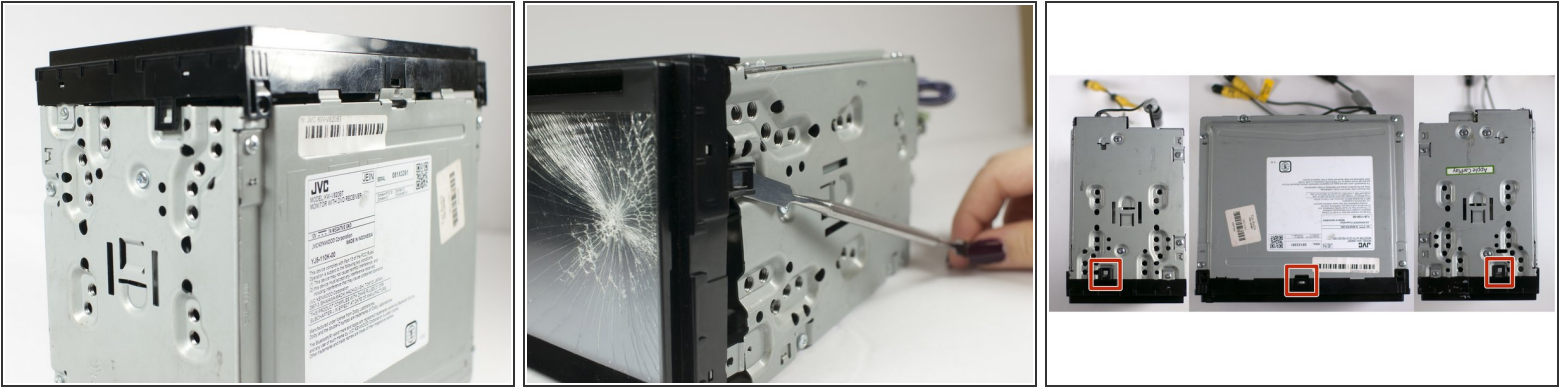
Step 3

- Using your fingers and/or a metal spudger, gently release the plastic locking tabs of the front panel assembly from the steel enclosure while prying the front panel assembly away from the steel enclosure with your fingers.

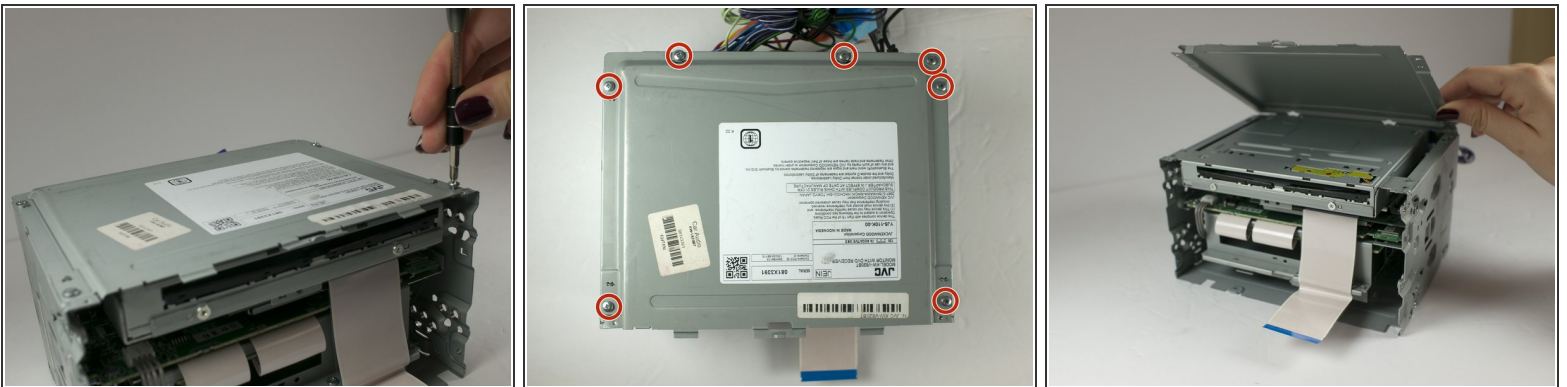
Step 6 — Top Panel Removal

- Remove seven 1/64 x 3/16" screws from the top panel using the Phillips #0 screwdriver.
- Remove the top panel.
