## INTRODUCTION

Over time, the Micro USB charging port may become worn out or defective. Here is a guide on how to replace this part. During step 1, take special care to the black ribbon as it can be easily damaged.

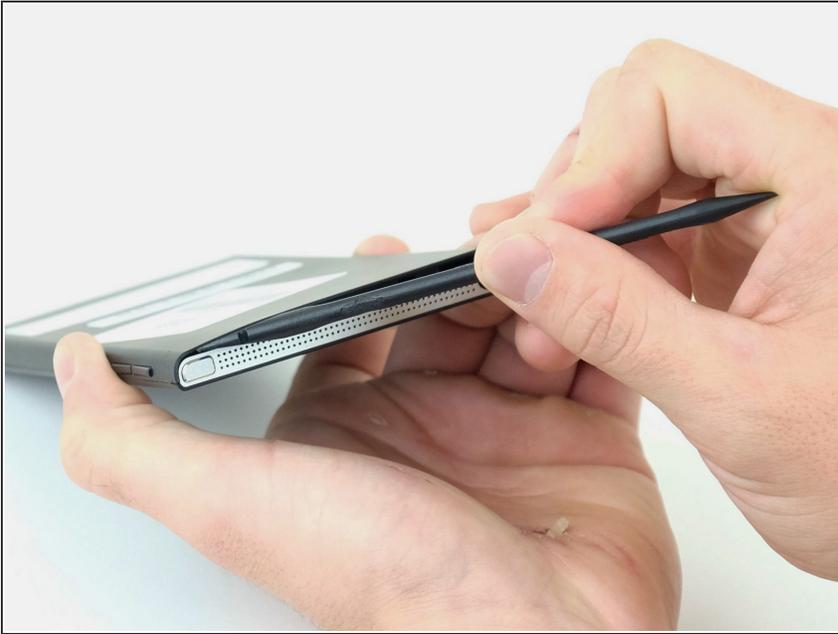
## Step 1 — Back Cover

- Obtain the black plastic spudger tool from the iFixit toolkit. Position the device as shown in the picture. Insert the flat end of the spudger directly in the space above the power button between the back cover and front screen.

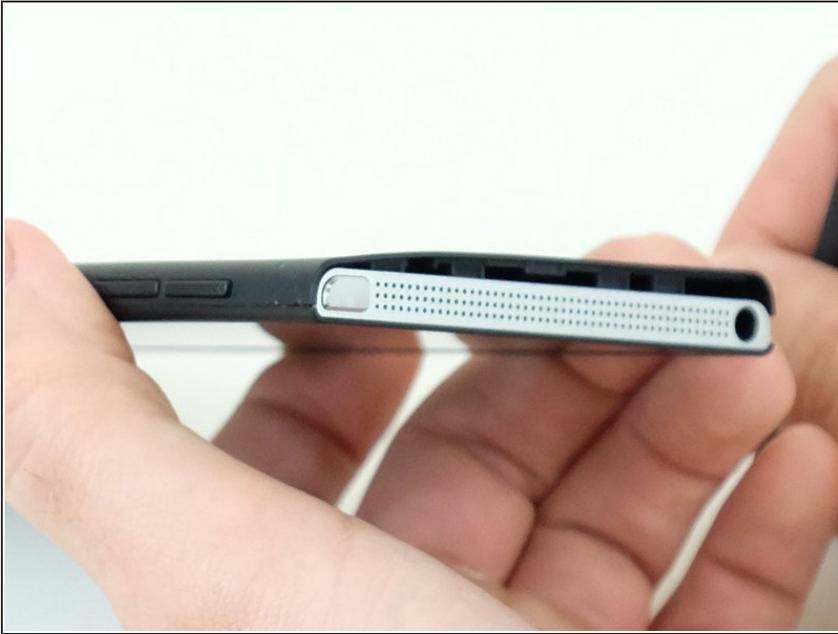
## Step 2

- Gently pry up on the plate with the spudger. You may hear some cracking noises as you work the spudger around your device, this is normal.

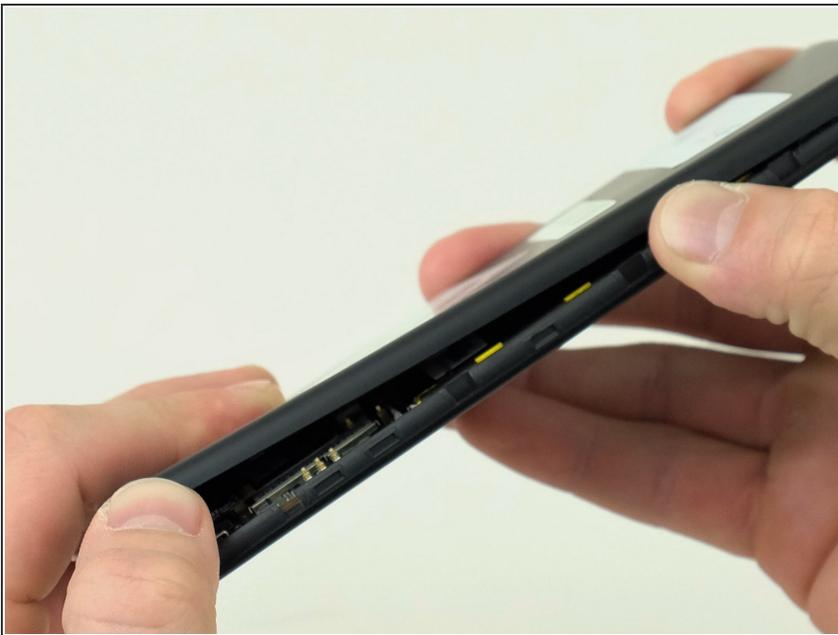
## Step 3

- Pry around the edges of the tablet with your fingers until you have successfully removed the back of the device.

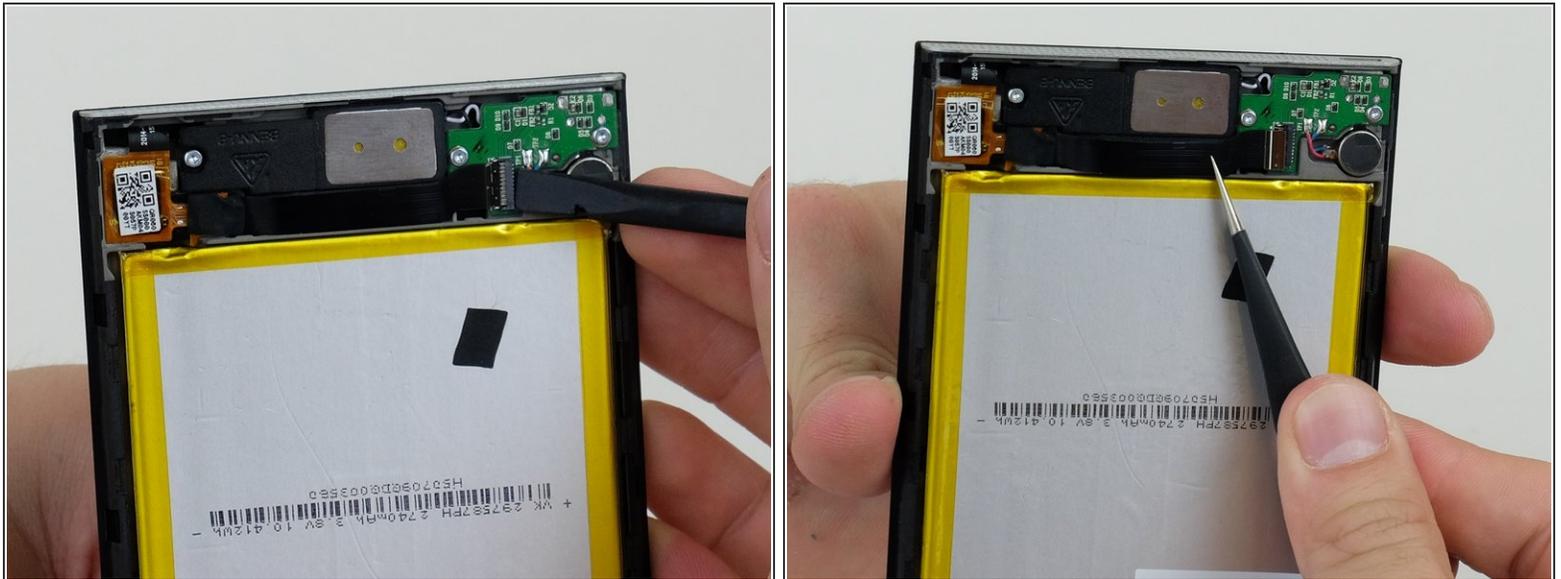
## Step 4 — Micro USB Charging Port

**!** The black ribbon can be easily damaged during this step, so proceed with caution.

- Place the flat end of the black plastic spudger under the black plug and pry up to release the black ribbon. Using the metal tweezers, pull the black ribbon out of the plug.

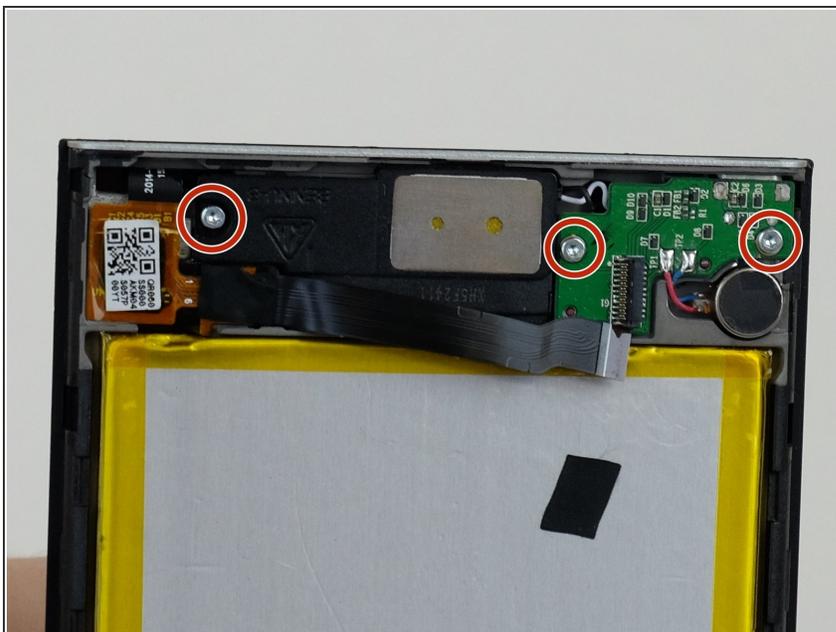
## Step 5

- Remove all three 3mm-long silver screws using the T5 Torx screwdriver.

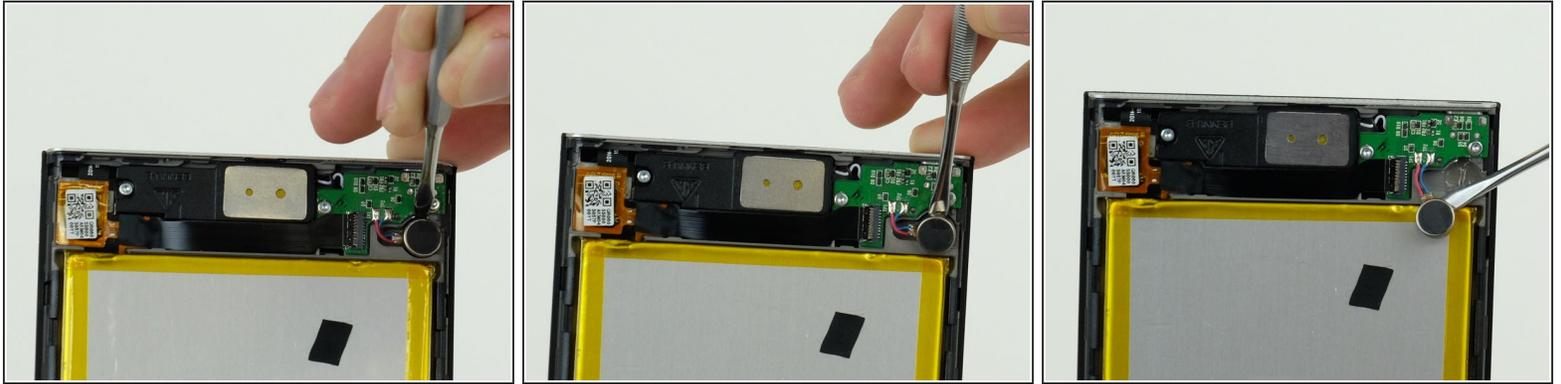
## Step 6

- Place the shovel end of the metal spudger under the speaker and pry upwards to remove the speaker from the device.
- ⓘ The speaker is secured to the device with adhesive glue so you may hear cracking noises while prying with the spudger.

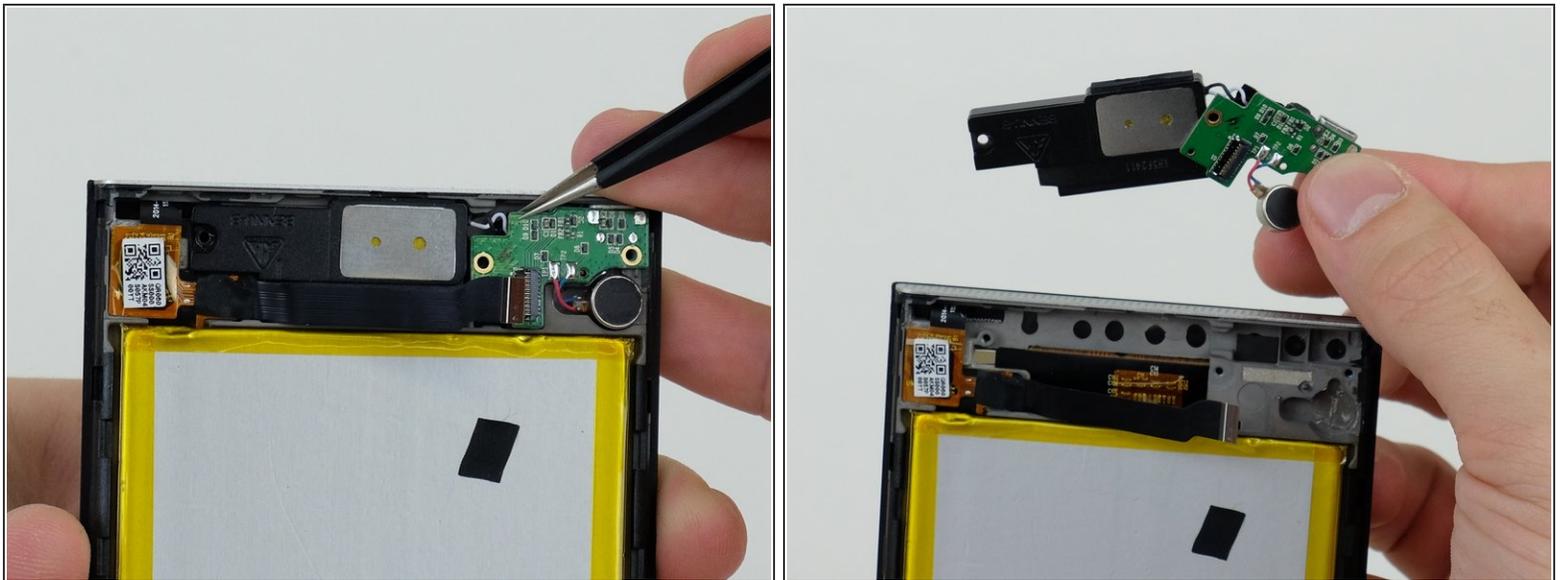
## Step 7

- Using the tweezers, grab a hold of the Micro USB assembly and gently remove it from the device.

To reassemble your device, follow these instructions in reverse order.
