# Casio G'zOne Commando Verizon MIL-SPEC Camera Replacement

In this guide, we will be replacing the camera on the rear side of the Casio G'zOne Commando Verizon MIL-SPEC with a brand new one.

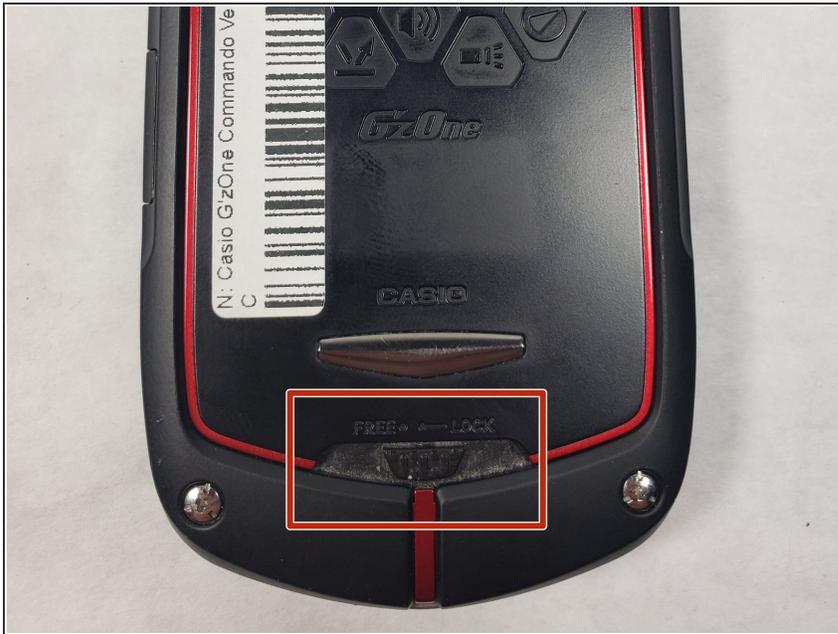
## Step 1 — Battery

- Slide the slider on the back of the phone to the free position.

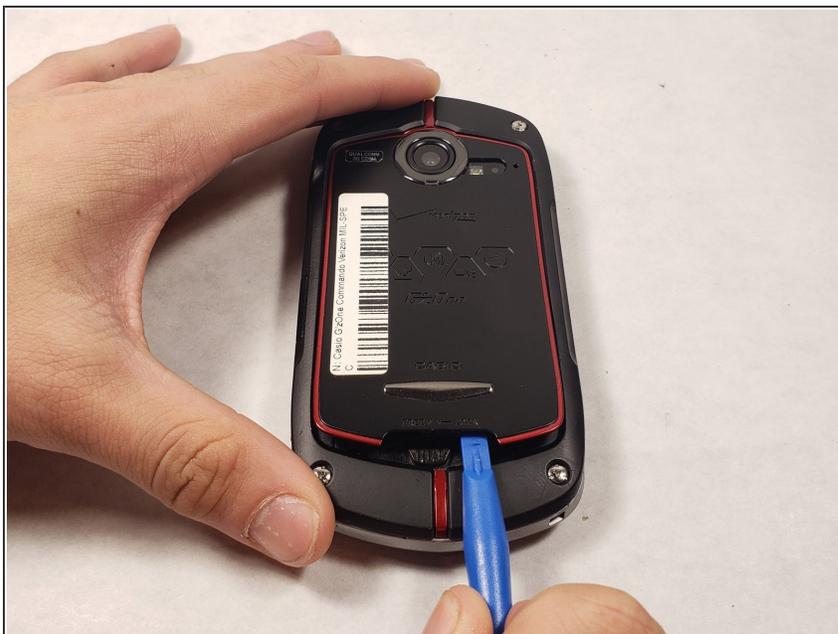
## Step 2

- Using a plastic opening tool, gently lift open the back panel from bottom of the panel.

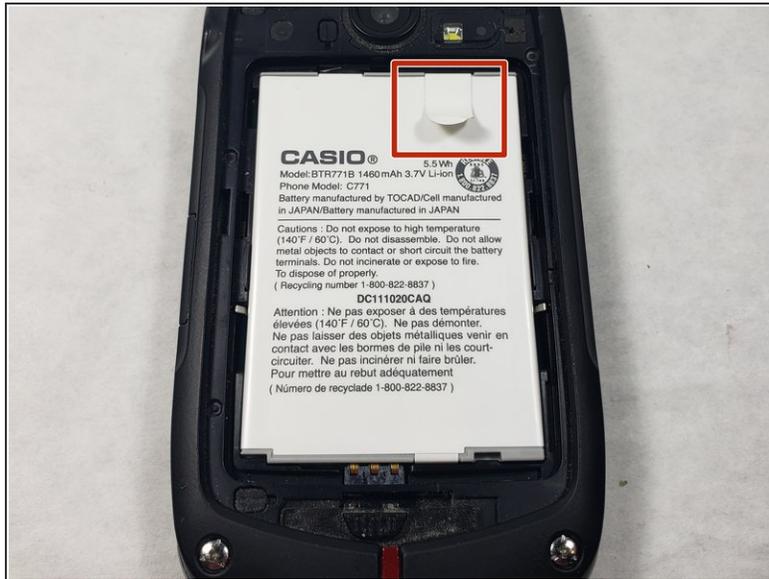
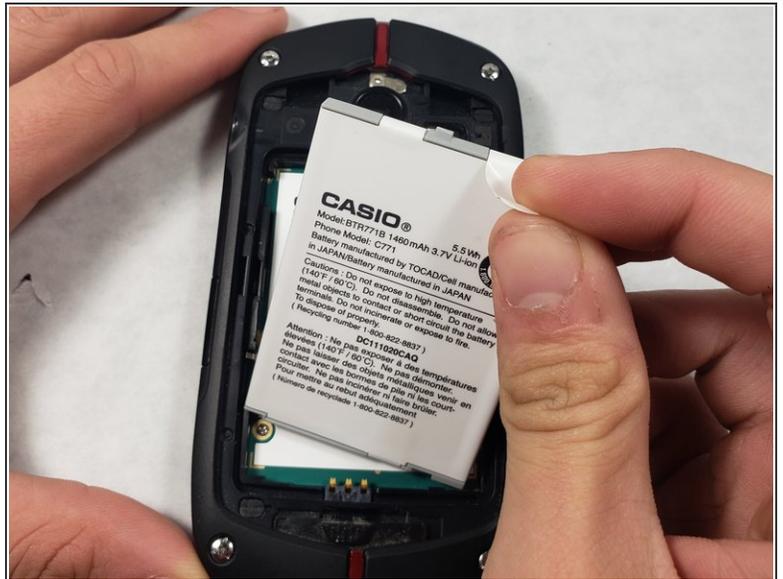
## Step 3

- Pull the white battery tab upwards and remove the battery.

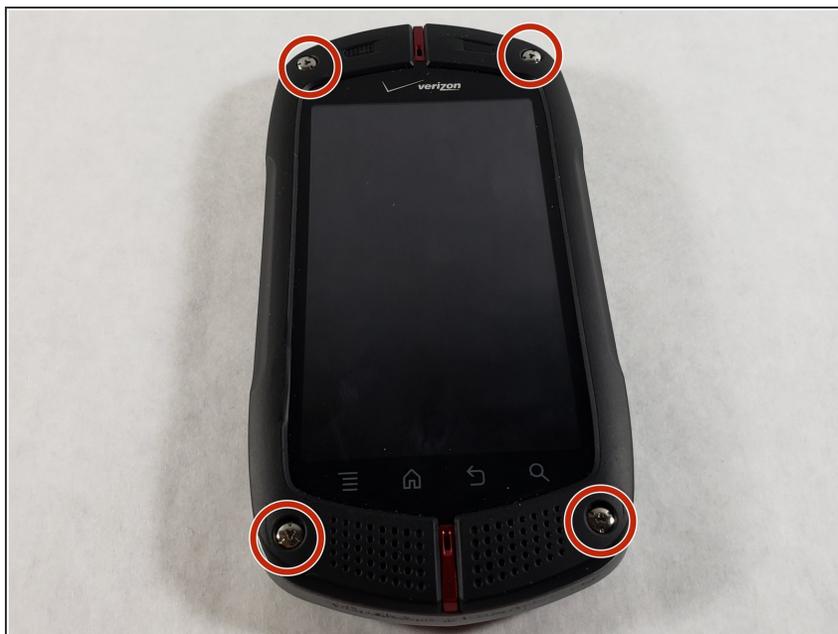
## Step 4 — Motherboard

- Remove the four 6mm Y0 screws from the corners of the device.

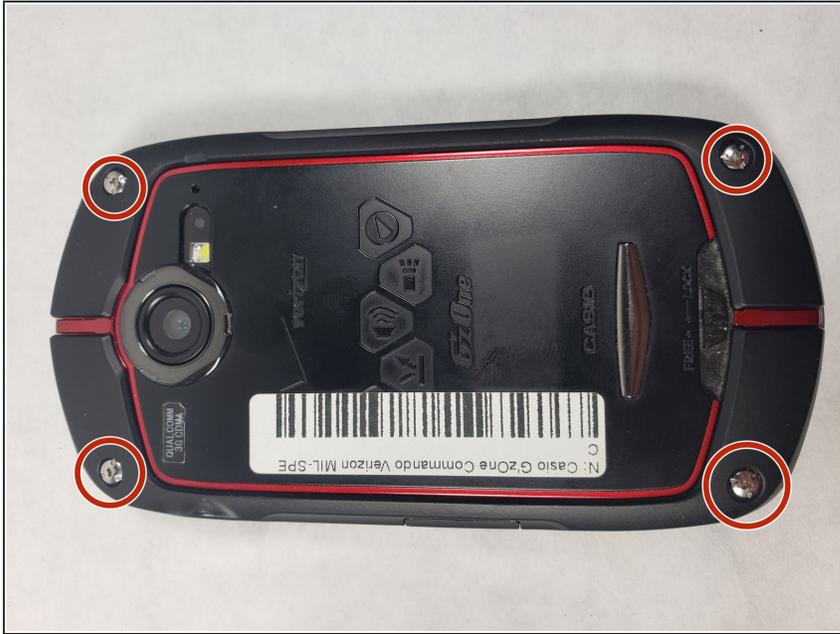
## Step 5

- Remove the four 5mm Y0 screws from the back of the device.

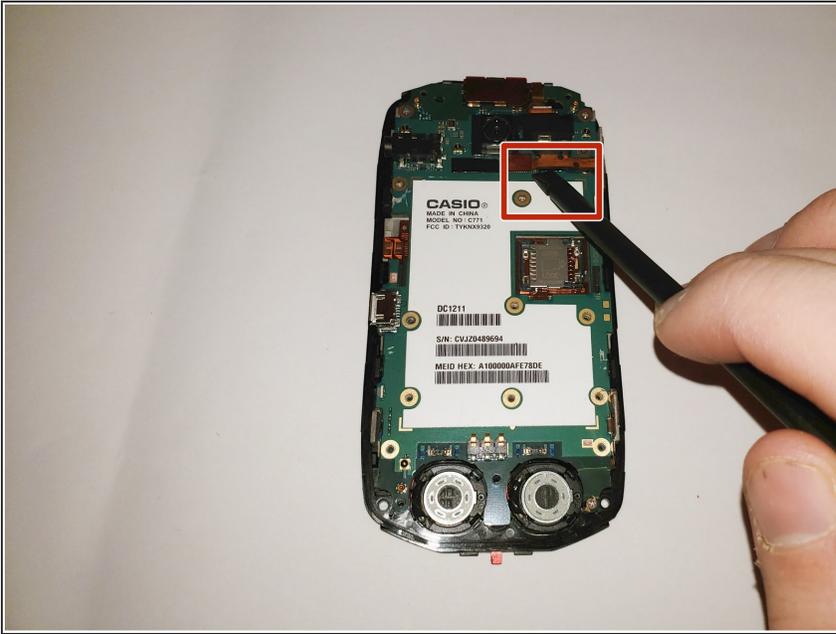
## Step 6

- Using a spudger, pry away the motherboard from its compartment, by inserting the spudger in the compartment and lifting upwards until fully out.

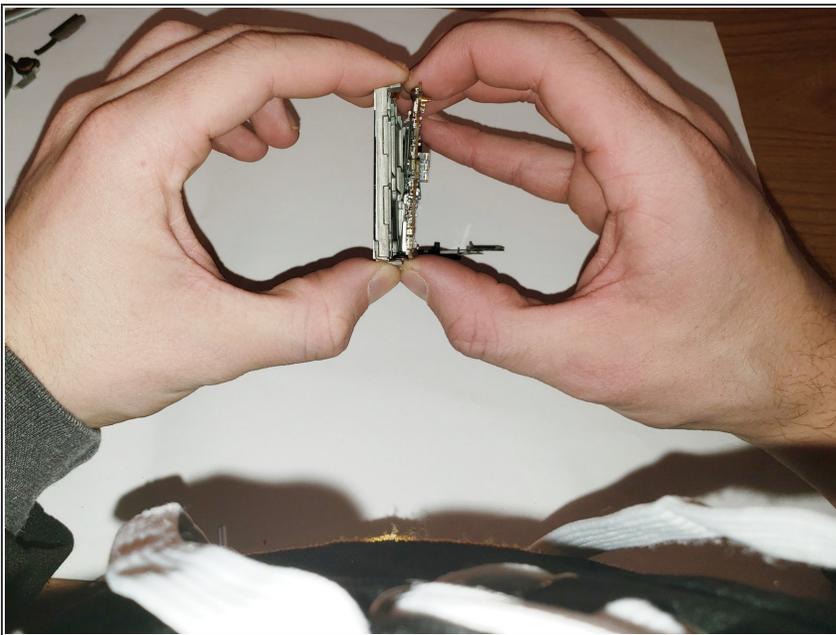
## Step 7

- Lastly, using your hands, separate the motherboard from its compartment.

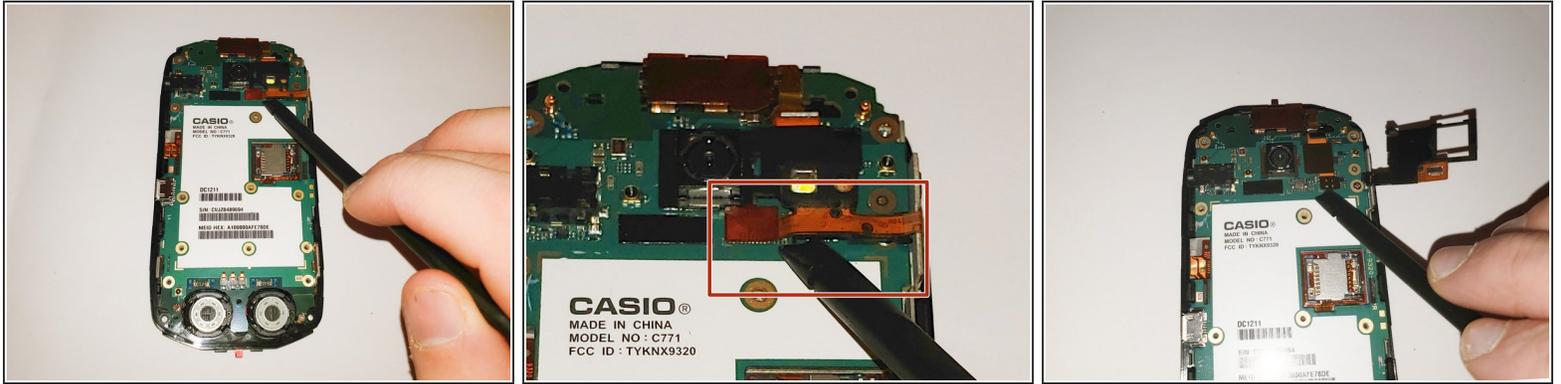
## Step 8 — Camera

- Using a spudger, gently lift up the orange connector.

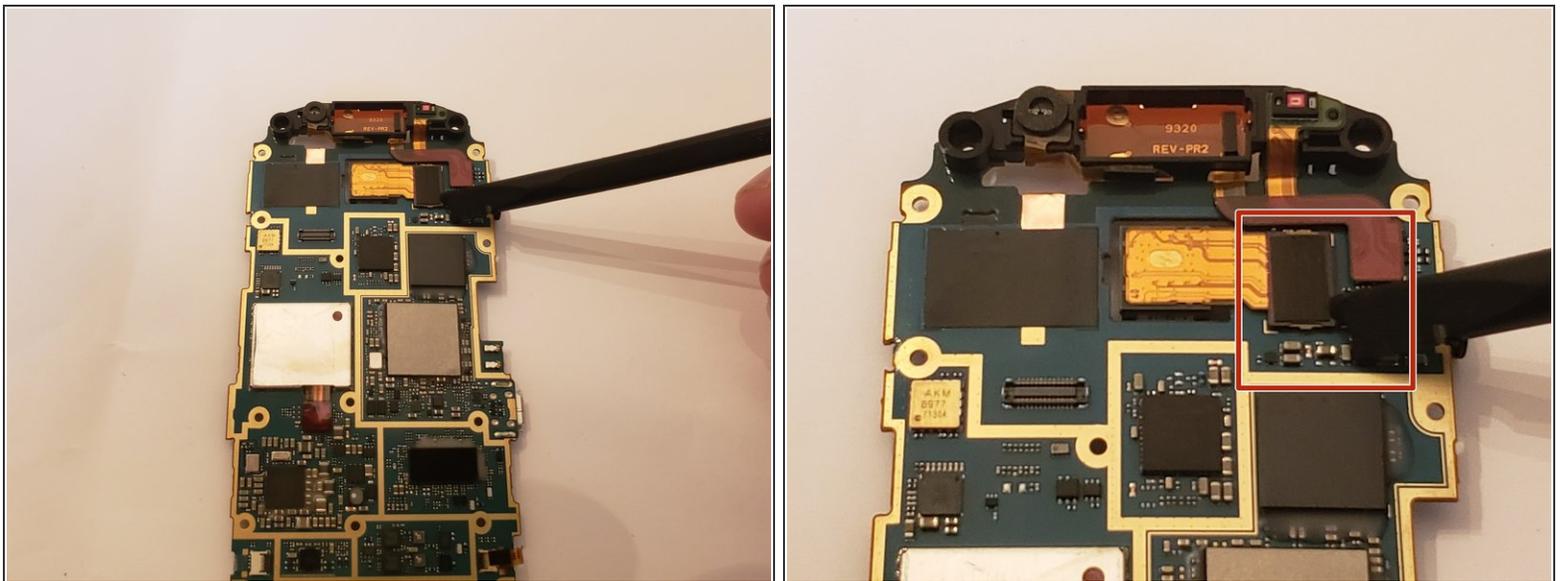
## Step 9

- Flip over the motherboard
- Using a spudger, lift up the small black connector and remove the camera.
