Escort Passport 9500IX Back Panel Replacement

How to replace a Escort Passport 9500IX back panel.

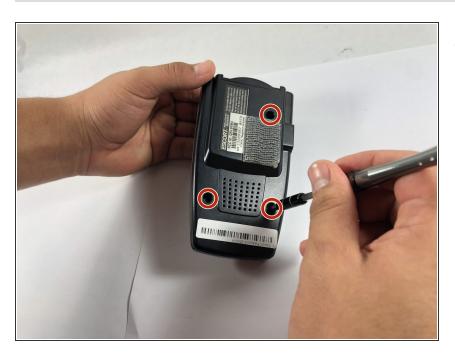
Step 1 — Back Panel

Remove the three 1.2 mm Phillips
#1 screws on the back of the device.

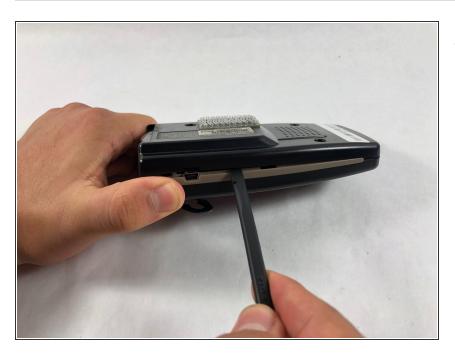
Step 2

Pry off the back panel of the radar using the nylon spudger.
