Nokia Lumia 2520 Display Assembly Replacement

This guide demonstrates the steps needed to replace the Nokia Lumia 2520 display assembly

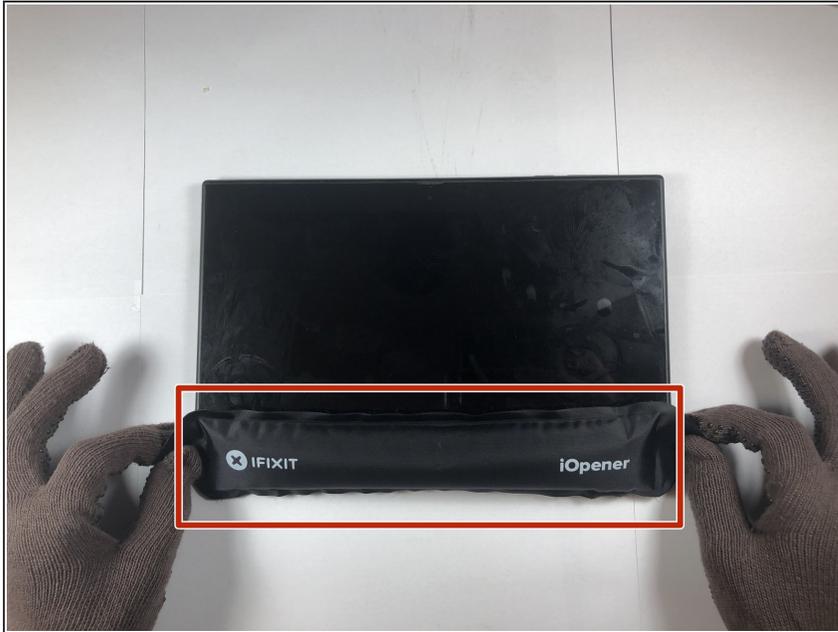
Step 1 — Display Assembly

- Apply heat pad to each side of the device.
- ⚠ When using any heat pad please use some form of padded gloves so you don't burn your fingers.
- ⓘ Microwave the pad for 30 seconds so an ample amount of heat is given on all four sides. Do not microwave more than once every two minutes.

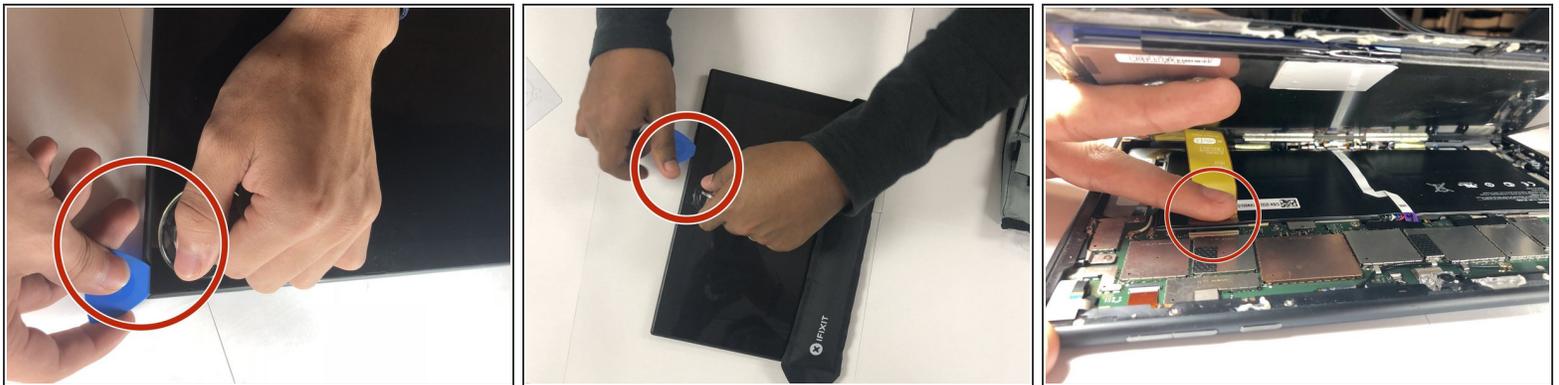
Step 2

- Insert the pick between the glass to separate the glass from the device. You can also use the suction cups to help lift the glass.
- ⚠ When pulling the screen off the chassis, be careful not to cut the ribbon cable that connects the screen to the logic board.
- ✦ Take your time to pry open the screen from the chassis as you can easily break the screen or crack it.

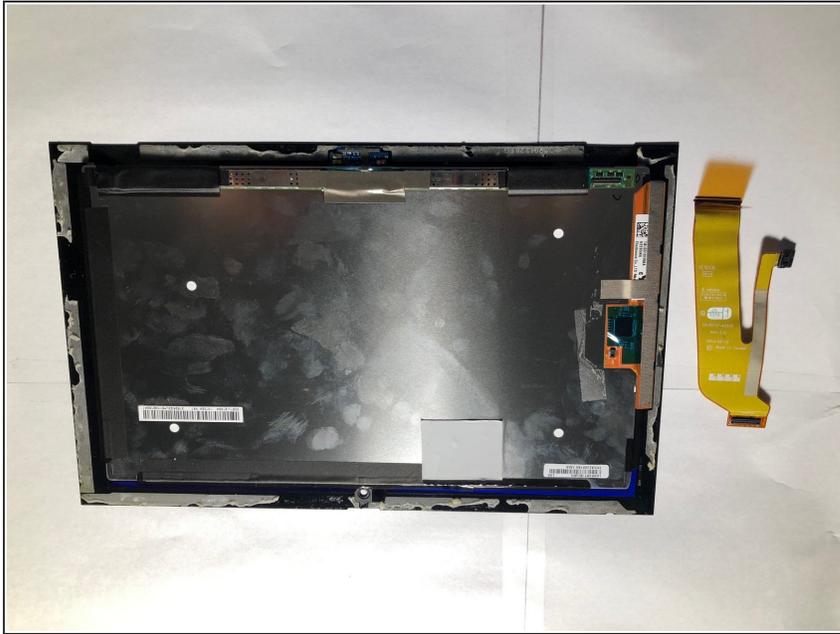
Step 5

- Set aside the screen and the display assembly for repair.
