HTC One (M8) Teardown

Written By: Sam Goldheart

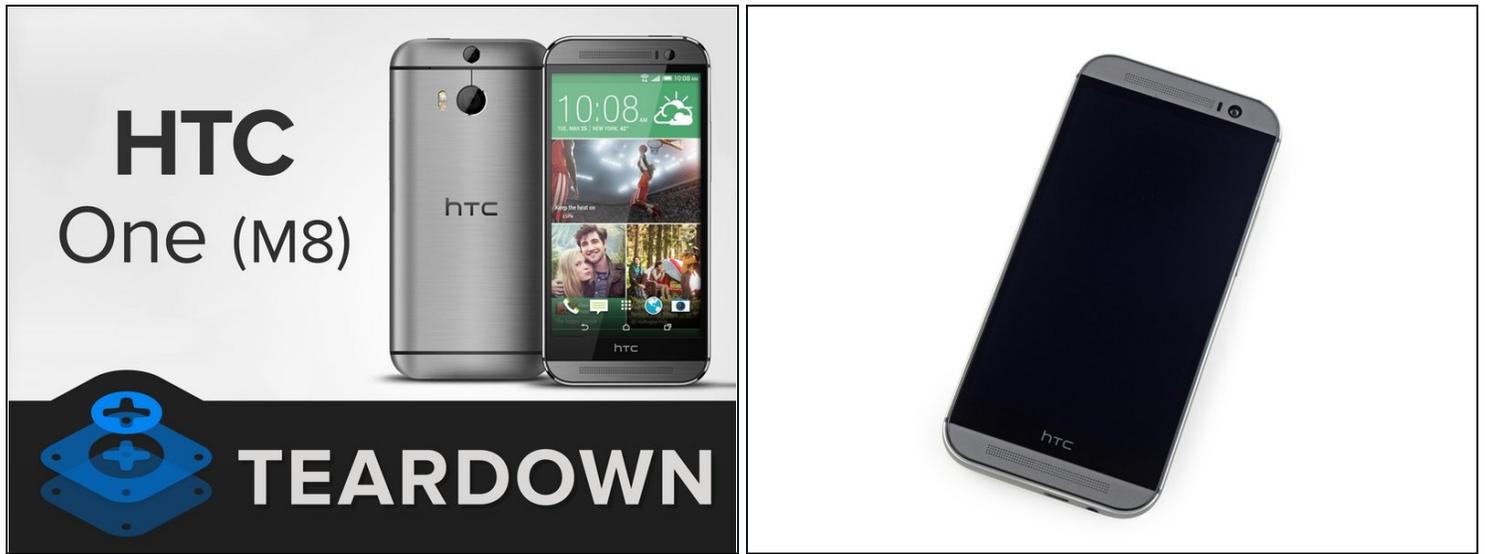
Step 1 — HTC One (M8) Teardown

- For its second act, the HTC One brings some impressive props. The lengthy list of hardware includes:
 - Quad-core, 2.3 GHz Qualcomm Snapdragon 801 processor
 - 2 GB RAM
 - 5" 1080p display with dual front-facing speakers
 - 4 MP (2 "ultrapixel") f/2.0 rear Duo Camera with dual flash; 5.0 megapixel front-facing camera
 - 16 or 32 GB on-board storage; up to 128 GB additional storage via microSD
 - LTE, Bluetooth 3.0, NFC, 802.11ac Wi-Fi, and IR blaster
- The immediate question is whether the M8 will prove more cooperative than its [nigh-unreparable predecessor](#), whose hardware secrets had to be pried from its mangled aluminum corpse.

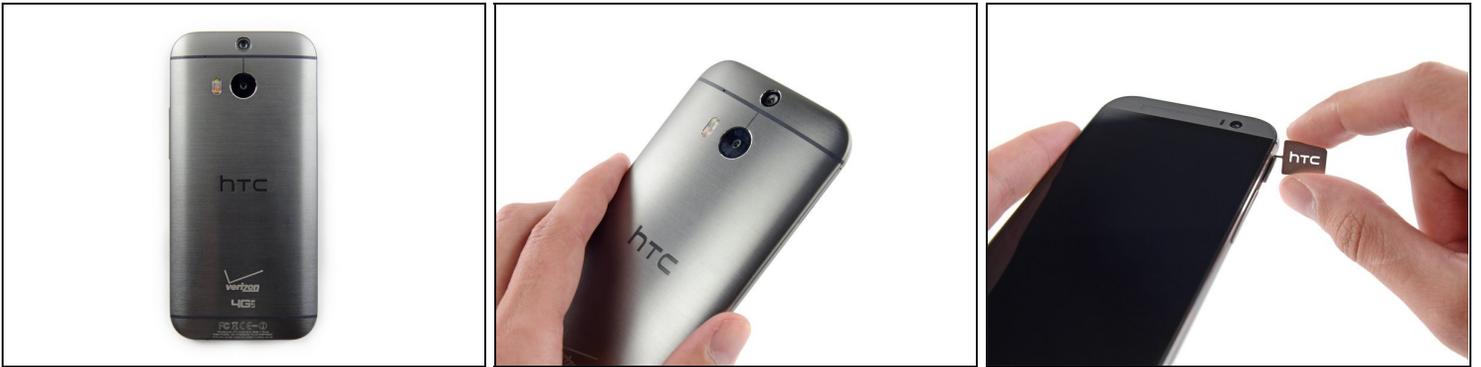
Step 2

- While we ponder our plan of attack, we pause to appreciate the One M8's appealing—albeit inscrutable—brushed metal design.
- Dual rear cameras, dual flash—despite being dubbed the One, this phone [likes its Twos](#).
- Spinning the M8 around, we find the first of another pair—two card trays straddling the upper end of the phone (microSD and SIM).
 - Maybe we can just call it the One-Two? No? Moving on...

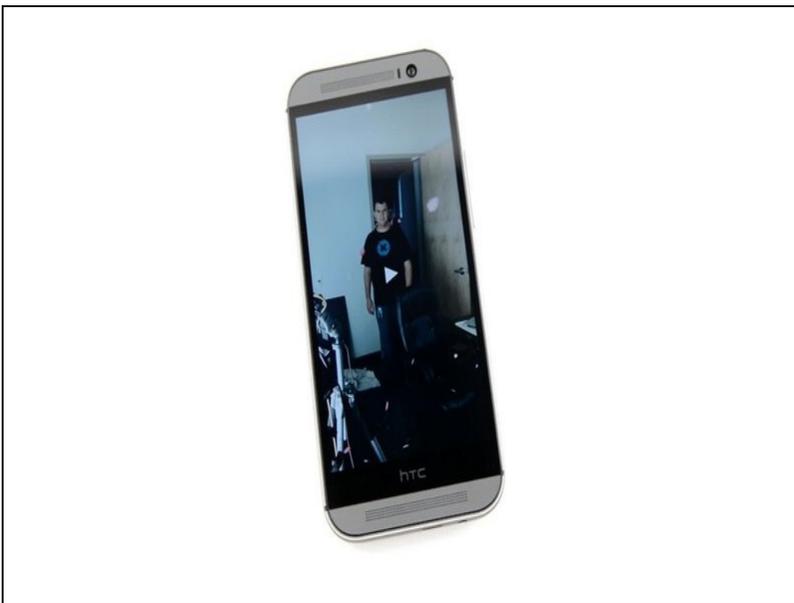
Step 3

- The extra rear camera captures depth information, enabling a host of trick features like *ex post facto* focus adjustments and background removal. We can hardly wait to dig our spudgers in and see how it comes apart.
- ① But first: an homage to [Miro-senpai](#).

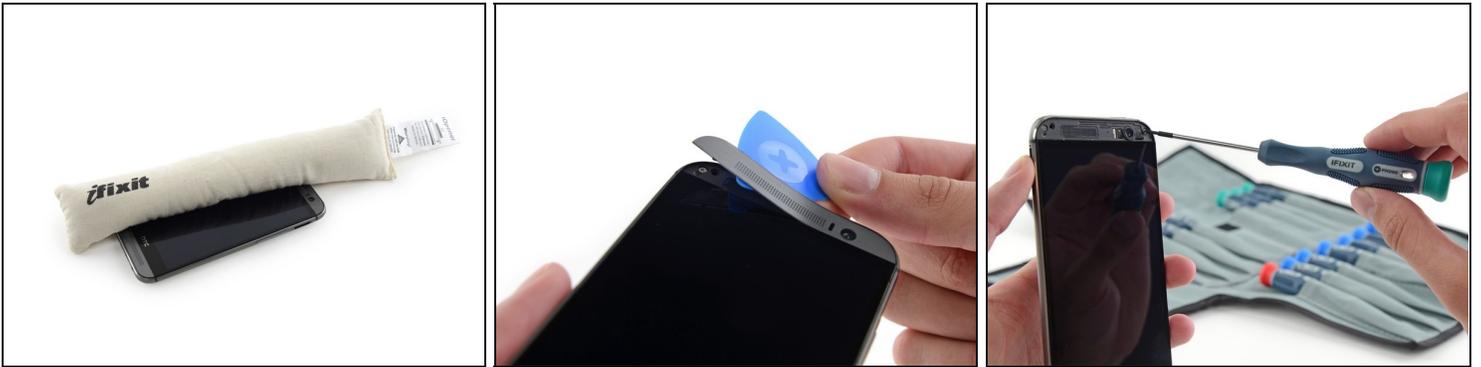
Step 4

- Looking for a point of entry, we surprise the One M8 with a spicy hot [iOpener](#).
- With the underlying glue sufficiently softened, we strum away with a guitar pick until the first screw peeks through.
 - ⓘ Screws! Glorious screws! Here's the missing link to make this unibody design repairable. Whenever we see [gobs of adhesive and tough clips](#) replaced with screws, we know we're in for a (slightly) happier time.
- Just like that, the One M8's first line of defense is down—with the power of the Pro Tech Screwdriver Set, these screws are deftly dispatched.

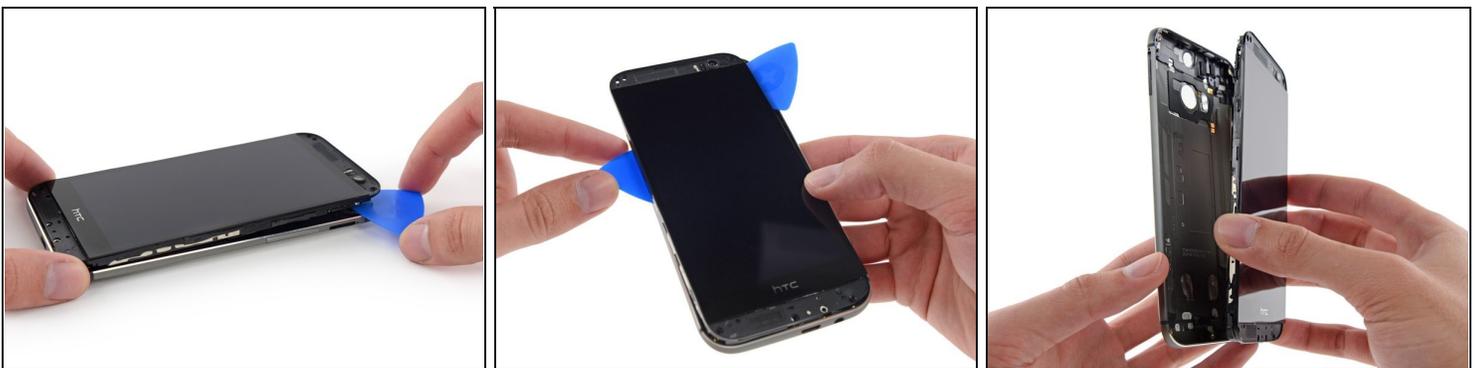
Step 5

- We're on a roll. Gaining momentum, we free the M8's guts from its rear case with the power of rock n' roll [guitar picks](#).
- ⓘ We're happy to get this far, but we're not sure this will be a platinum record for repairability. There's only one way to find out: Keep on rockin'.

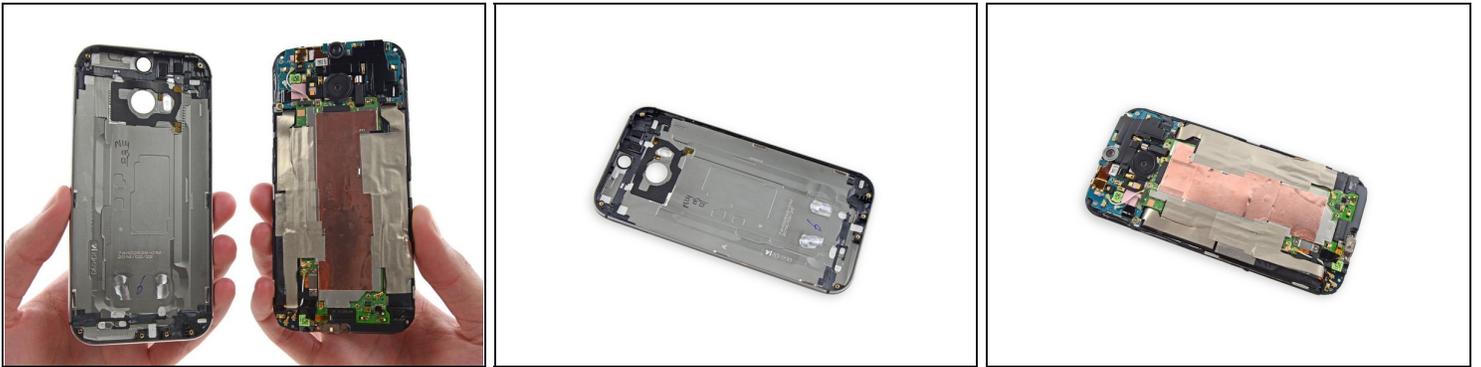
Step 6

- Here's where things turned ugly during our teardown of the first-gen HTC One (the phone that garnered the [all-time worst repairability score](#) of any smartphone we've ever had on the teardown table.)
- To our delight, the pesky display cables of yesteryear have given way to spring contacts—so this time, the phone assembly comes out cleanly.
- No mangled aluminum here—the rear case remains intact. Apart from the NFC antenna and some nice machine work, there's not much to see.
- The rear case weighs in at 27.5 grams.
- The remaining assembly is a fair sight less tidy. A mass of copper shielding and tape awaits...

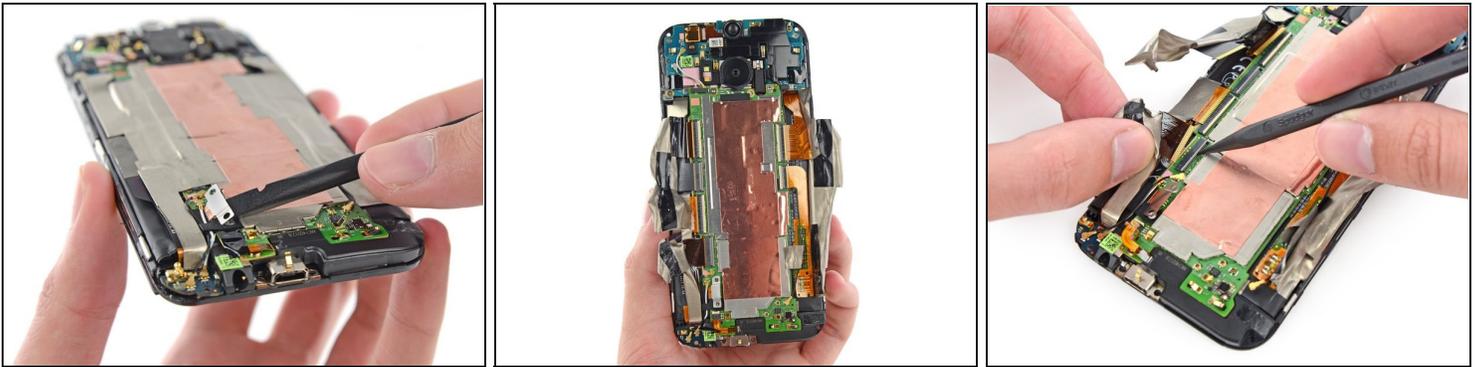
Step 7

- Next, we spudge up the battery connector.
 - ① Shocky the Bear says, *"Only you can prevent electronic shocking."*
- We start working our way through what looks like aeons of tape strata. Digging through the entire Earth's supply of tape feels a little like a chest burster emerging from a ribcage.
- We're free! Well, except for the billion cables yet to be disconnected.
 - ① Billion meaning approximately ten.

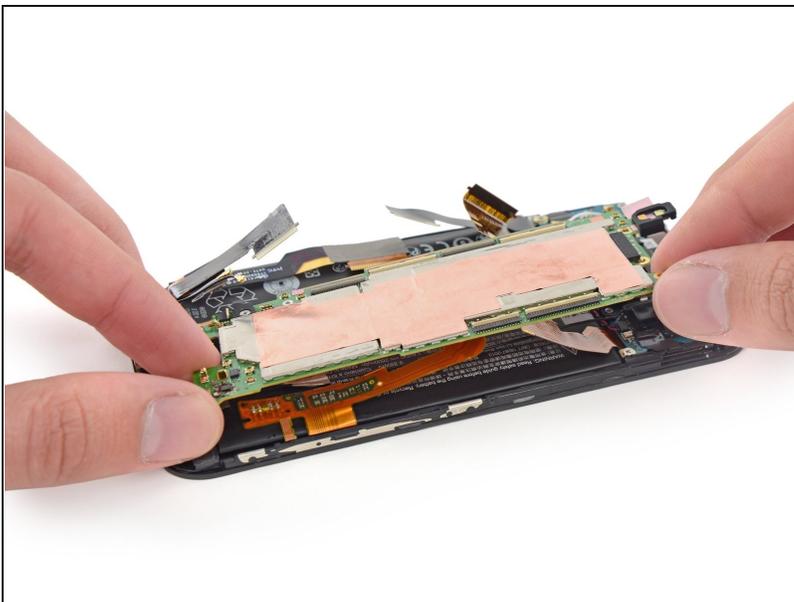
Step 8

- If the rear case removal sparked our hopes for an improved repairability score, this glued-down motherboard is a [bad sign](#).
- [To improve is to change; to perfect is to change often](#). From a repairability standpoint, we'd like to see more change from this One.

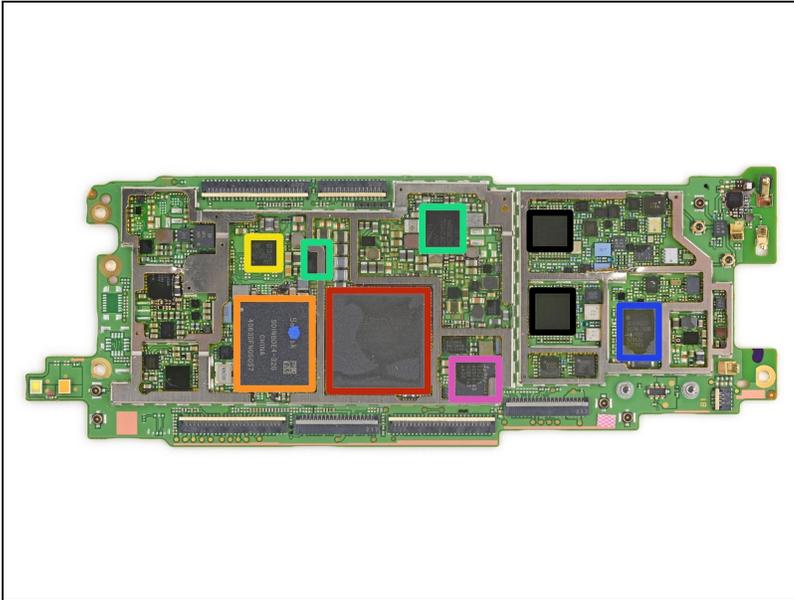
Step 9

- The shields are down! Here's what we found lurking below:
- Elpida FA164A2PM 2 GB RAM + Qualcomm Snapdragon 801 quad-core 2.3 GHz CPU
- SanDisk SDIN8DE4 32 GB NAND flash memory
- STMicroelectronics 0100 AA 9058401 MYS
- Qualcomm [PM8941](#) and [PM8841](#) power management ICs
- Avago [ACPM-7600](#) power amplifier module
- Synaptics S3528A touchscreen controller
- Qualcomm [WTR1625L](#) RF transceiver and WTR1625 (modem?)

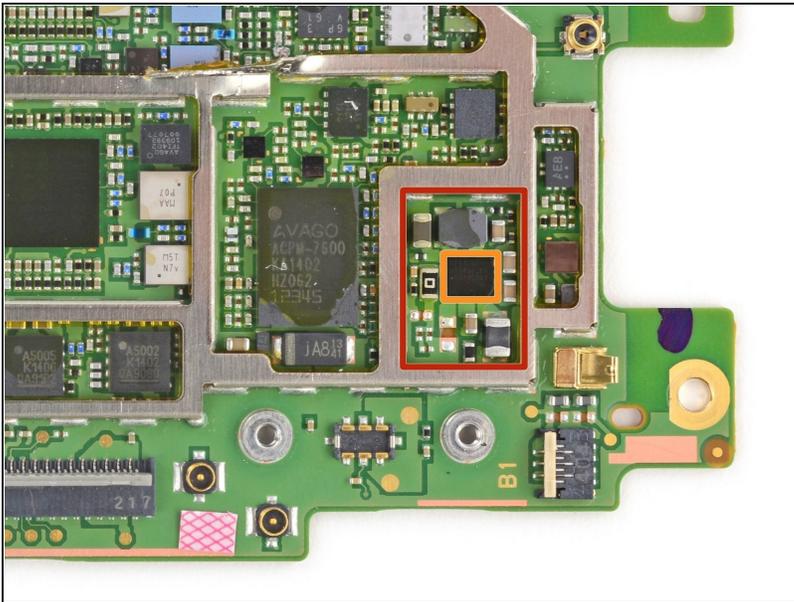
Step 10

- A close up of the RF front end, highlighting the Qualcomm ET subsystem. That's "Envelope Tracking", not "ExtraTerrestrial".
- Inside the red line is the Qualcomm QFE1100 ET IC, plus all the associated passives, weighing in at around 50mm² for the whole footprint.
- The QFE1100 ETIC itself

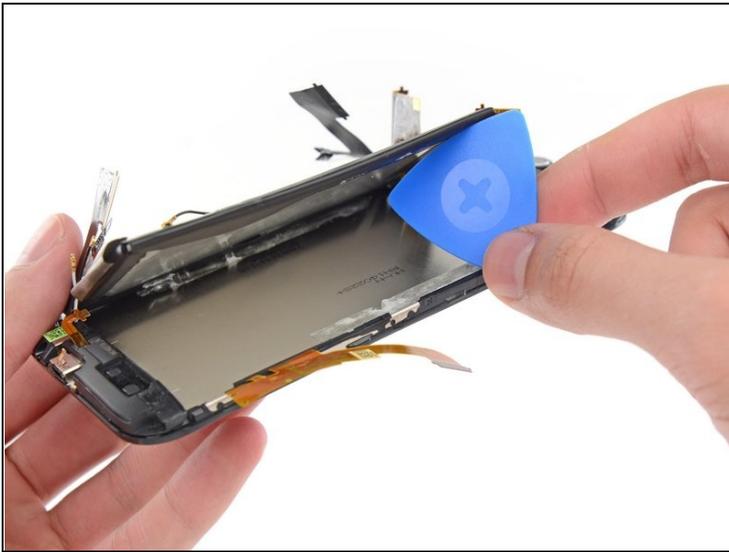
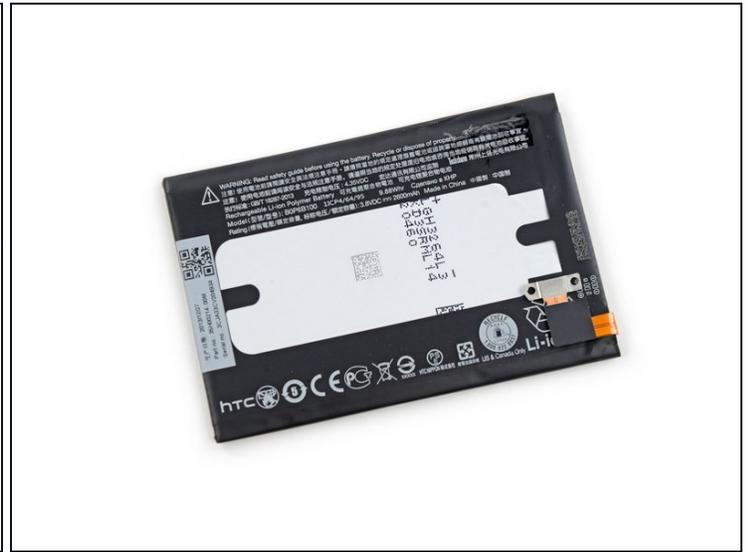
Step 11

- With the motherboard free, we turn our attention to the battery.
- You heard right: you have to remove the motherboard to get to the battery, [again](#), which is more than lightly adhered to the LCD shield.
 - ① This super-sized serving of adhesive is sure to be a health risk for the M8's repairability score. Too bad HTC doesn't take [a recipe from Google's book](#).
- HTC touted the all-new One's exceptional battery management, with up to 2 weeks of standby from a 100% charge, and 15 hours on 5%. Wowzers.
 - ① Much of this comes from low-power sensors and clever software, plus a 2600 mAh battery, up 300 mAh [from last year](#).

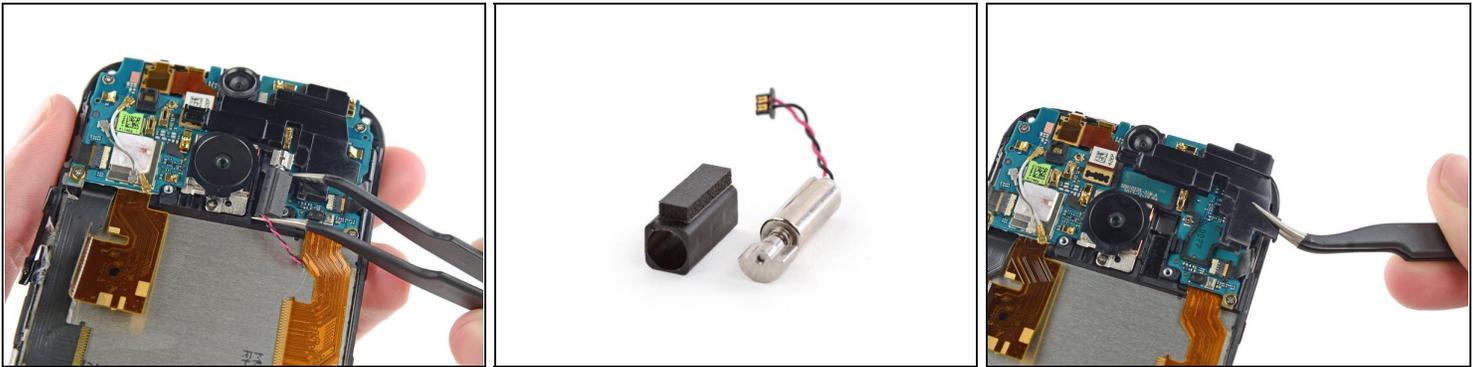
Step 12

- Time for a couple bite-sized goodies from the One:
 - The rotary vibrator motor lies in this square rubber case.
 - The earpiece speaker is backed by a plastic amplifying chamber, providing the required oomph for this half of the highly touted "BoomSound" stereo speakers.
- With the speaker chamber removed, we're cleared for take-off to get this daughterboard off the ground case.

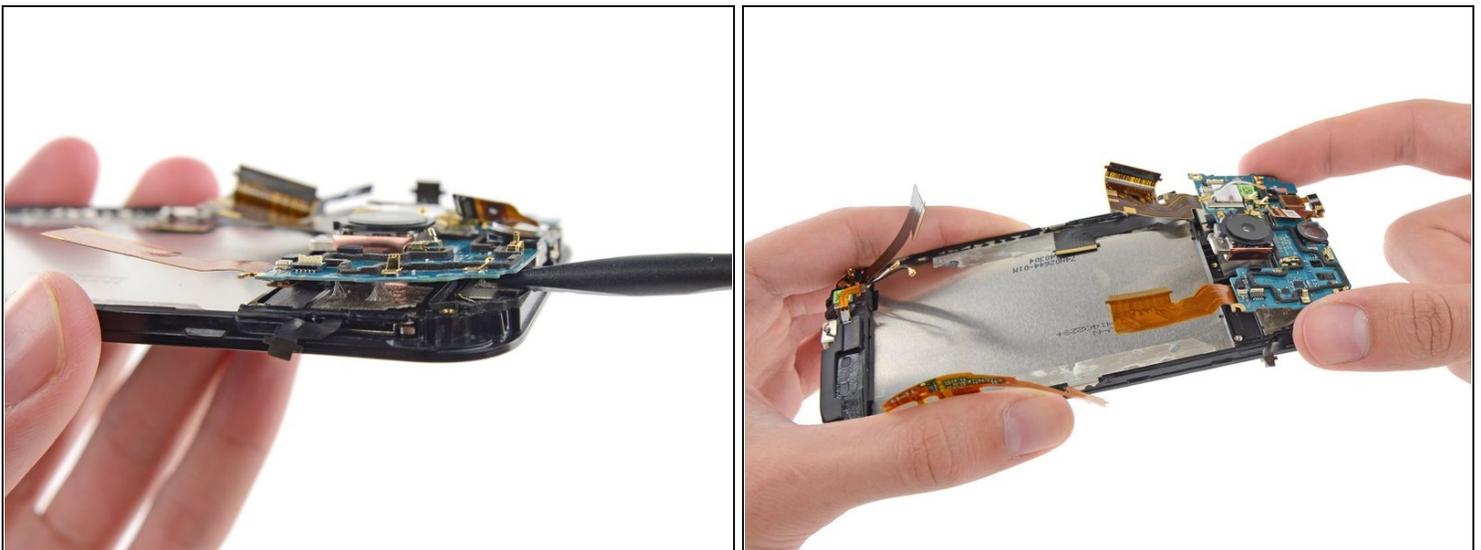
Step 13

- Or at least we thought we were, until we found the glue holding the board in place.
 - Our [will](#) spudger is strong, but our spudgering arm is getting mighty tired.
- With the daughterboard free, it's time to gather 'round for a peek at the fancy camera tech.

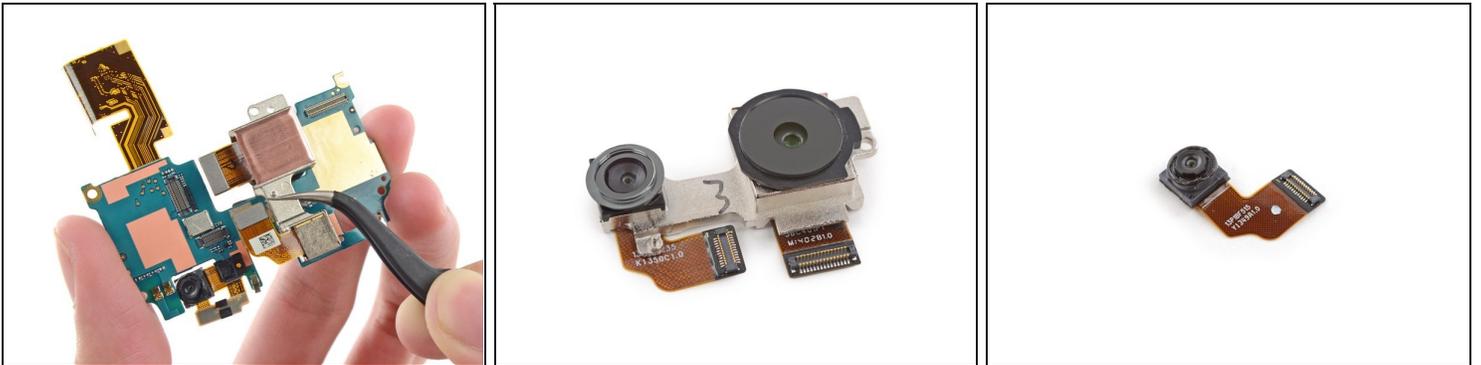
Step 14

- Chipworks found [last year's "UltraPixel" cam](#) to be a 4-megapixel affair. This revision likely has the same pixel count, but with larger pixels.
- Much more interesting is the addition of this secondary rear camera, which in concert with the first enables all sorts of fancy image data manipulation, retroactive focusing, and special effects.
- Not to be outdone, the intrepid selfie-cam gets a huge spec bump, leaping from last season's [2.1 megapixels](#) to a whopping 5.0 MP (more than selfiesufficient).

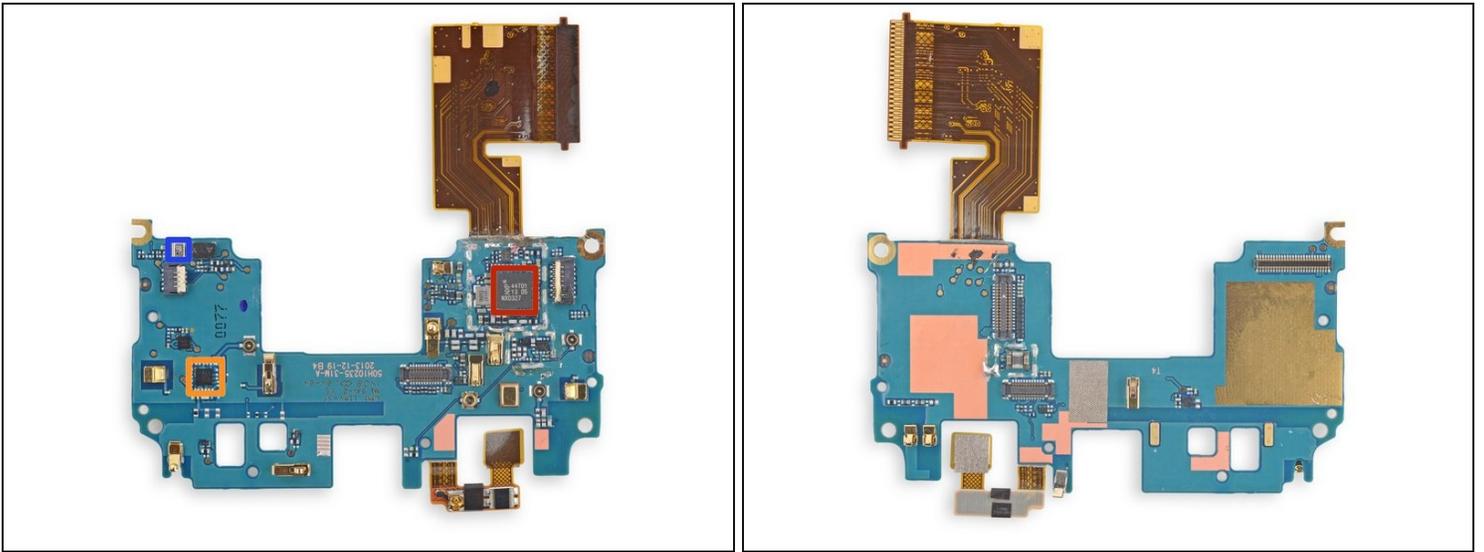
Step 15

- Keeping each other company on the now-sparsely-populated daughterboard are a couple of remaining chips:
 - NXP [44701](#) NFC controller
 - Bosch Sensortec BMP280 pressure sensor
 - Qualcomm [QFE1550](#) dynamic antenna matching tuner

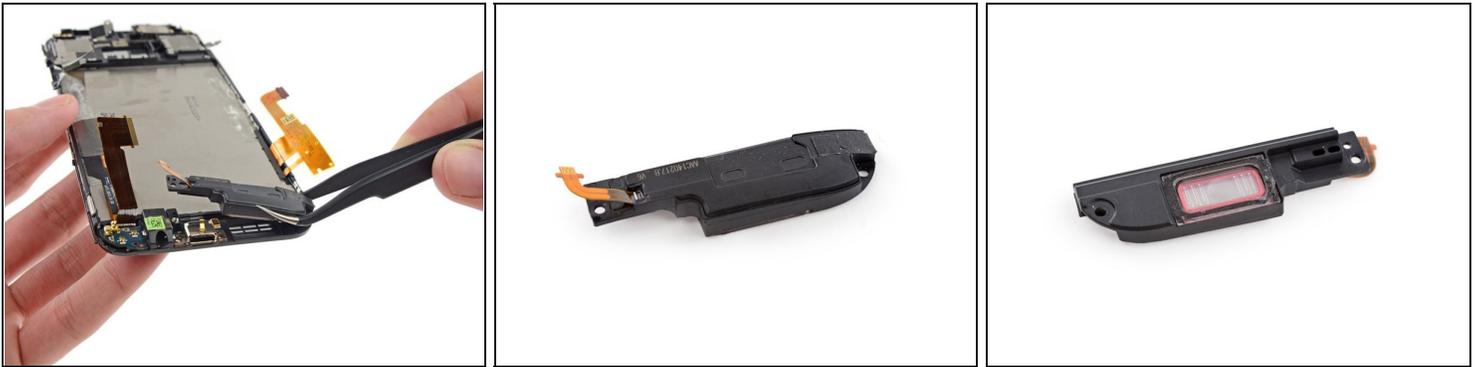
Step 16

- A tap of our [tweezers](#) and we step into ~~speakeasy~~ speaker action.
- Dr. Dre fans, beat your chests in sorrow: HTC's partnership with Beats Audio has ended. Despite this, early reviews confirm the speakers are quite good... for a phone.
- These HTC BoomSound speakers give some good vibrations, rated up to 95dB, or [just shy of a pneumatic drill](#).

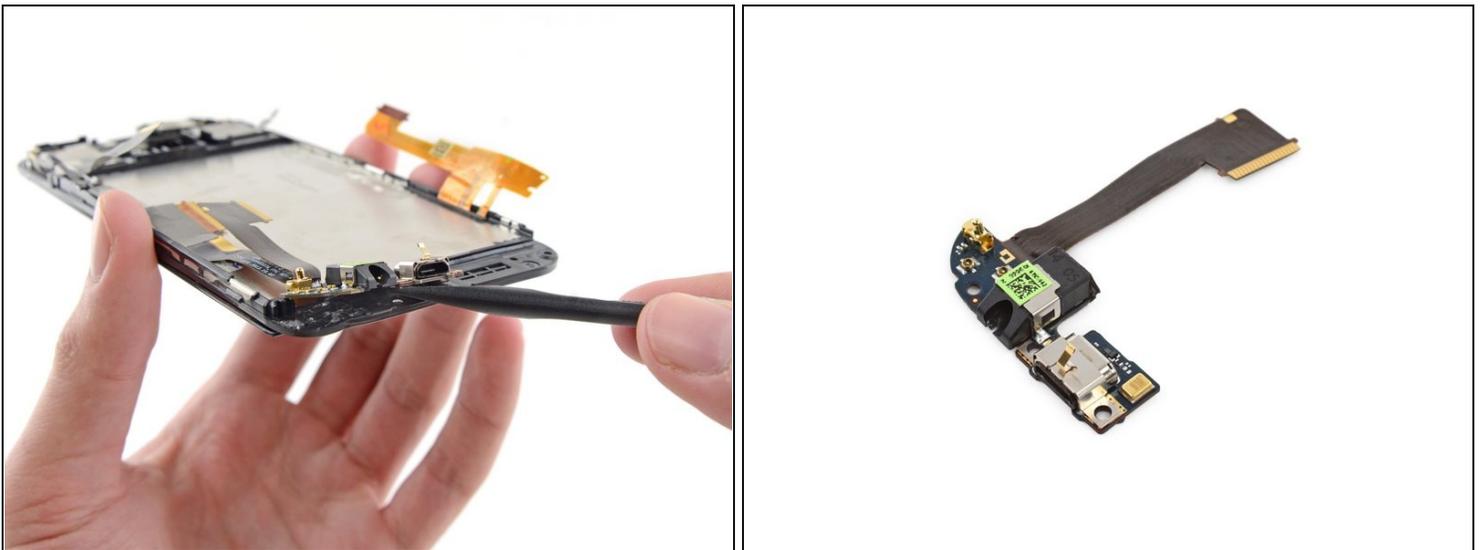
Step 17

- Last to leave the party is the 3.5 mm audio jack, now sharing a small cable assembly with the microphone and micro-USB port on the bottom of the phone.
- We give it a gentle nudge out the door with the spudger. [The end is in sight...](#)

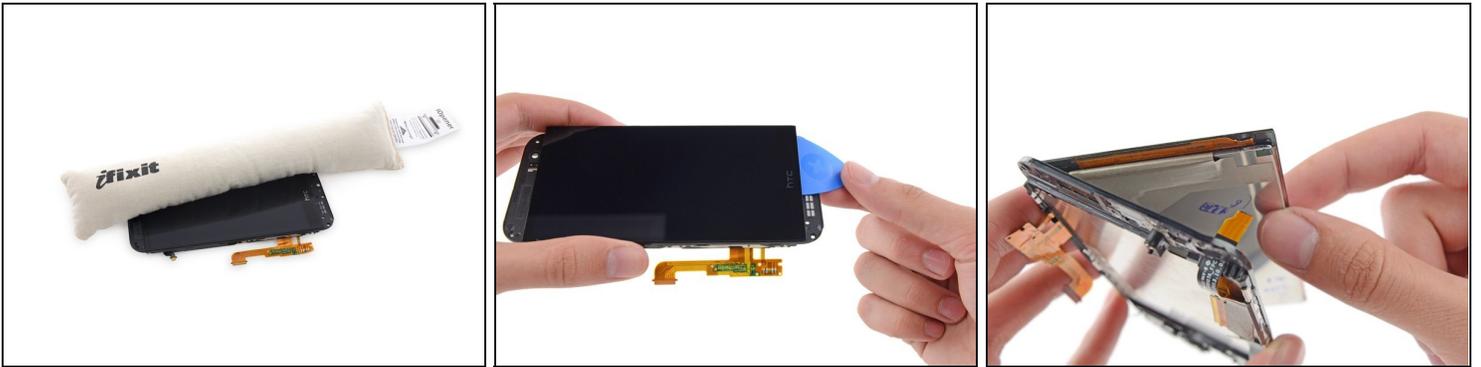
Step 18

- With the front panel mostly stripped down, we finally get to display removal.
 - ① "Finally" because we've gotten accustomed to Apple's [display-out-first iPhone assembly](#)—which greatly simplifies display repairs—so we're not sure why some manufacturers insist on burying both the screen and the battery. At least make one easy to replace!
- Liberal heat around the edges of the glass and we're able to easily slide an opening pick around the perimeter, separating the adhesive.
 - ...A little too easily, in fact, as we discovered the exact **wrong place** to slice and dice, severing the digitizer cable.
- ① Feel free to thank us for our noble sacrifice, breaking our phone so you don't have to.

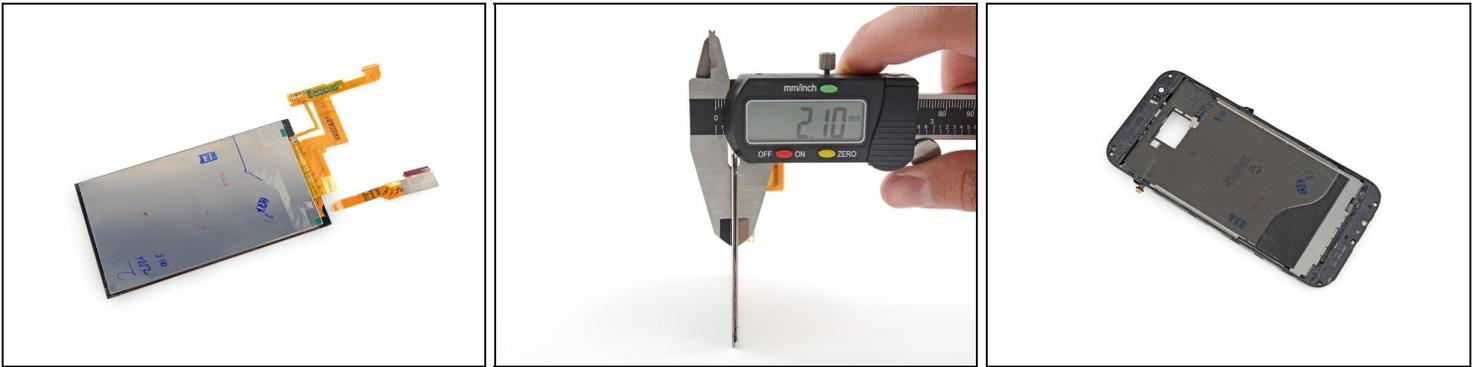
Step 19

- ① What a trial, to remove and replace the screen. Luckily HTC acknowledges the difficulty and provides [one free screen replacement](#) on your new M8 (in the first six months). Don't break it after that.
- With all of the quality control stamps and signatures on the back of the 1080p display, we're reminded of a certain [Macintosh](#) we recently tore down.
- To make a thin phone (9.4 mm), you need thin components. The fused LCD and digitizer measures little more than 2 mm.
- Down to a bare midframe, it's time for the teardown team to high-five, have a beer, and mull over the storm of a repairability score to come.
- ① Spoiler alert: it's going to look a lot like [this One](#).

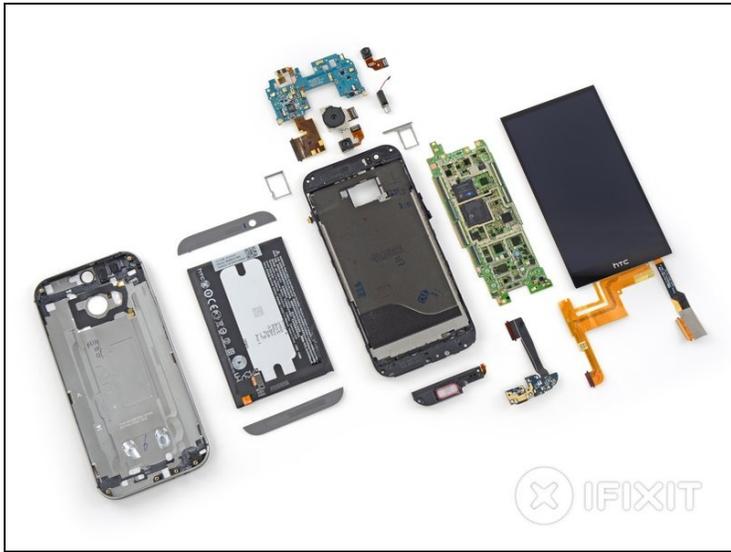
Step 20

- HTC One M8 Repairability Score: **2 out of 10** (10 is easiest to repair)
 - It's very difficult—although no longer impossible—to open the device without damaging the rear case. This makes every component extremely difficult to replace.
 - The battery is buried beneath the motherboard and adhered to the midframe, hindering its replacement.
 - The display assembly cannot be replaced without tunneling through the entire phone. This makes one of most common repairs, a damaged screen, very difficult to accomplish.
 - Copious amounts of tape, adhesive, and copper shielding make many components difficult to remove and replace.
 - Solid external construction improves durability.
