Cr-48 Chromebook Network Card Replacement

The Cr-48 Chromebook shipped with a combined Wi-Fi / Cellular network card that can be easily removed and replaced if necessary. Use this guide to replace a malfunctioning network card in a Cr-48 Chromebook.

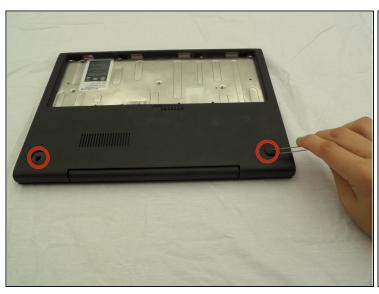
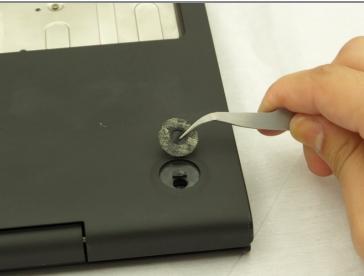
Step 2 — Remove Rear Rubber Feet

• Using a pair of tweezers, remove the two rear rubber feet to expose two hidden screws.
