# RCA RCT6378W2 Volume Button Replacement

This guide will illustrate faulty volume button removal and replacement.

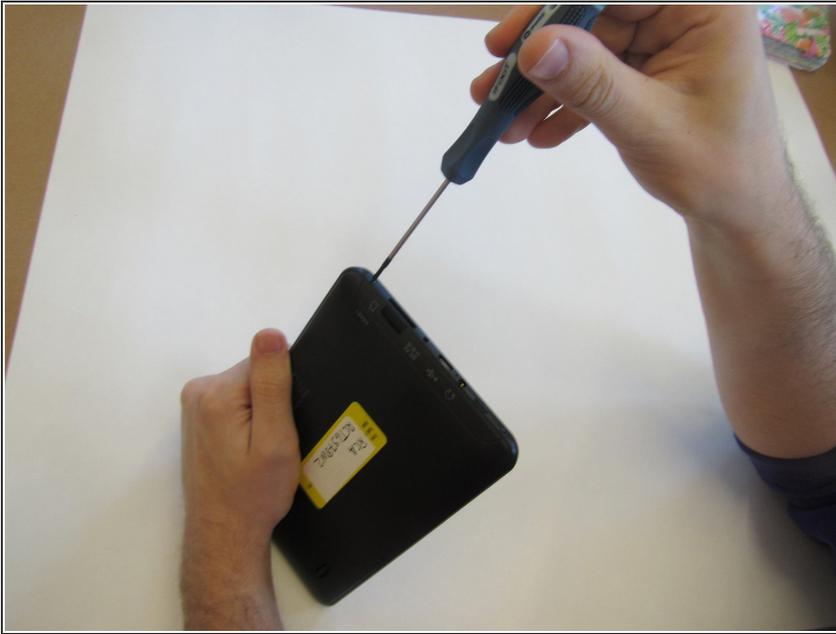
## Step 1 — Removal of Back Cover

- Remove the two 2.4mm x 4mm screws from the bottom of the tablet with a Phillips #00 Screwdriver.

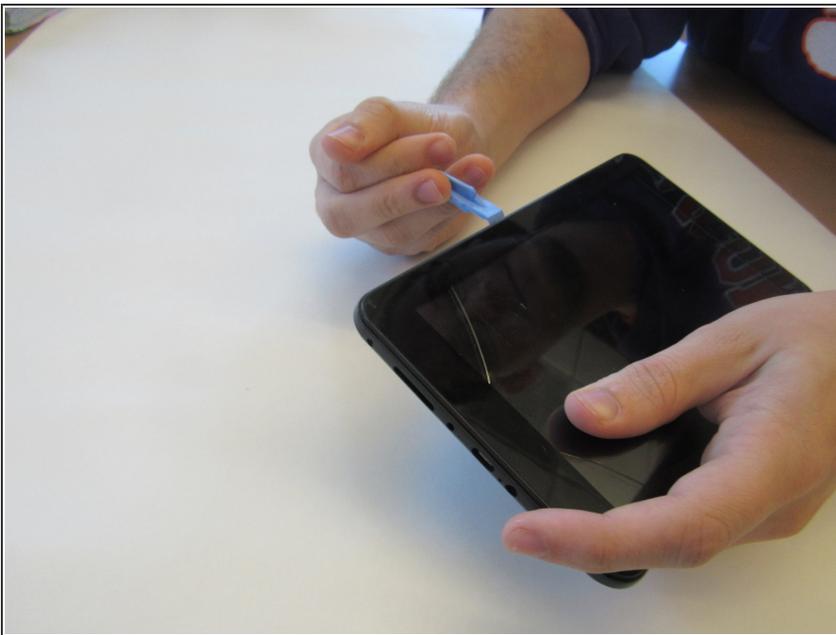
## Step 2 — Cover Separation

- Separate the front and back covers using one of the plastic opening tools.

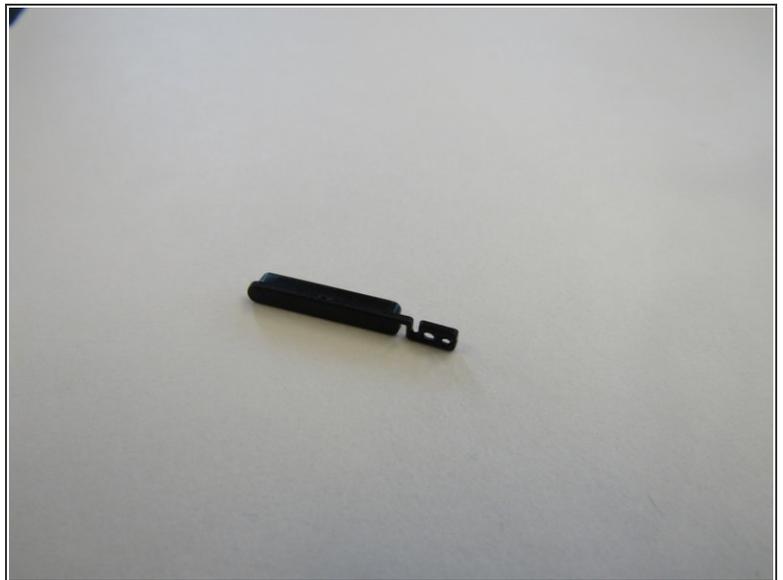
### Step 4 — Insertion of New Button

- Align and place the new replacement button with positive and negative engravings facing outward into the volume space found in the cover.
