Cobra SPX 5300 Audio Dial Replacement

Replace your audio dial if you are having problems with audio distortion in the Cobra SPX 5300.

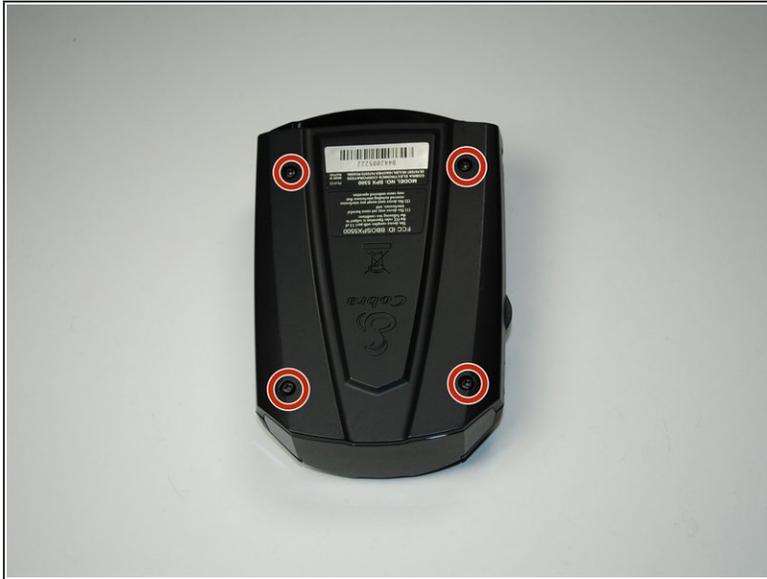
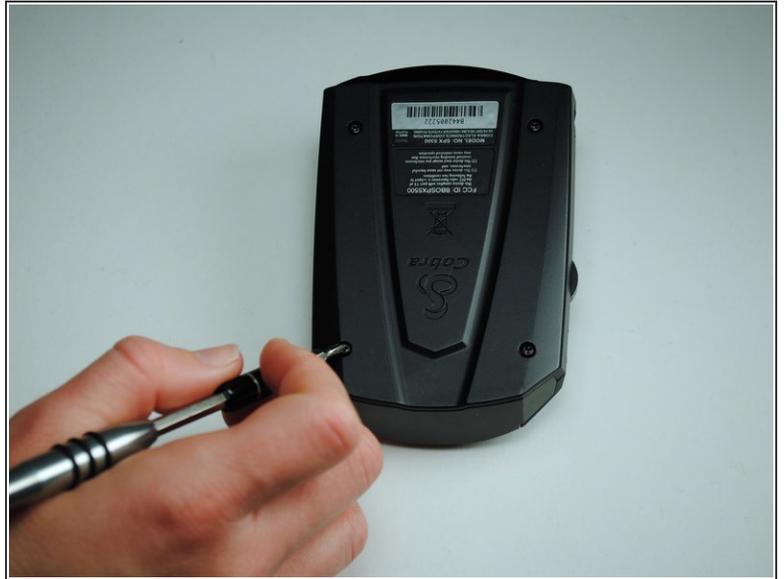
Step 1 — Windshield Bracket Mount

- Remove the four 9.5 mm Phillips #0 screws from the back of the device.

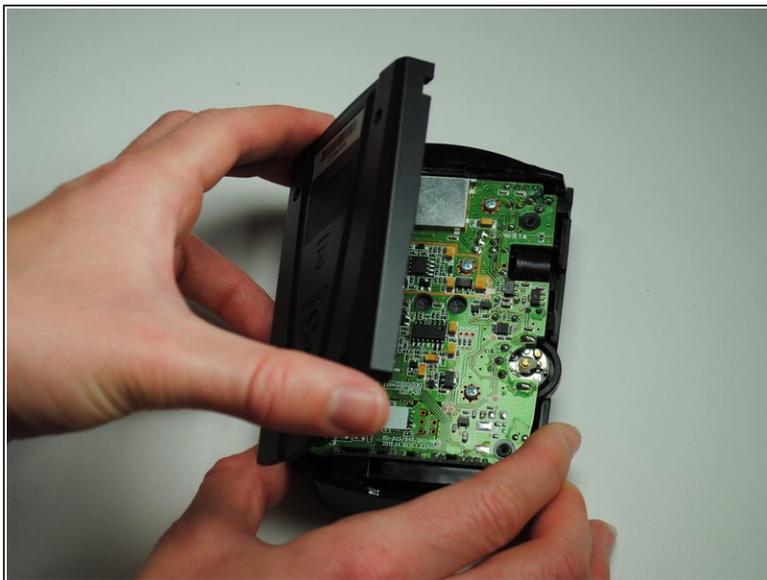
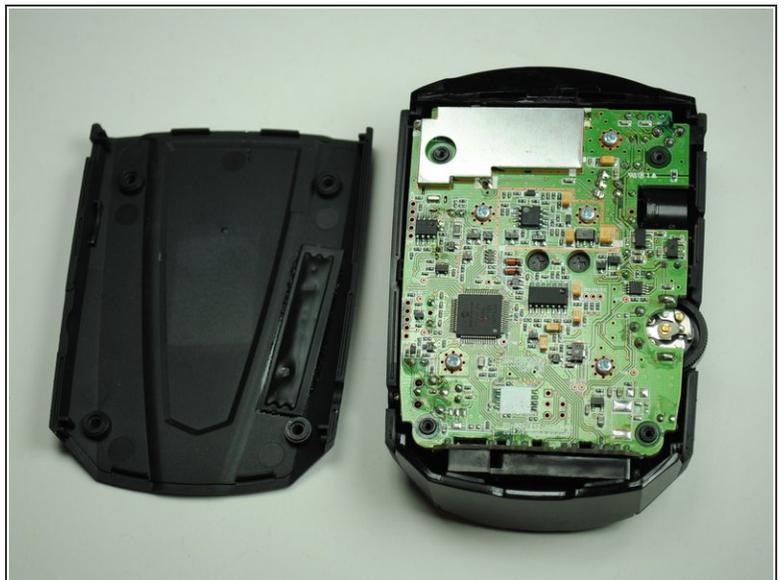
Step 2

- Pull the black plastic back case off of the device.

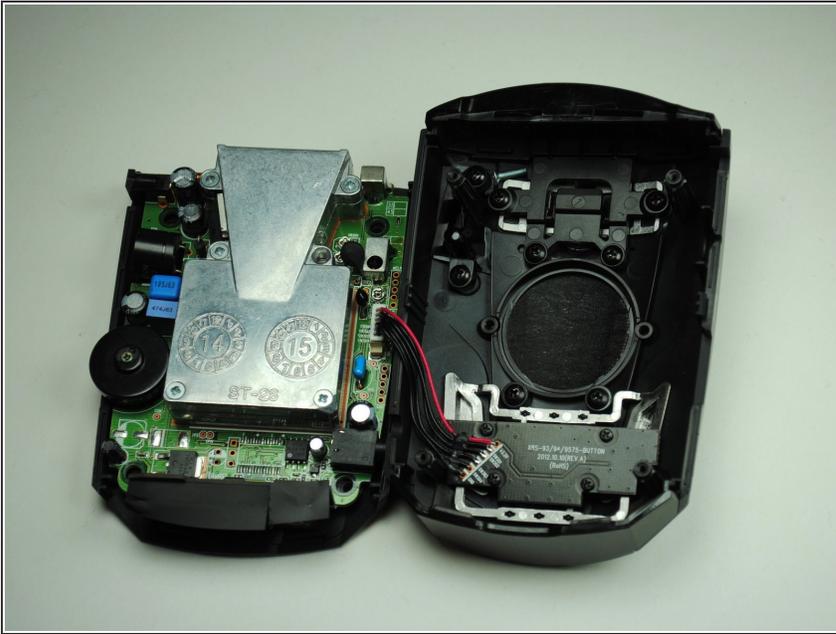
Step 3

- Lift up the motherboard and lay it flat next to the device.

⚠ Be careful not to sever the wires. The buttonboard is connected to the motherboard by the wires.

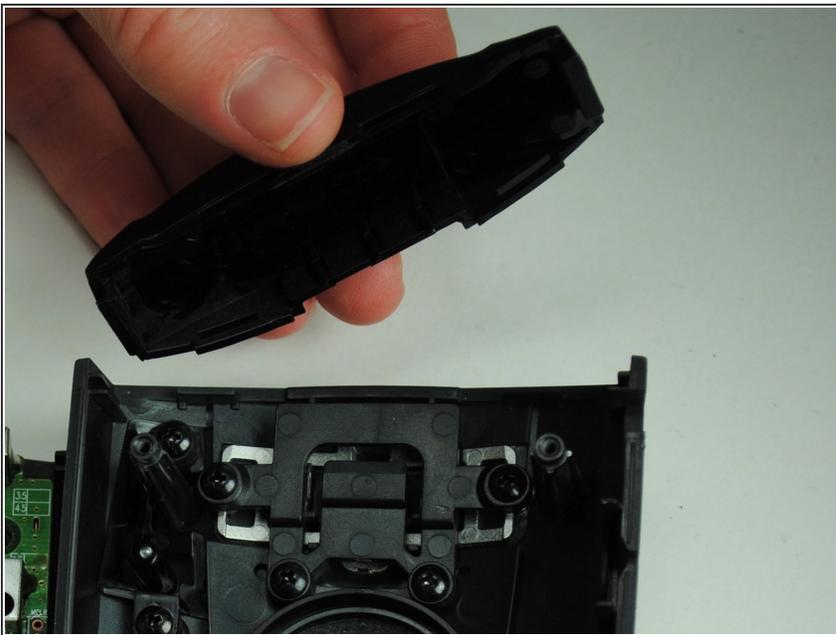
Step 4

- Remove the windshield bracket mount.

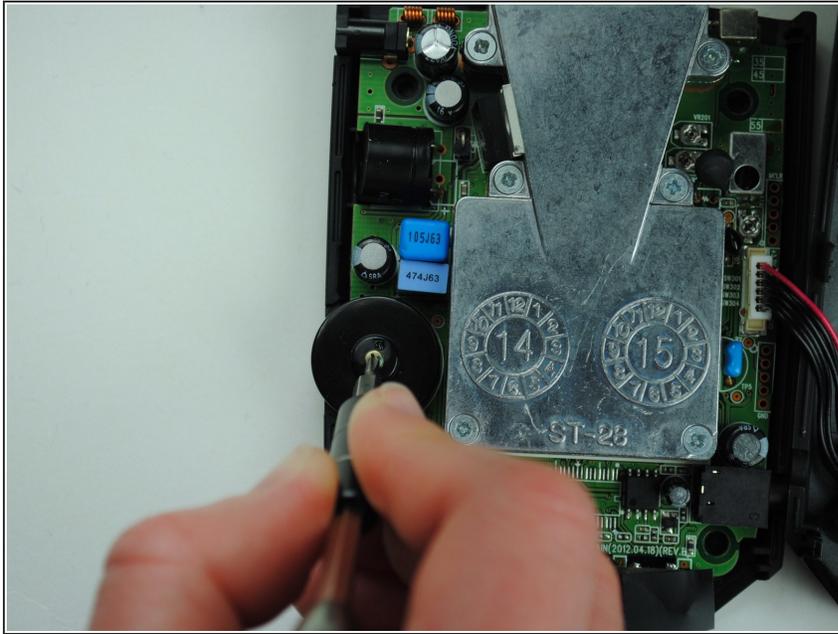
Step 5 — Audio Dial

- Remove the one 4.8 mm Phillips #00 screw from the center of the audio dial.

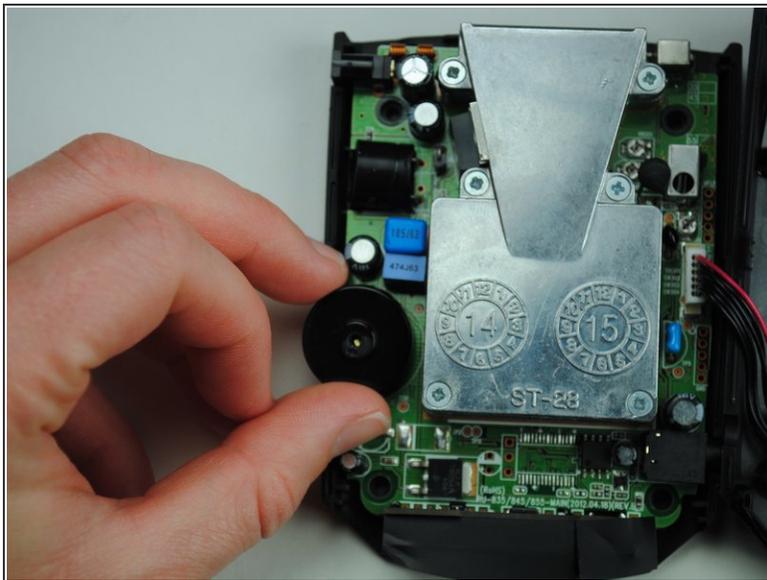
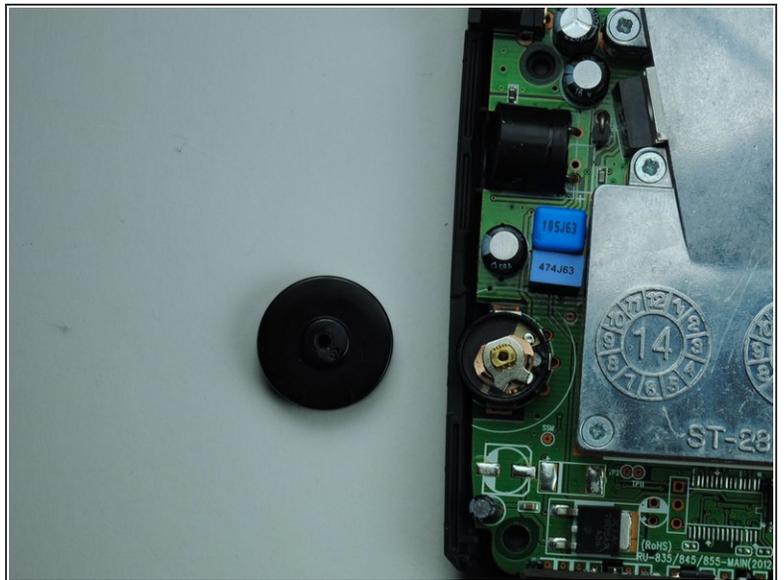
Step 6

- Remove audio dial.

To reassemble your device, follow these instructions in reverse order.
