Slingbox SOLO DC Power Connector Replacement

Replace the faulty DC Power Connector to bring power back to the Slingbox.

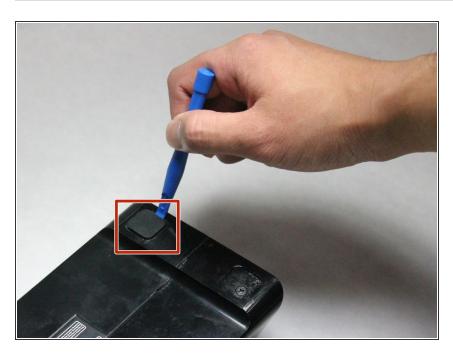
Step 1 — Motherboard

Use the plastic opening tool to remove the four rubber pads from the bottom of the device.

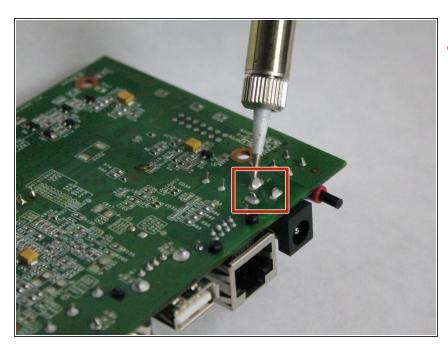
Step 4 — DC Power Connector

- Do not touch the heated tip of the soldering iron.
 - (i) Check this guide out to learn how to use a soldering iron.
 - Desolder all three lead prongs.
- Gently pull the DC power connector from the motherboard.
