# Leader Impression i10A-LE Back Facing Camera Replacement

Replacing the back facing camera to take pictures with your Leader Impression i10A-LE.

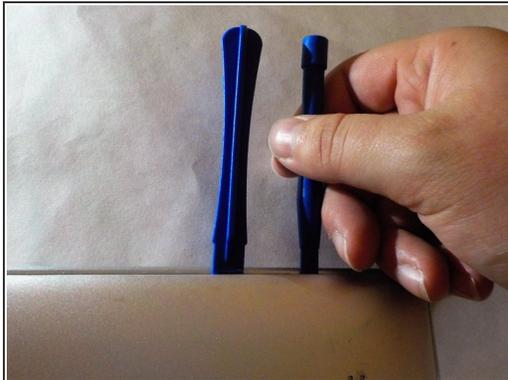
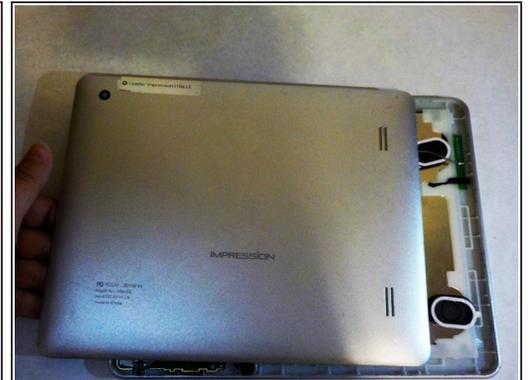
## Step 2

- Start by prying the back off by using plastic opening tools.
- Using the plastic tools slide the flat end into the device.
- Gently pry the back piece until you hear a popping noise.
- Once the back is loose, remove it from the device and set aside.

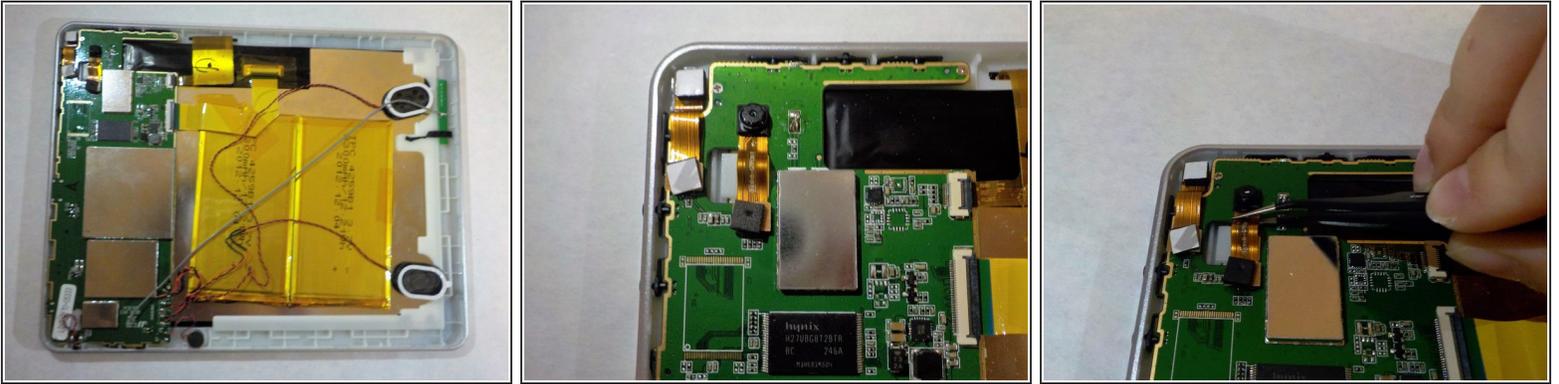
### Step 3

- Once the back is off, locate the back facing camera.
- The camera will be in the top left corner.
- Using the precision tweezers that are bent, gently grab the strip below the camera.
- slowly lift up until the camera lifts from its spot.
